## **Volvo Chassis - Models VNL, VNX Only Equipped With A USD16 Volvo Engine - AHI Harness Failure Related Fault Codes P249F00, P20DD13, P113413**

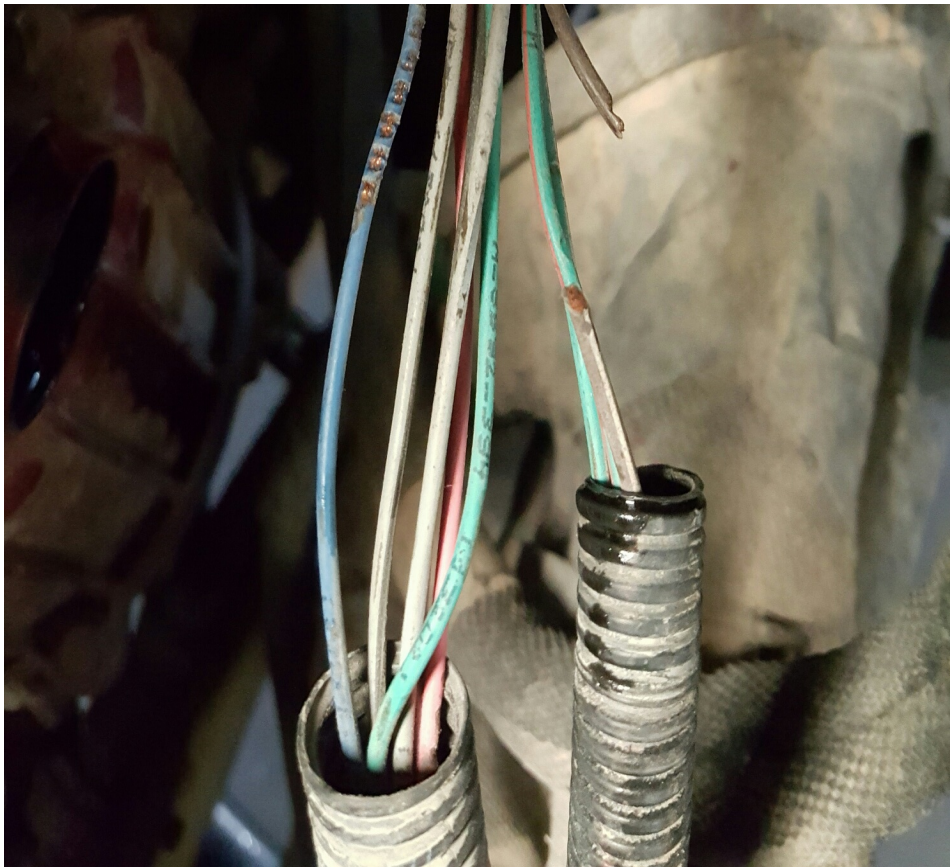
Once the AHI harness has been inspected and found to have failed internally, example as seen in the picture below, it will need to be replaced.
