## Volvo Chassis - FSB 891 - 021, Center Fairing, Repair

## 89004-9 FSB 891-021, Center Fairing, Repair

(May 2019)

On some VOLVO trucks, the fixed chassis fairing rails can come loose from the truck. This is due to the fairing rails rubbing and thus wearing faster than acceptable. To correct this issue follow the instructions outlined in the documents below.

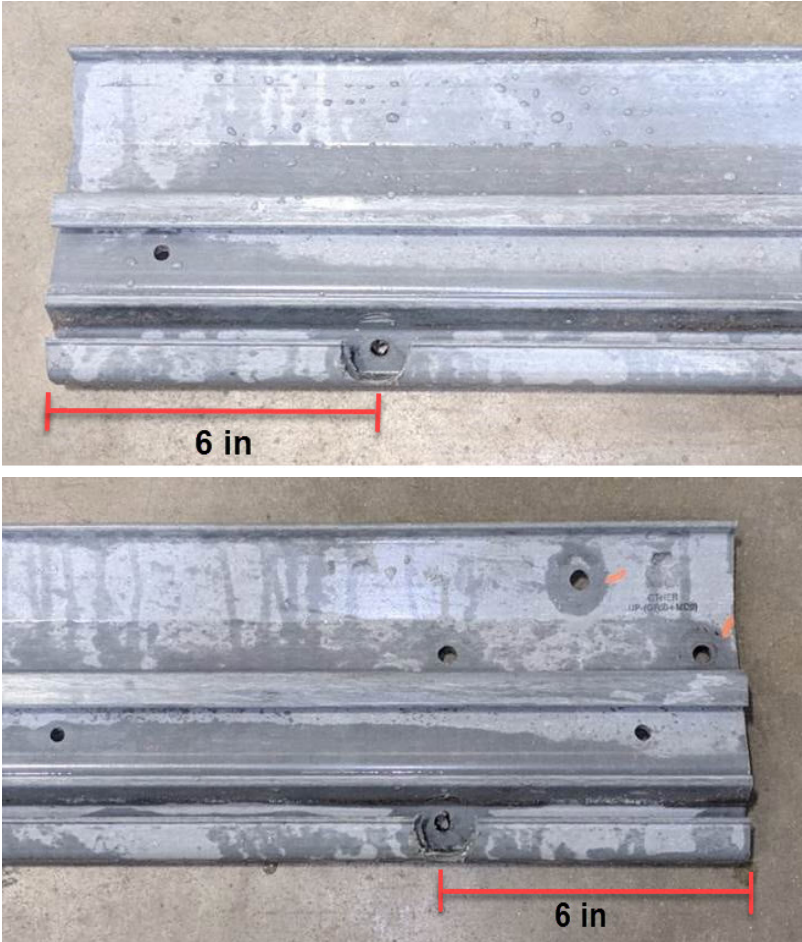
##### 2.1 Make sure the hole saw only drills through the outboard portion of the "hook"

##### 2.2 Pilot bit should drill through the lower support

Hole saw should remove only the outboard portion of the support.

#### 2. Use 1in hole saw and drill a hole 6in from each end of lower support (See below pictures for more details)
