PANORAMIC SUNROOF DIAGNOSIS

This Service Information Bulletin (Revision 4) replaces SI B54 11 19 **dated July 2021**.

SUNROOF DIAGNOSIS

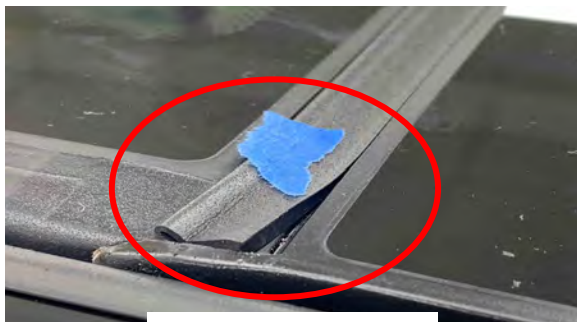
FRONT CENTER SEAL LOOSE/SHRINKING

Defect: separated

Situation: Excessive water enters through the sunroof seals.

Repair: Look for gap near end of the seal on front glass. If found, replace seal according to ISTA/AIR instructions REP 54 13 052. Also refer to B54 04 21.

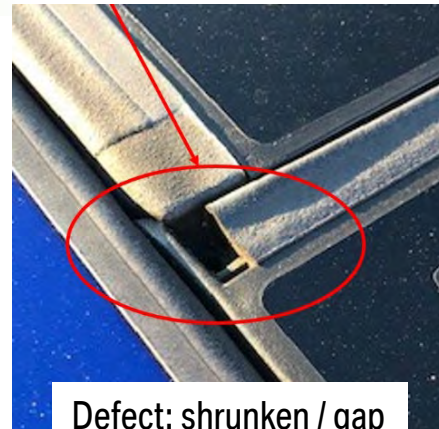
Defect: shrunken / gap

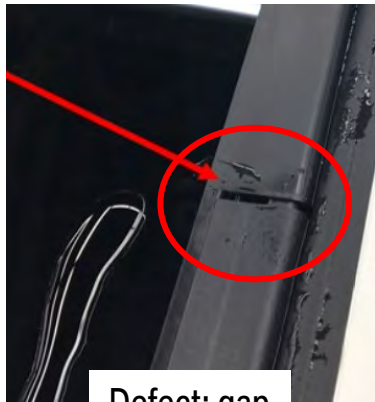
Defect: gap

Situation : Excessive water enters through the sunroof seals. (see pictures)

Repair: Look for gap near ends or twist in seal. If found, replace seal according to ISTA/AIR instructions.
REP 54 13 050

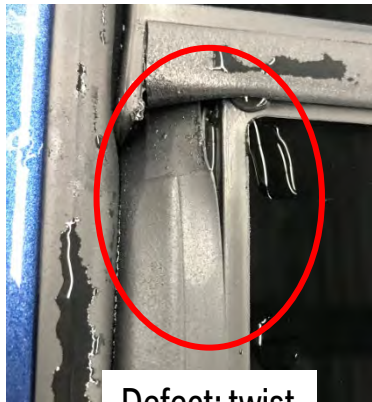
Defect: twist

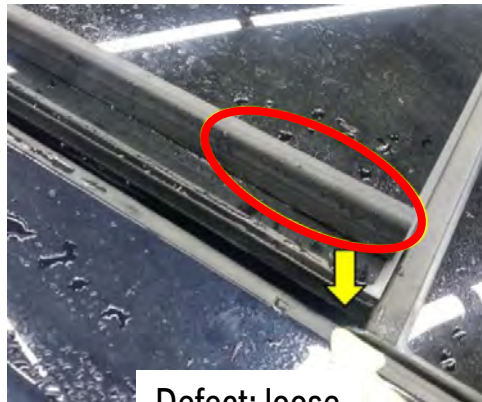
Defect: loose

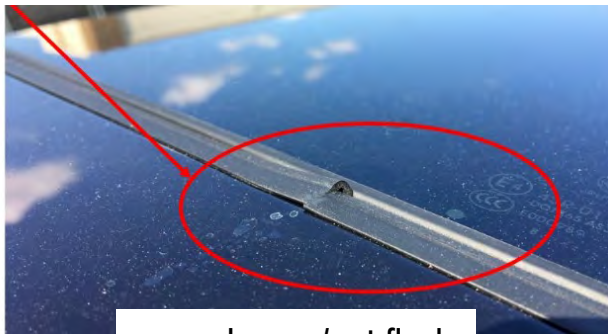
BODY SEAL NOT ATTACHED

example: gap/not flush

Repair: Inspect the sunroof perimeter seal for defects. Replace body seal according to ISTA/AIR instructions REP 54 13 055.

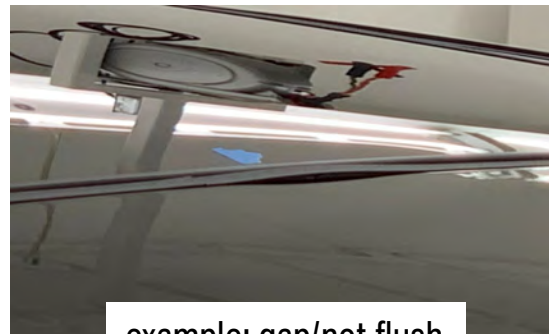
example: gap/not flush

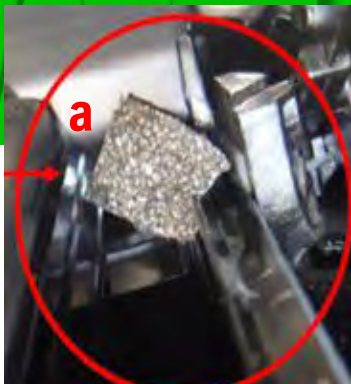
Defect picture foam (a)

Situation: Water leaks near the middle drain channel

Repair: Check position of the seal/foam.
Remove foam/seal If deformed or damaged. Improved seal being developed. SI B will publish when available.

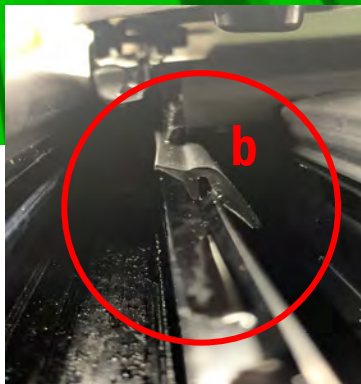
Defect picture seal (b)

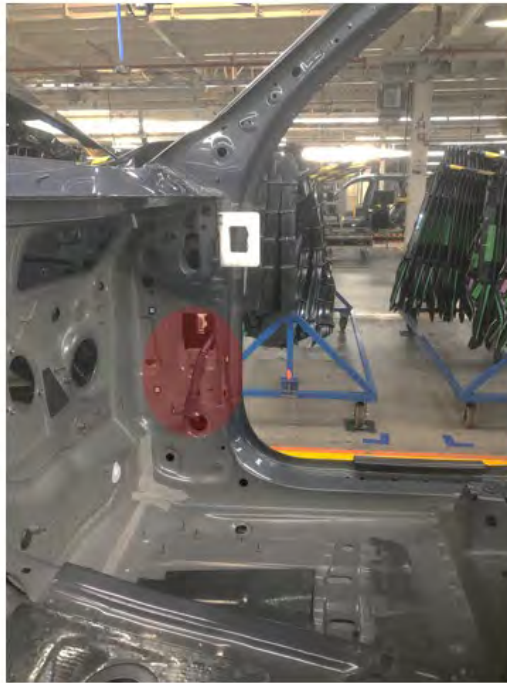
twisted

Situation: There is a water leak near the front or rear carpets. The drain tubes may be twisted. Remove A-pillar kick panels to check if front drain tube is twisted/kinked. Use borescope if needed.

Repair: Reposition hose to remove kink. If kink can't be removed, refer to B54 11 19 Attachment 1 for repair instructions.

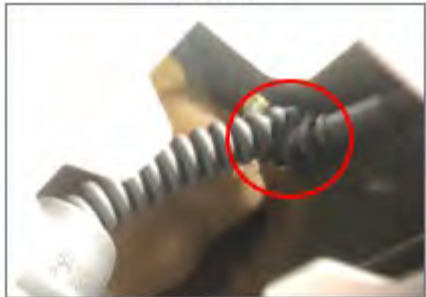
kinked

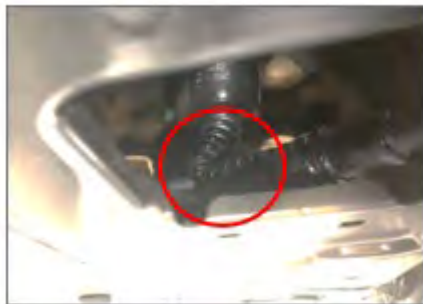
Slightly kinked

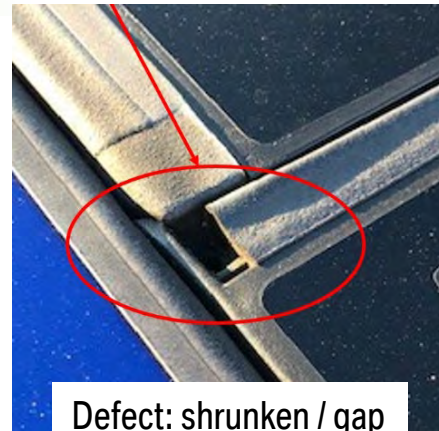
Defect: shrunken / gap

Repair: Replace seal according to ISTA/AIR instructions REP 54 13 052. Refer to B54 04 21.

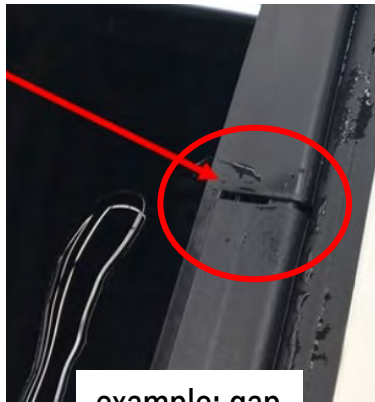
Situation: Wind noise heard at speeds of 30mph.

example: gap

Repair: Look for gap near ends or twist in seal. If found, replace seal according to ISTA/AIR instructions.
REP 54 13 050

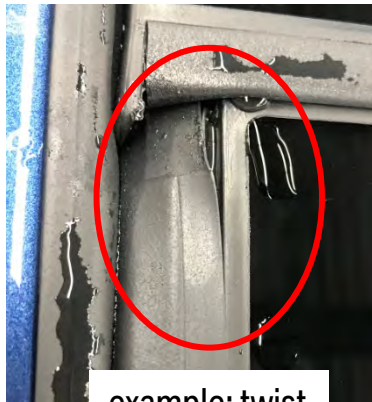
example: twist

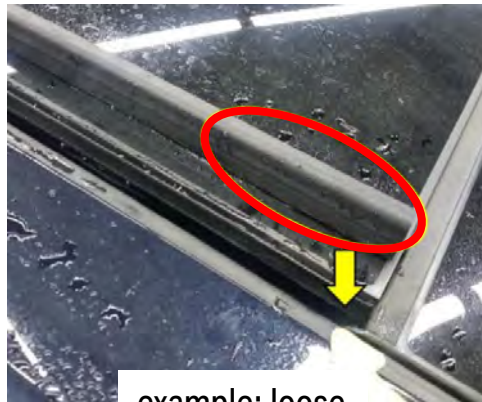
example: loose

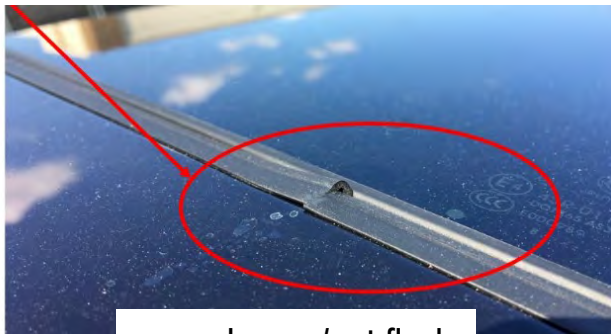
example: gap/not flush

Situation: The body seal may be detached or improperly installed.

Repair: Check body seal to see if it is flush to vehicle. (no loose areas/wrinkles)

If damaged, replace body seal according to ISTA/AIR instructions REP 54 13 055.

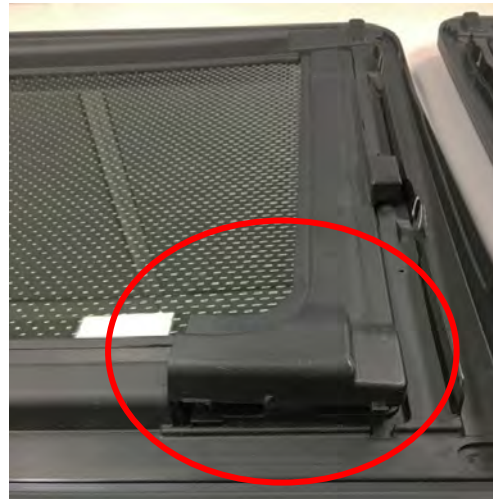
example

Situation: Rattle is heard from plastic cover tapping on glass panel (front or rear glass) when driving on rough road surfaces.

Repair: Attempt to insulate with felt tape is visually appropriate. Replace glass panel according to ISTA/AIR instructions REP 54 13 250 if insulation is not possible.

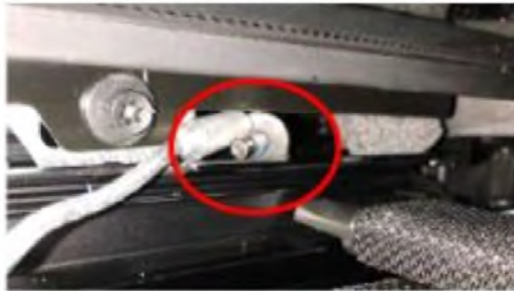
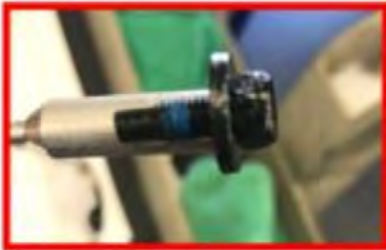
Situation: A metallic “rolling” noise is heard during acceleration/deceleration. An extra screw may have fallen into the track during production. The screw is not missing from any location.

Repair: Remove the extra screw. Additional repairs are not necessary, all other screws are correctly installed.

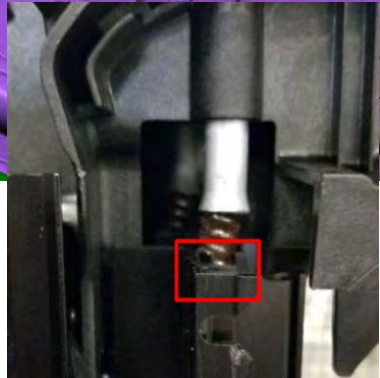
Defect: misaligned or burr

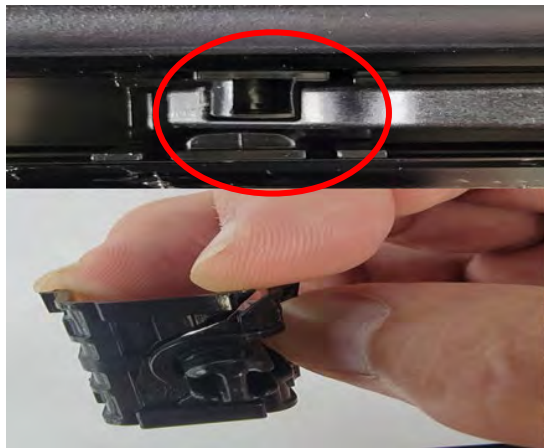
Situation: A creaking noise is present while the wind deflector raises/lowers. Sunroof may reverse due to anti-trap when closing.

Repair: Replace pivot point and wind deflector according to ISTA/AIR instructions REP 54 13 090

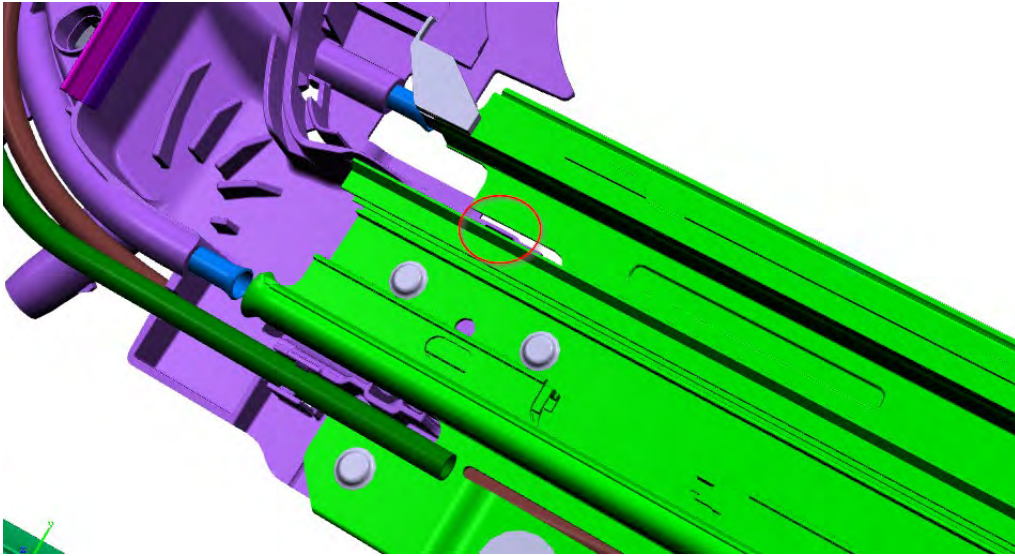
WIND DEFLECTOR EXCESS BUTYL

Picture of NOK (Before adjustment)

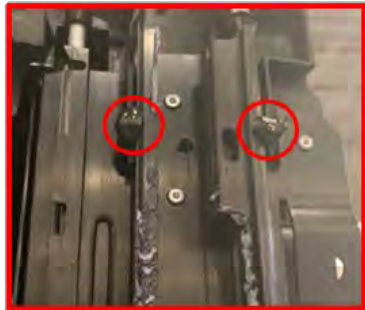
Situation: A popping noise is heard when the wind deflector raises/lowers.

Repair: Remove excess butyl to allow the wind deflector to move freely.

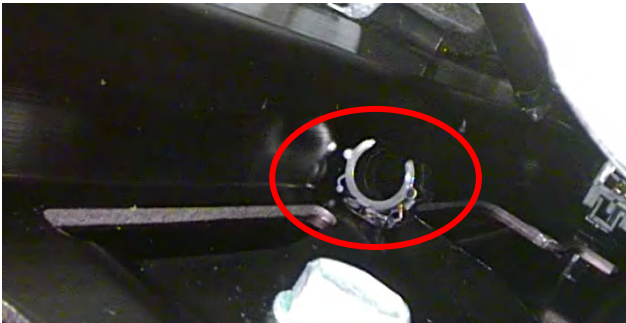
RELIEF CABLE TUBE NOT INSTALLED

Situation: A humming / crackling noise is present when opening the glass or sunshade.

Repair: Replace frame according to ISTA/AIR instructions REP 54 13 261.

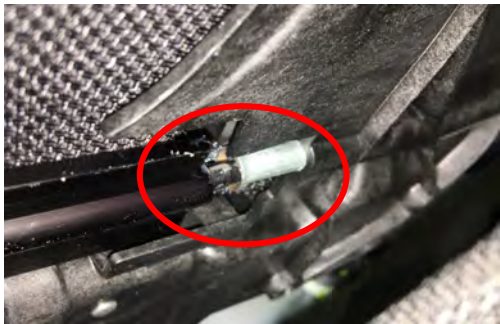
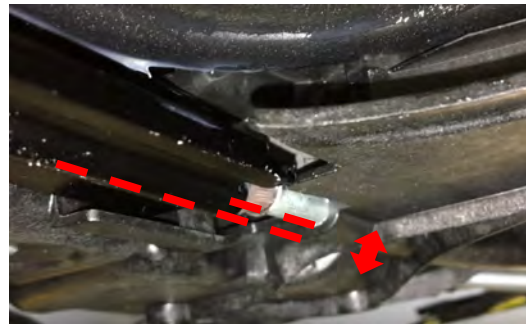
CABLE TUBE CLIP NOT INSTALLED

Situation: A humming / crackling noise is present when opening the sunshade. Or, a plastic rattling noise is heard while driving on rough road surfaces.

Repair: Reinstall the guide tube clip into the frame. If tube is damaged and noise persists then replace the frame according to ISTA/AIR instructions REP 54 13 261.

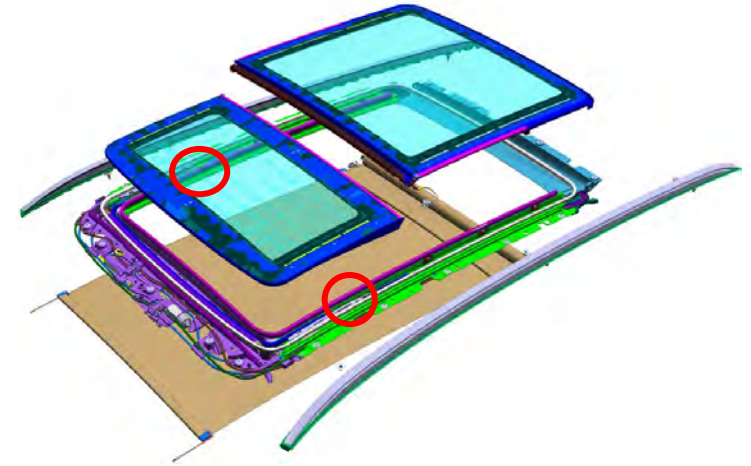
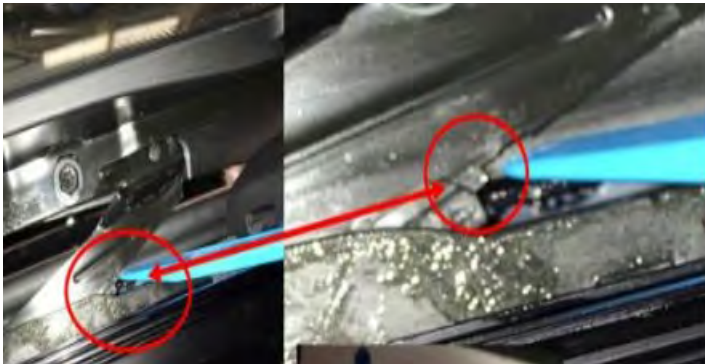
MECHANIC ARM BURR

Situation: A clicking sound is present when the glass is opened to vent.

Repair: Inspect the pivot area for a burr and remove it if found. If burr is not found then replace the sunroof mechanisms according to ISTA/AIR instructions REP 54 13 515.
