# Service Bulletin

Bulletin No.: 19-NA-111

**Subject:** Ticking/Rattle Noise from B-Pillar Area

| Brand: | Model: | Model Year: | | Date Breakpoint: | | Engine: | Transmission: |
|---|---|---|---|---|---|---|---|
| Chevrolet | Blazer | 2019 | 2021 | | | All | All |

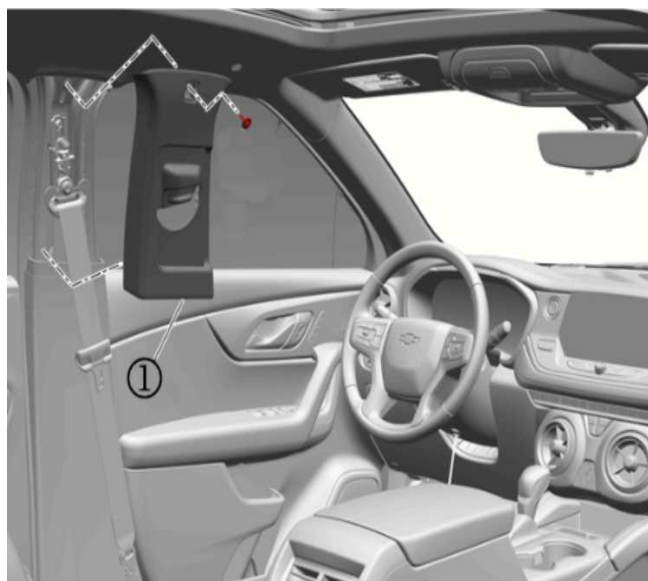
4573545

| <b>Cause 2</b> | This condition may be caused by sheet metal surface to surface contact, between the inner panel and the sheer plate, located behind the upper trim panel on the B-pillar. |

1. Remove the center pillar upper trim panel (1) on the affected side. Refer to in SI. *Center Pillar Upper Trim Panel Replacement*, in SI.

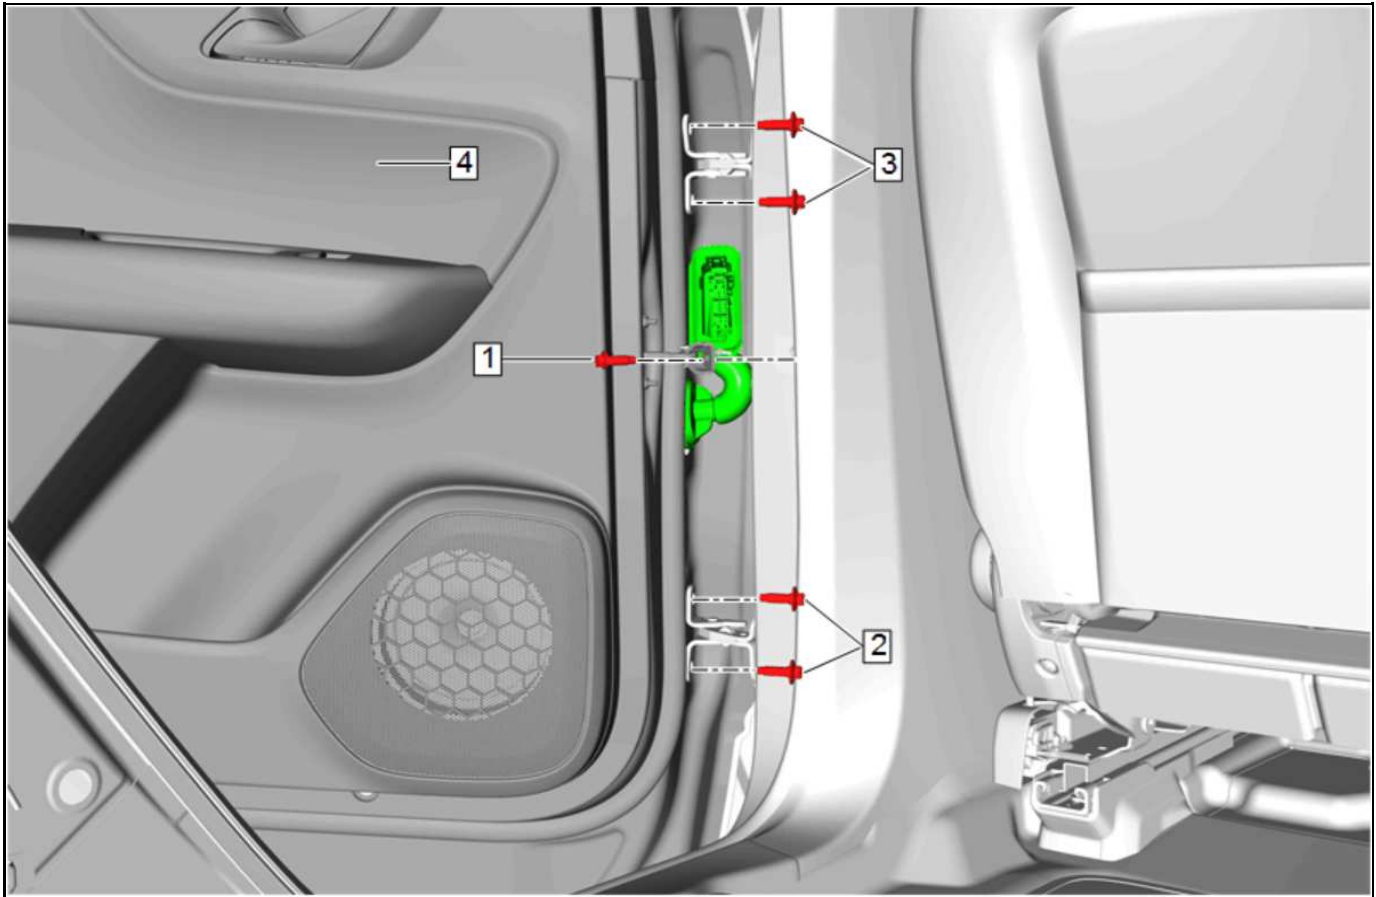
5132108

| Cause | The cause of the condition may be a flexing between the upper center pillar outer panel structure and the upper hinge inner reinforcement plate. |

1. Remove the rear door from the side of the vehicle affected with the tick noise. Refer to *Rear Side Door Replacement*, in SI.
