STAR ONLINE PUBLICATION

Case Number: S2102000005

Release Date: August 2021

Symptom/Vehicle Issue: Slower Than Normal Raising Time And Or Failure To Achieve Desired Ride Height And OR Difference In Front Ride Height

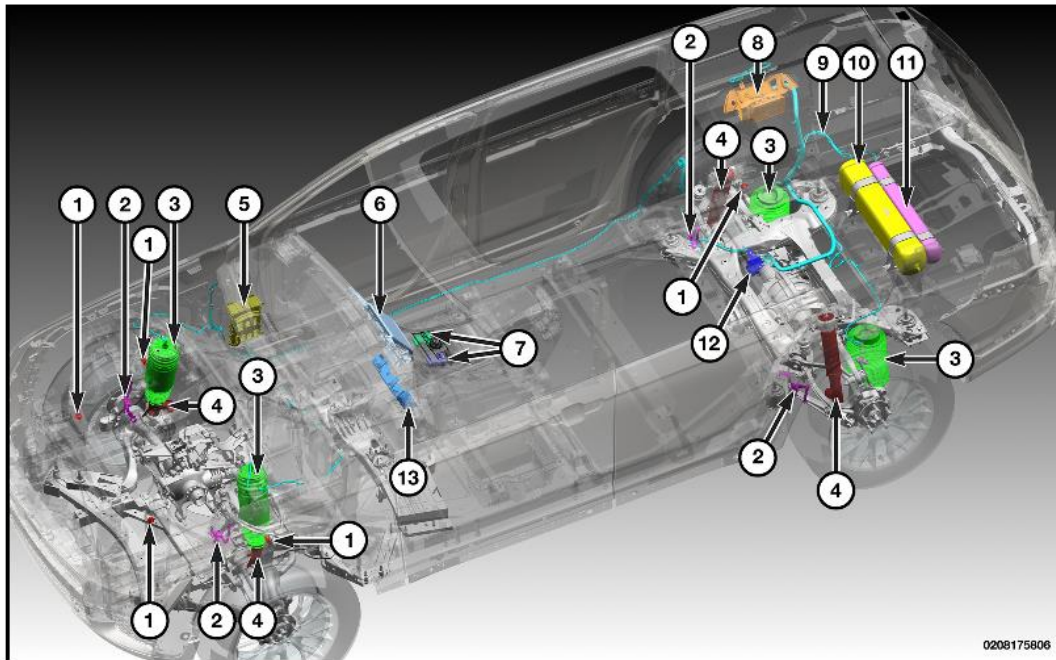
Refer to Service Library for Air Suspension System information. 02 - Front Suspension / Air Suspension / Description and Operation. Service Library contains a system lay out and component over view that may assist you in repairing the vehicle.
