NUMBER: 08-063-21

UJQ and UMQ Radio Enhancements

This bulletin involves inspecting the software level and update the radio software level to 34.2.

2018	(BU)	Jeep Renegade
2019	(BV)	Jeep Renegade

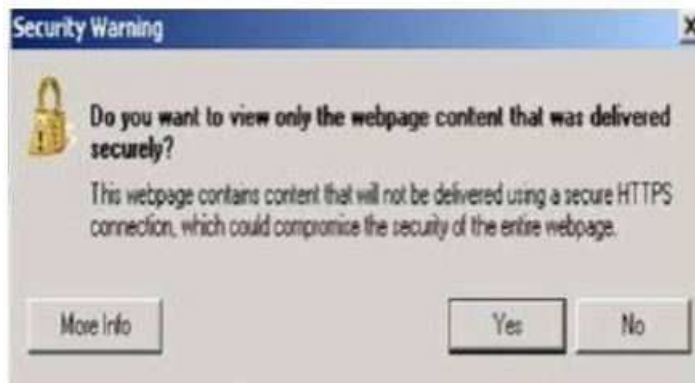
Fig. 2
Pop-Up Security Message

3. Go to DealerCONNECT>Service>Uconnect Command Center>Uconnect>More Information >Dealer software downloads to download the files.
4. If a security message appears “Do you want to view only the web page content that was delivered securely?” ([Fig. 2](#)) . Press “No” to continue.

NOTE: If the software cannot be downloaded, make sure you have proper security access. If not, have the Service Manager or Shop Foreman download the software update.

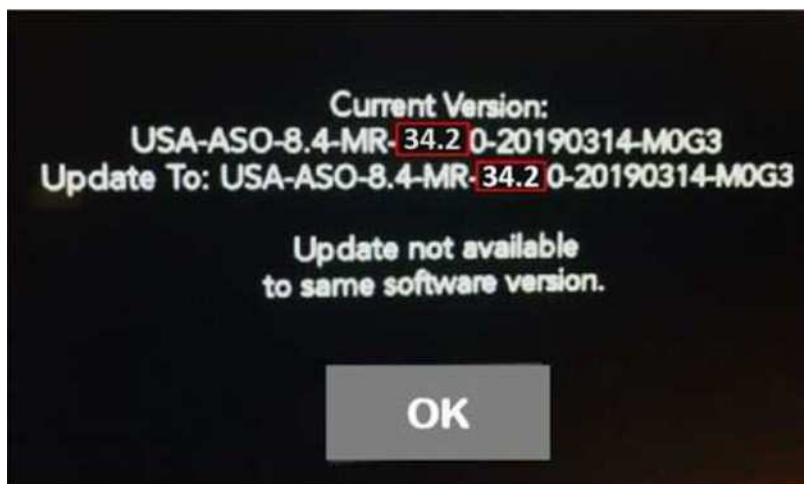
Fig. 6
Screen Displayed When Radio Software Level Is Up To Date

12. If the radio software is already up to date, the screen in (Fig. 6) will be displayed. Press "OK" and remove the USB flash drive.

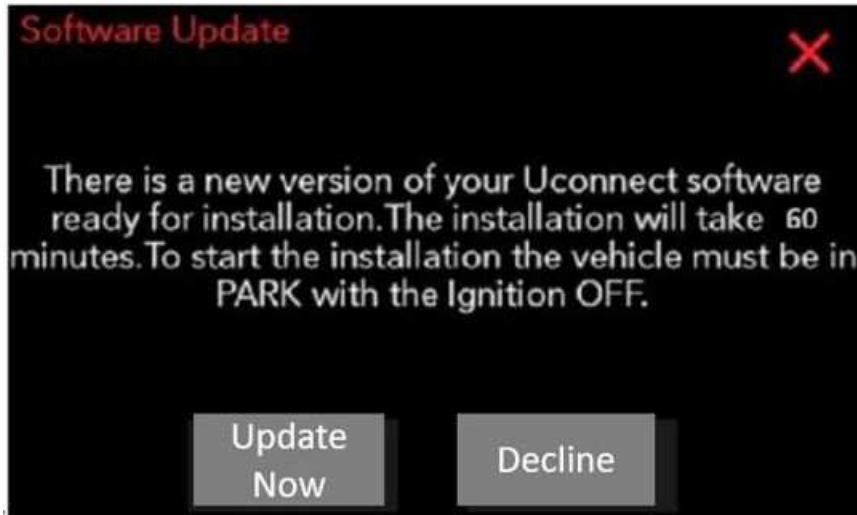
Fig. 7
Software Update Is Available

13. Once the system has verified there is an available update, press the “Update Now” button. Make sure the vehicle is in park, **DO NOT** turn off the ignition (Fig. 7) .

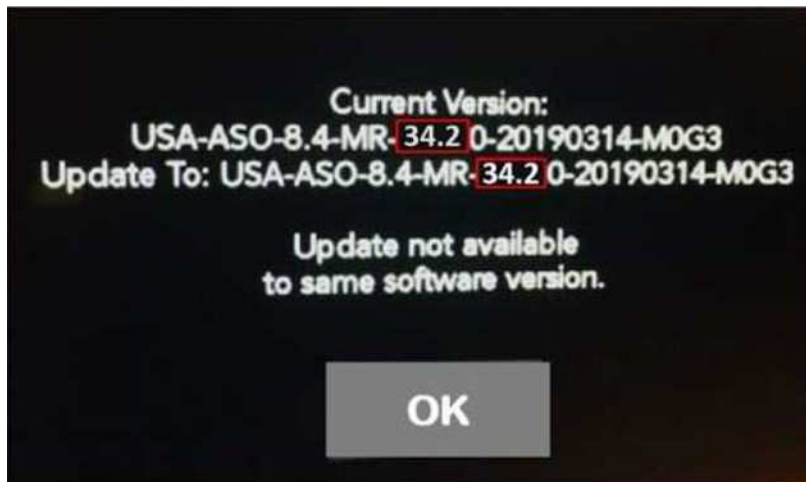
Fig. 10
Radio Software Has Been Updated

16. After the update has completed, the radio will shut down. With the USB flash drive still inserted in the USB port, cycle the ignition back to the run position. If the radio software was updated correctly the "Current Version:" and the "Update To:" software levels in (Fig. 10) will display the identical software level. Press "OK" and remove the USB flash drive.

17. Cycle off the ignition, open and close the driver door and let all modules go into a sleep mode.
18. Using wiTECH create a Vehicle Scan Report and save a copy to the work order.
19. Check if the navigation is working properly by pressing the 'Nav' button on the bottom tool bar. Verify the navigation map loads properly.
20. If the radio or navigation software didn't update properly or the navigation map doesn't load, attempt the software update one more time. If the software doesn't update properly or the navigation doesn't work, the radio may need to be replaced.
21. Using wiTECH, clear all DTCs that may have been set in any module due to reprogramming. The wiTECH application will automatically present all DTCs after the flash and allow them to be cleared.
