NUMBER: 08-105-21

GROUP: 08 - Electrical

DATE: June 23, 2021

UAV and UCV Radio Enhancements

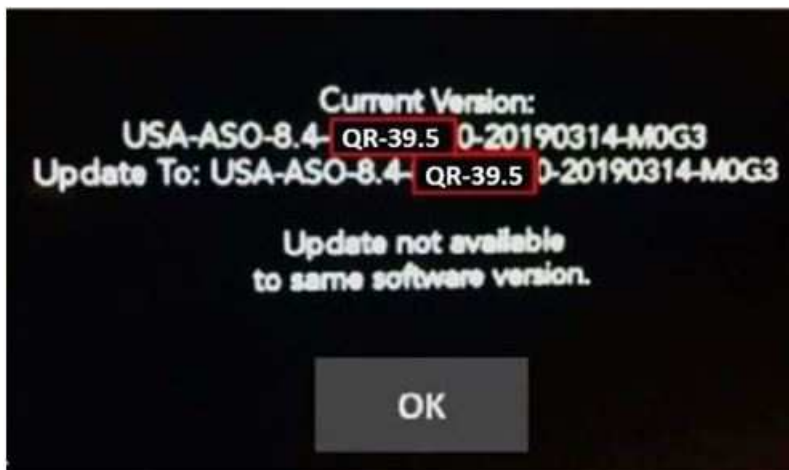
Fig. 6
Screen Displayed When Radio Software Level Is Up To Date

12. If the radio software is already up to date, the screen in (Fig. 6) will be displayed. Press "OK" and remove the USB flash drive.
