STAR ONLINE PUBLICATION

Case Number: S2124000008

Symptom/Vehicle Issue: Poor Airflow From 2nd Or 3rd Row Vent Outlets

WL 7574 Battery Cover Installation Process

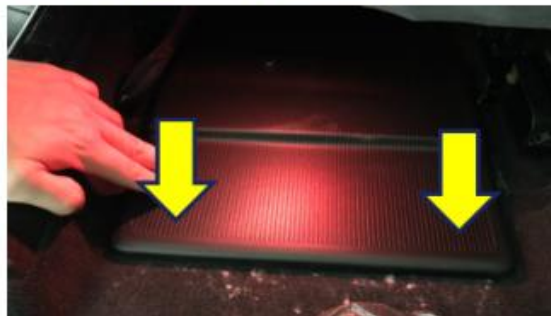
Tabs needs to be precisely aligned with the openings

Press downwards on the two tabs until an audible or tactile "click" is heard / felt

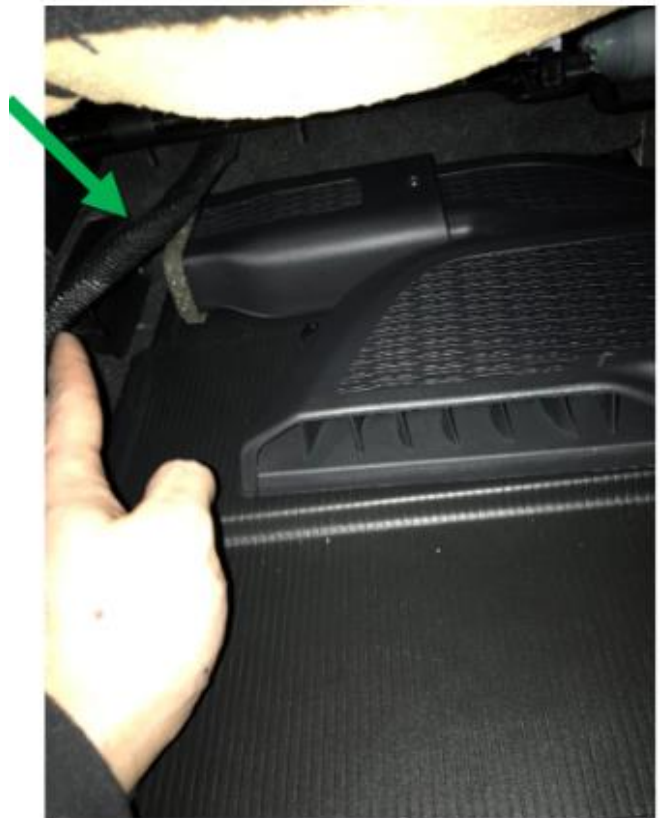
Wiring harness needs to go OVER the duct

Align inboard and outboard duct with the HVAC openings / housings on both left (outboard) and right (inboard) sides

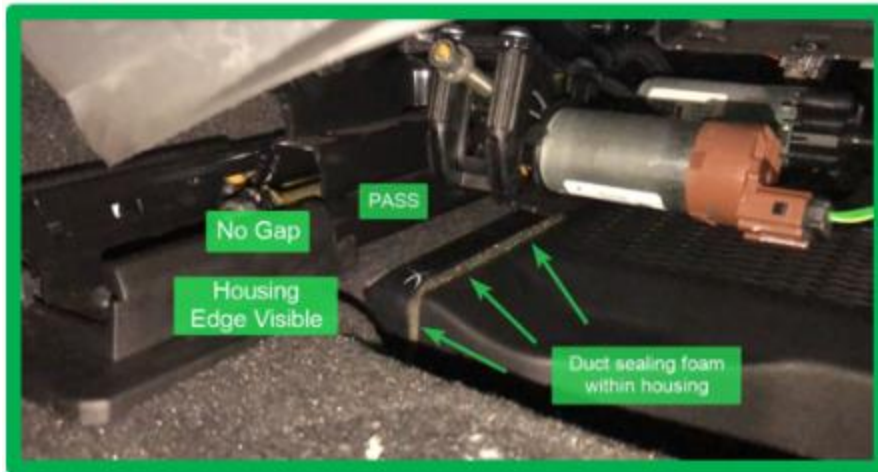
Inboard side foam: perfectly seated GOOD

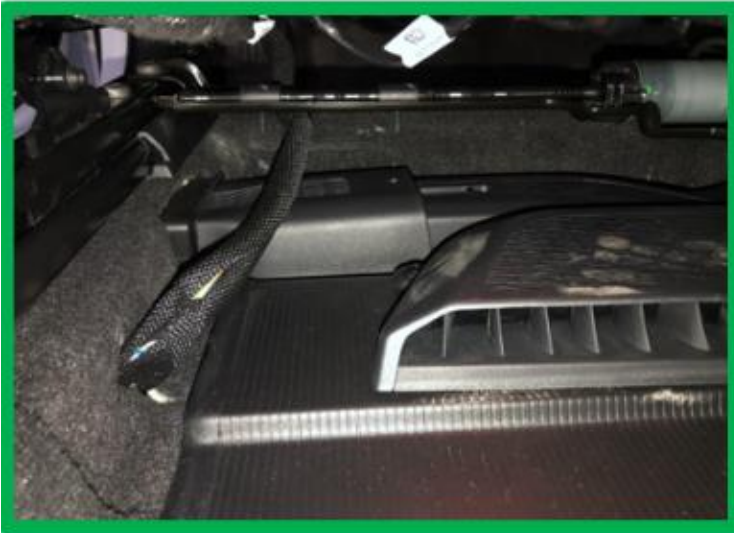
Telescoping duct: GOOD

- Telescoping duct is fully telescoped outwards and in 2nd detent position
- No foam is showing
- Wire harness is over duct

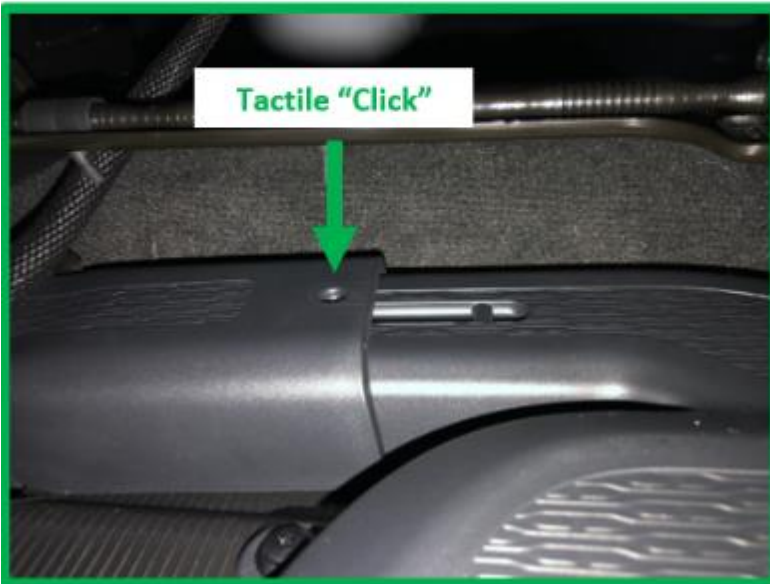
Telescoping duct extension: GOOD

- Telescoping duct is fully telescoped outwards
- Duct is in 2nd detent position

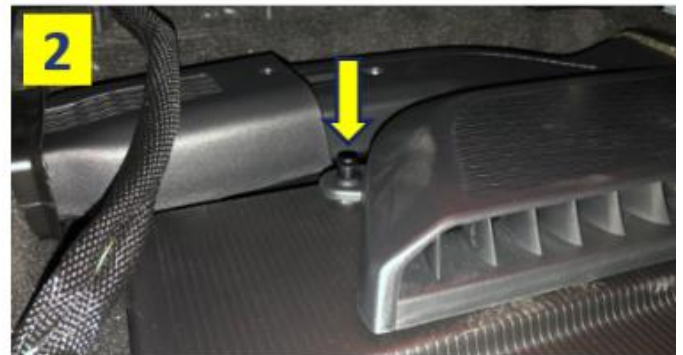
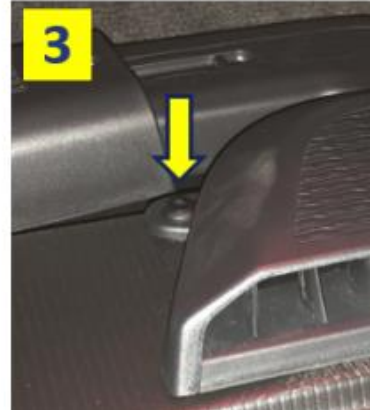
If push pin is bent on installation, a short length screwdriver is required to remove the push pin by unscrewing (CCW) and a new push pin is to be used

Push down to engage push pin outer sleeve

Push down again to fully engage push pin
