NUMBER: 08-074-21

GROUP: 08 - Electrical

DATE: May 7, 2021

UGQ, UGV, UJV and UJQ Radio Enhancements

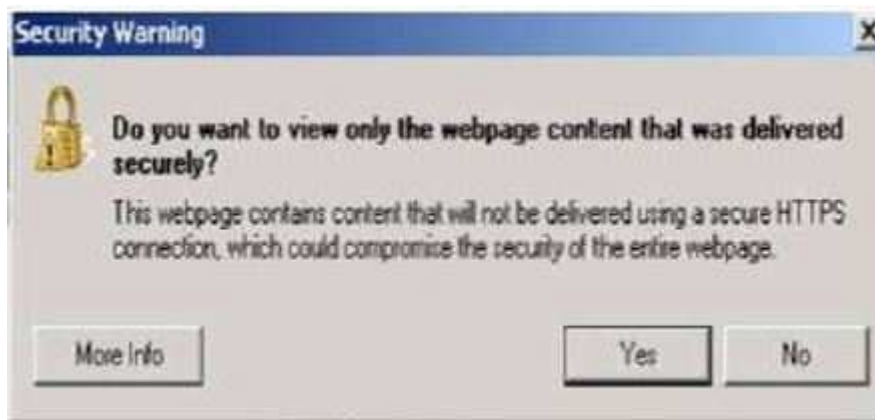
**Fig. 2
Pop-Up Security Message**

1. Using wiTECH create a Vehicle Scan Report and save a copy to the work order.
2. Has a **16GB** USB flash drive been created?
 - YES>>> Proceed to [Step 10](#).
 - NO>>> Proceed to [Step 3](#).
3. Go to DealerCONNECT>Service>Uconnect Command Center>Uconnect>More Information >Dealer software downloads to download the files.
4. If a security message appears “Do you want to view only the webpage content that was delivered securely?” (Fig. 2) . Press “No” to continue.

NOTE: If the software cannot be downloaded, make sure you have proper security access. If not, have the Service Manager or Shop Foreman download the software update.

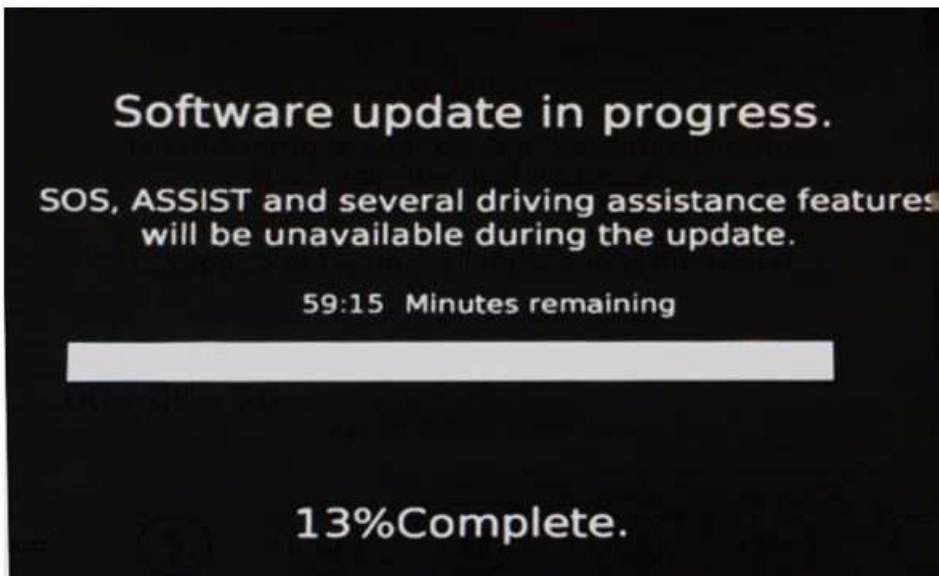
Fig. 8
Software Update In Progress

14. When the radio starts updating, the screen in (Fig. 7) will be displayed.
15. The radio will reboot and the update will begin. The update should only take 30 minutes, the timer on the screen may display the incorrect time remaining (Fig. 8) .

NOTE: The completion indicator may not reach 100%, even though the software update has been completed. Once the software update has finished, the radio and display screen will turn off.
