**January 14, 2022**

**Product Improvement: Multi-Model 3G OTA TCU Software Update****AFFECTED VEHICLES**

On February 22, 2022 the current 3G network that the vehicle connects to for services, will no longer be in-service. The Telematics Control Unit (TCU) Over the Air Update (OTA) is required to connect to the VoLTE network to continue communications.

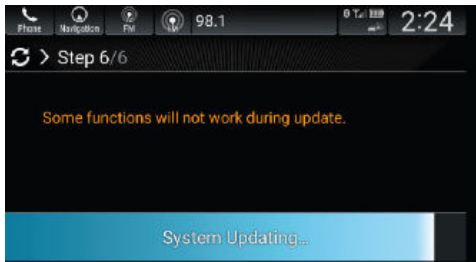
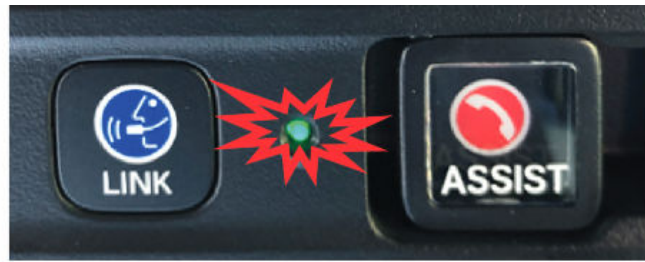
- If you see CODE: 57D or CODE: 5AC, the **Update Failed** due to **Poor cellular signal**.

- Move the vehicle to an open-air area to get **Optimal Cellular Signal** strength.

- Go back to step 1 to start the process once again
