Instructions for navigating the document

Index of models

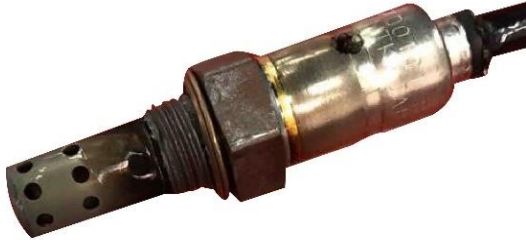
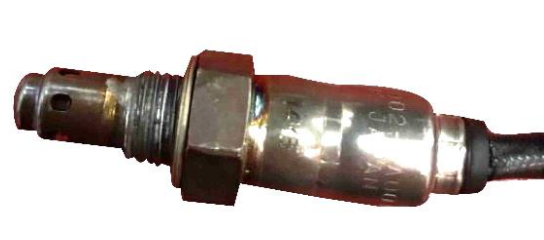
no.	Symptom	Subject	Photo	Notes and Indications - Corrective action
3	<p><u>ONLY</u> Hypermotard 950 MY22</p> <p>Possible validation of errors P2A03 Horizontal cylinder lambda sensor (oxygen sensor) [Value out of range] and/or P2A00 Vertical cylinder lambda sensor (oxygen sensor) [Value out of range]</p>	Lambda sensors	-	<p>We have received some isolated reports of the possible validation of the following errors:</p> <ul style="list-style-type: none"> • P2A03 Horizontal cylinder lambda sensor (oxygen sensor) [Value out of range] • P2A00 Vertical cylinder lambda sensor (oxygen sensor) [Value out of range] <p>after riding only 1000km/600mi.</p> <p>Our analysis has shown that this phenomenon is linked to the possible installation of lambda sensors relating to the previous Model Year (Model Year 2020-2021 EURO4 version) despite having the same connector on the wiring side.</p> <p>We would like to inform you that the production line has made the process more robust in order to avoid this issue.</p> <p>Should you find the above mentioned errors, we ask you to ensure that the dedicated lambda sensors part no. 55215021A for the Hypermotard 950 Model Year 2022 are actually installed</p> <div style="display: flex; justify-content: space-around; align-items: center;"> <div style="text-align: center;">

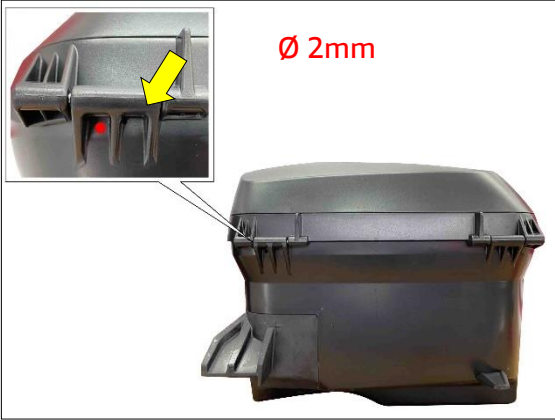
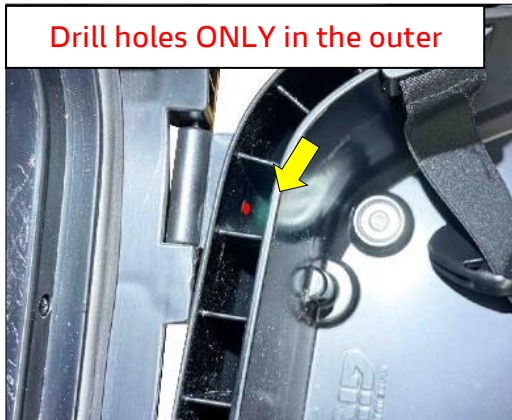
no.	Symptom	Subject	Photo	Notes and Indications - Corrective action
10	<p>ONLY Multistrada V4 (all model versions)</p> <p>Difficulties in opening the side panniers part no. 96781551AA</p>	<p>Side panniers part no. 96781551AA</p>

<p>We have received a few isolated reports of possible difficulties in opening the side panniers due to the “vacuum” effect that occurs when travelling with significant changes in altitude.</p> <p>To avoid this phenomenon, it is necessary to drill a venting hole with a maximum diameter of Ø 2 mm at the bottom of the bag, between the ribs near the rear hinge as shown in the figure.</p> <p><u>DO NOT drill through the second internal wall of the bag.</u></p> <p>This modification has also been implemented by the supplier and does not affect the water tightness.</p> <div style="display: flex; justify-content: space-around;"> <div data-bbox="1055 616 1608 1037">

<p>Ø 2mm</p> </div> <div data-bbox="1626 616 2136 1037">

<p>Drill holes ONLY in the outer</p> </div> </div>

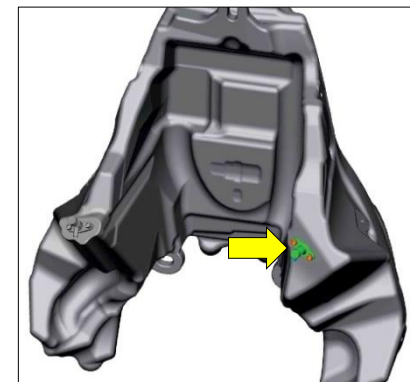
18	<p>ONLY <u>Multistrada V4</u> <u>(all model versions)</u></p> <p>Incorrect residual fuel in the tank</p>	Fuel tank	-	<p>In some cases, we have found that the tap on the right-hand side of the fuel tank is completely closed instead of open; this leads to an incorrect remaining range when there are only a few liters of fuel in the tank (fuel reserve conditions).</p> <p>If the above-mentioned event occurs, we ask you to ensure that the tap on the right-hand side of the fuel tank is fully open</p>

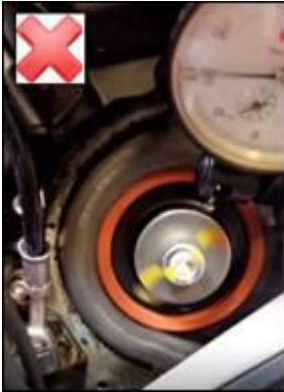
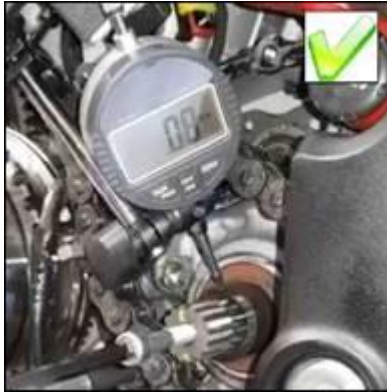
no.	Symptom	Subject	Photo	Notes and Indications - Corrective action
19	<p>ONLY <u>Multistrada V4</u> <u>(all model versions)</u></p> <p>Possible oscillation of the final drive chain (non-uniform sliding)</p>	Gearbox secondary shaft	-	<p>We have received some isolated reports about a possible oscillation of the final drive chain even if the chain is correctly tensioned. In these cases the customer may complain an uneven sliding of the chain at constant speed.</p> <p>In these cases, you are asked to check for a possible deformation of the gearbox secondary shaft by removing both the chain and the sprocket and taking the measurement with a dial gauge directly on spacer Part no. 713P0011C, as shown in the figure (the measurement should NOT be taken on the sprocket since an uneven wear of the rubber material may occur during the first few kilometers): by slowly rotating the shaft, the value taken with the dial gauge must be at most 0.1 mm.</p> <div style="display: flex; justify-content: space-around;">

</div> <p>a) If the measurement shows values below 0.1 mm, replace the sprocket only. a) If the measurement shows a value greater than 0.1mm, fill out a Youtech service request.</p>
