SERVICE BULLETIN

2017-22MY Impreza 2018-22MY Crosstrek 2019-22MY Forester 2019-22MY Ascent **NUMBER: 16-132-20R**

SUBJECT: Diagnostic Information for Alleged Chain Slip Condition

on TR580 / TR690 Transmissions

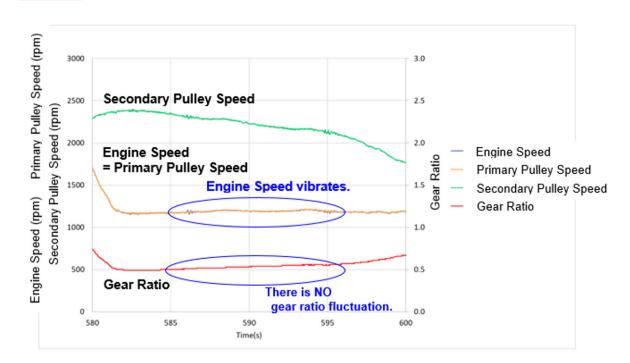
The graph above is an example of recorded SSM data showing the torque fluctuation is NOT being caused by the transmission but by torque fluctuation of the engine.
