GROUP ENGINE	NUMBER 22-EM-004H	
	ΗΥυπαρι	DATE	MODEL(S)	
Techni	cal Service Bulletin	JANUARY 2022	Santa Fe Sport (AN) Santa Fe (TM) Sonata (LF/YF) Veloster N (JSN)	
SUBJECT: THETA-II 2.0T TURBOCHARGER EWGA DIAGNOSIS AND SERVICE PART REPLACEMENT GUIDELINES			iosis Nes

This bulletin supersedes TSB 21-EM-009H to update turbocharger part number information.

Description: This bulletin provides additional service diagnostic information and repair procedures related to Electric Waste Gate Actuator (EWGA) equipped vehicles listed below.

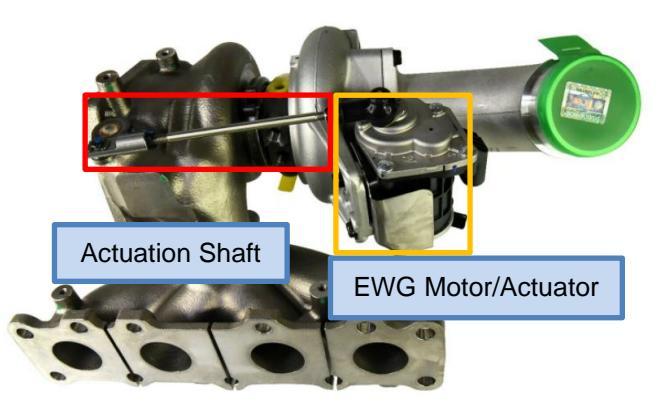
(Figure Example: JSN Turbocharger – Exhaust Manifold)

- The EWG Motor/Actuator is connected to an actuation shaft that controls a swing valve, releasing excess exhaust gases from the turbocharger.
- Diversion of exhaust gases regulates the rotating speed of the turbocharger compressor turbine.
