Technical Service Bulletin

92 Repairing corrugated hose for windshield washer system

92 22 28 2065963/1 February 8, 2022.

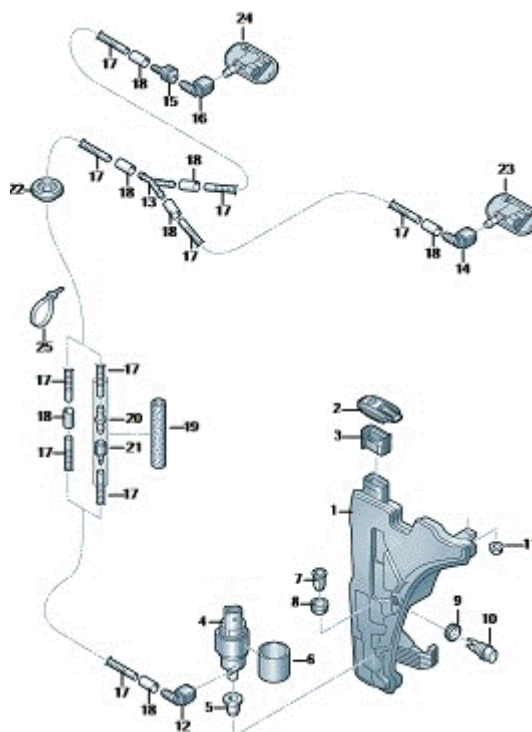
Figure 3. ETKA illustration of windshield washer hose repair components.

3. The repair components can be found in ETKA using the VIN of the vehicle being serviced. Figure 3 shows the typical illustration found in ETKA.

4. Make all necessary repairs including any wiring damage. Package the removed washer hose section and retain for WPRC request for return.
