Instructions for navigating the document

NEW TOPICS 3

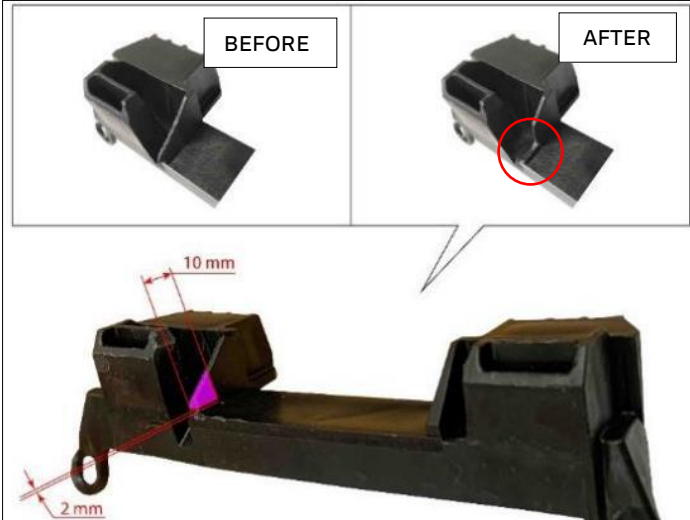
<p>When mounting the rider seat in "high configuration", an excessive gap can be seen between the lower trim and the RH side panel. This is due to interference between the central riser and its support. To avoid such interference and therefore improve the coupling between the rider seat and the side panel, it is necessary to:</p> <ol style="list-style-type: none"> 1) Remove the center riser from the seat; 2) Working on the RH side support, remove the excess material with a cutter, as shown in the figure. 3) Reinstall the center riser to the seat.

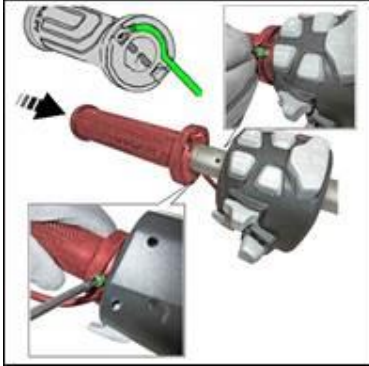
<p>We have received some reports about heated handgrips that have not been installed correctly and so the cable between the handgrip and the switch may be pinched.</p> <p>We kindly ask you to always follow the instructions provided on the DCS under the “accessories catalogue” section or in the model presentation bulletin (SRV-SRB-20-049) and to <u>comply with the correct orientation of the cable and handgrip</u> as shown in the figure.</p>

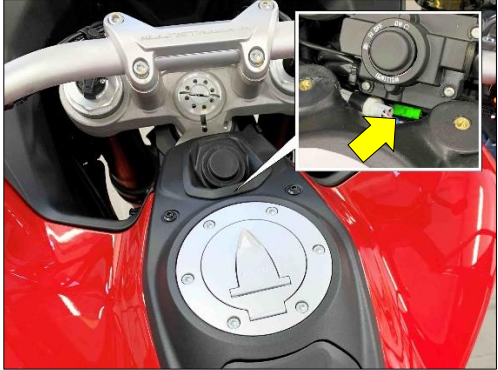
5	<p>ONLY <u>Multistrada V4</u> <u>(all model versions)</u></p> <p>Precaution during the installation of the heated handgrip kit part no. 96680702A</p>	<p>Heated handgrip kit part no. 96680702A</p>

<p>We inform you that for the installation of the heated handgrip kit part no. 96680702A, the main wiring harness connectors where to connect the heated handgrips, are positioned below the ignition switch cover as shown in the figure.</p>

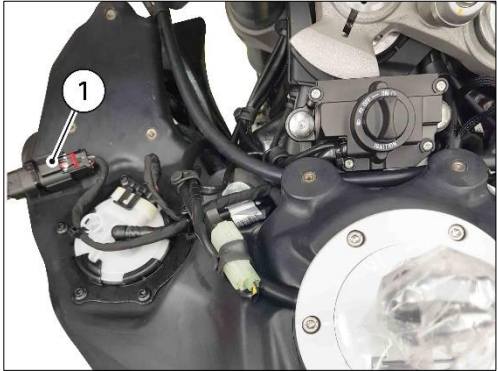
6	<p>ONLY <u>Multistrada V4</u> <u>(all model versions)</u></p> <p>Assembly precaution for the anti-theft system kit part no. 96681081AA</p>	<p>Anti-theft system kit part no. 96681081AA</p>

<p>We inform you that for the installation of the anti-theft system kit part no. 96681081AA, the main wiring connector (1) where to connect the anti-theft device, is positioned near the fuel pump flange, in the front left area of the fuel tank.</p>

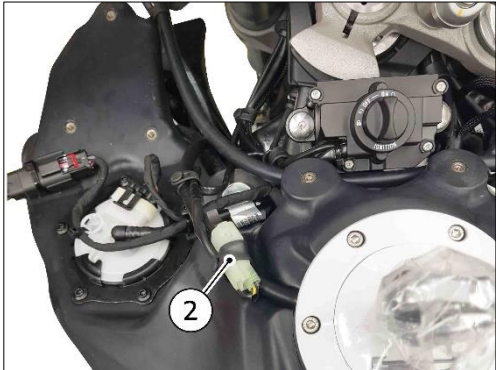
<p>We inform you that for the installation of the Hands Free fuel tank cap kit part no. 96681021AA, the main wiring connector (2) where to connect the Hand Free fuel tank cap, is positioned near the fuel pump flange, in the front left area of the fuel tank.</p>

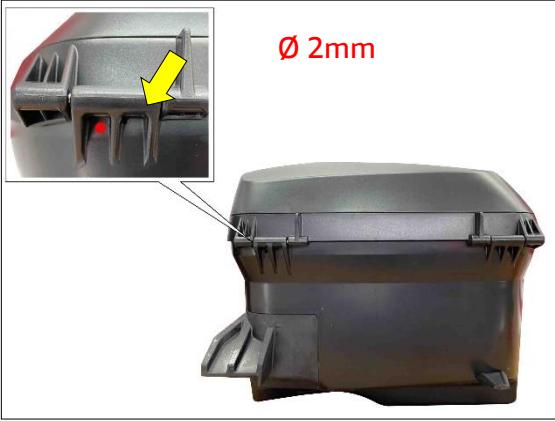
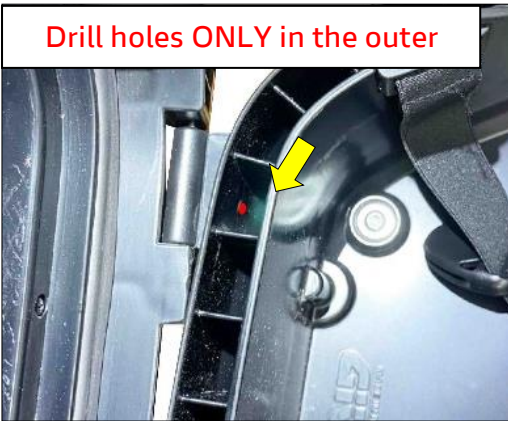
no.	Symptom	Subject	Photo	Notes and Indications - Corrective action
10	<p>ONLY Multistrada V4 (all model versions)</p> <p>Difficulties in opening the side panniers part no. 96781551AA</p>	<p>Side panniers part no. 96781551AA</p>	 	<p>We have received a few isolated reports of possible difficulties in opening the side panniers due to the “vacuum” effect that occurs when travelling with significant changes in altitude.</p> <p>To avoid this phenomenon, it is necessary to drill a venting hole with a maximum diameter of Ø 2 mm at the bottom of the bag, between the ribs near the rear hinge as shown in the figure.</p> <p><u>DO NOT drill through the second internal wall of the bag.</u></p> <p>This modification has also been implemented by the supplier and does not affect the water tightness.</p> <div style="display: flex; justify-content: space-around;"> <div data-bbox="1055 616 1608 1038">

<p>Ø 2mm</p> </div> <div data-bbox="1630 616 2136 1038">

<p>Drill holes ONLY in the outer</p> </div> </div>

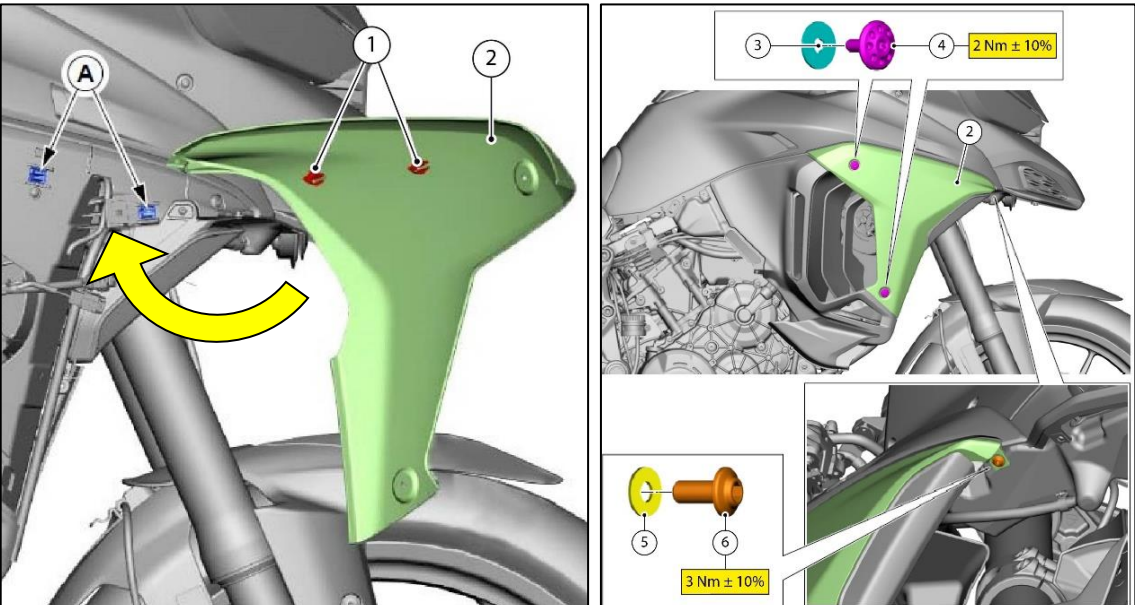
no.	Symptom	Subject	Photo	Notes and Indications - Corrective action																		
34	<p><u>Multistrada V4</u> <u>(all model versions)</u> ONLY</p> <p>Installing the RH and LH side cowlings during PDI</p>	RH and LH side cowlings

<p>We would like to inform you that from approx. 1 Nov 2021, in order to avoid transport damage to the cowlings of the Multistrada V4, the kit supplied will also include the RH side cowling, the LH side cowling and the relevant hardware, which you must install during PDI. For this reason we also updated the PDI Checklist SRV-SRB-20-049_PDI Checklist for Multistrada V4 Rev.02.</p> <p>The additional kit will include:</p>

<p>When assembling, fit clips (1) on brackets of cowlings (2). Install cowlings (2) and engage clips (1) in the corresponding housings (A). Tighten the special screws (4) to 2 Nm \pm 10% and the screw (6) to 3 Nm \pm 10%.</p>

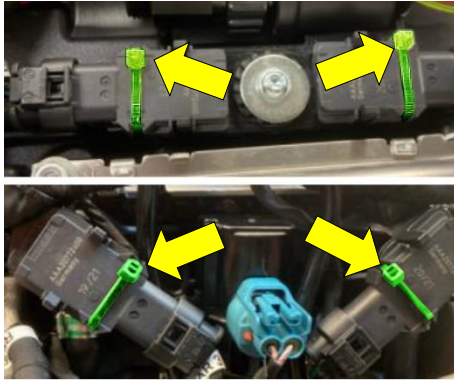
<p>We have received a few isolated reports of erratic engine operation at idle, hard starting, the possibility of the MIL warning light on the instrument panel coming on and/or memorized MAP sensor errors or P061B Torque Monitoring error. Our analysis has shown that this phenomenon could be due to the MAP sensors not fitting perfectly in their seats; we therefore ask you to check the correct installation of the MAP sensors if the symptoms described above should occur, and to fix them properly using self-locking ties positioned as shown in the figure.</p> <p>Create a Youtech for any cases found in your dealership. Attach PDF copy of the DDS Fault Report (with freeze frame parameters) and photos of the MAP sensor(s) as discovered during inspection and after with self-locking ties.</p>

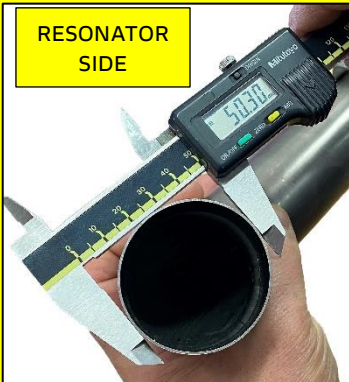
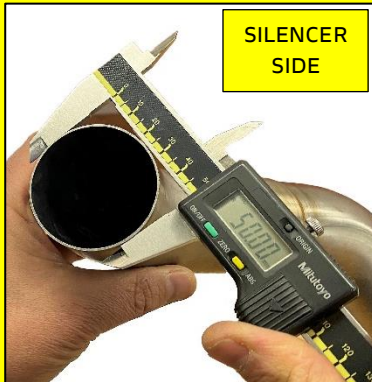
<p>For this reason, we ask you to check the kits in your possession and verify their Serial Number. If the serial number is the same as the one shown above, we ask you to measure the diameter of the holes in the silencer manifolds with a gauge and check that they have a diameter of:</p> <ul style="list-style-type: none"> - 50.0 mm for silencer-side hole - 50.3 mm for resonator-side hole <div style="display: flex; justify-content: space-around;"> <div data-bbox="1256 679 1603 1062">

<p>SILENCER SIDE</p> </div> </div> <p>If the measured values are not correct, it will be necessary to order the conforming manifold using the following part numbers:</p> <ul style="list-style-type: none"> - Silencer front manifold Part no. 96413531A - Silencer rear manifold Part no. 96413541A <p>For warranty claims on components, we ask you to fill out a YouTech report and ask your Service Area Manager for guidance.</p>

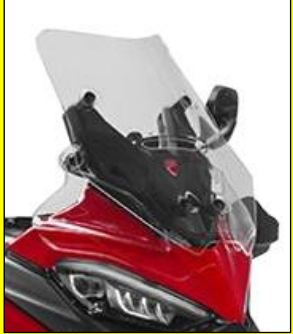
no.	Symptom	Subject	Photo	Notes and Indications - Corrective action	
NEW 41	ONLY <u>Multistrada V4</u> <u>(all versions)</u> Possible oxidisation of windscreen retaining screws	Windscreen retaining screws

<p>We have received some reports about a possible oxidization of the windscreen retaining screws. Analysis has shown that this phenomenon could be caused by an unsuitable technological process that causes oxidation in the groove of the flat and in the holes made for decreasing part weight.</p> <p>Should you find such a phenomenon, please replace the 4 windscreen screws (Part no. 7791C301AB) and tighten them to <u>3 Nm ± 10%</u>.</p>

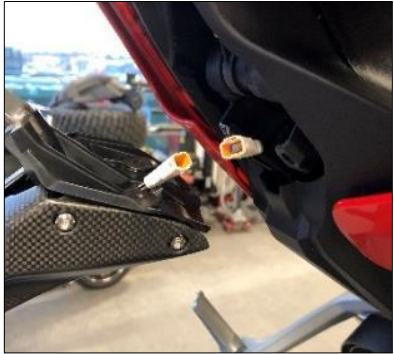
3	<p><u>ONLY</u> <u>Panigale V4</u> <u>(all versions)</u> <u>Panigale V2</u></p> <p>Installation precautions Carbon number plate holder kit part no. 97380921A</p>	Carbon number plate holder kit part no. 97380921A

<p>We kindly inform you that <u>ONLY</u> when installing the carbon number plate holder kit part no. 97380921A to a Panigale V2 model, it is necessary to purchase wiring part no. 5101H931A to connect the number plate holder connector to motorcycle rear wiring harness connector.</p> <p>We also inform you that the new carbon number plate holder kit part no. 97381161AA is now available. It is specific for Panigale V2 and Streetfighter V4 and will include the above-mentioned wiring.</p>

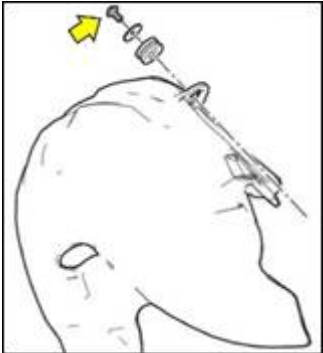
10	Possible loosening of the screw retaining the heat guard	Screw 77244163B retaining the rear bank exhaust manifold heat guard	-	<p>We have received a few reports about a possible loosening of the screw retaining the rear bank exhaust manifold heat guard.</p> <p>The issue is being investigated, therefore, we kindly ask you to check the correct tightening of the above-mentioned screw (part no. 77244163B) when coming to the workshop (the prescribed tightening torque is 5 Nm ± 10%).</p>

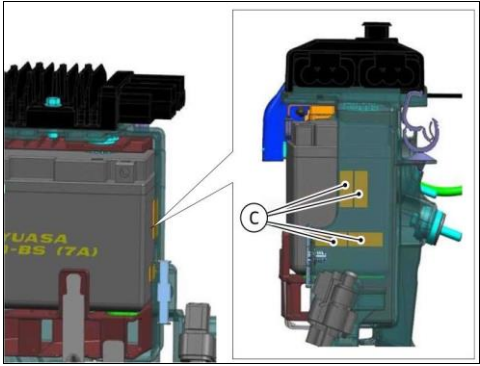
<p>The ongoing tests on the product have revealed the possibility of contact between the battery and its support, which causes marks on both surfaces due to vibration. These marks do NOT affect the correct operation of the electric system and therefore of the vehicle.</p> <p>In order to prevent such marks, 4 adhesive pads (C) in rubber 9X23X1.4 part no. 86612791A have been introduced in the production line to be applied inside the battery support.</p>
