Service Alert

Subject: "LOW BATTERY RISK. START VEHICLE TO CHARGE 12V BATTERY" WARNING MESSAGE	Service Alert No.: SA-002/22
	Last Issued : 02/10/2022

2021-2022 Mazda3 (Japan built) with VINS lower than JM1BP*****500044 (produced before November 6, 2021)
2021 Mazda3 (Mexico built)
2021 CX-30

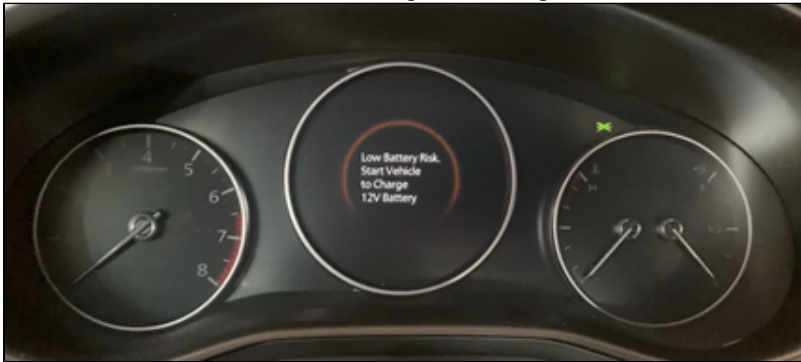
Some vehicles may have a "Low Battery Risk. Start Vehicle to Charge 12V Battery" warning message in the instrument cluster and a 30 second alarm sound. This is caused by the vehicle's electrical control area network (CAN) entering "Sleep Mode" when the network awake time reaches 30 cumulative minutes without the engine running.

No dealer visit is required. The warning message can be cleared by starting the engine and idling or driving for 5 minutes or longer.
