MAZDA DEALER EMAIL

Subject: Notification of Emission Recall 5421K - 2019 CX-5 Diesel - Selective Catalytic Reduction (SCR)/AWD Harness concern

Emissions Recall 5421K – 2019MY CX-5 Diesel – SCR/AWD Harness Concern

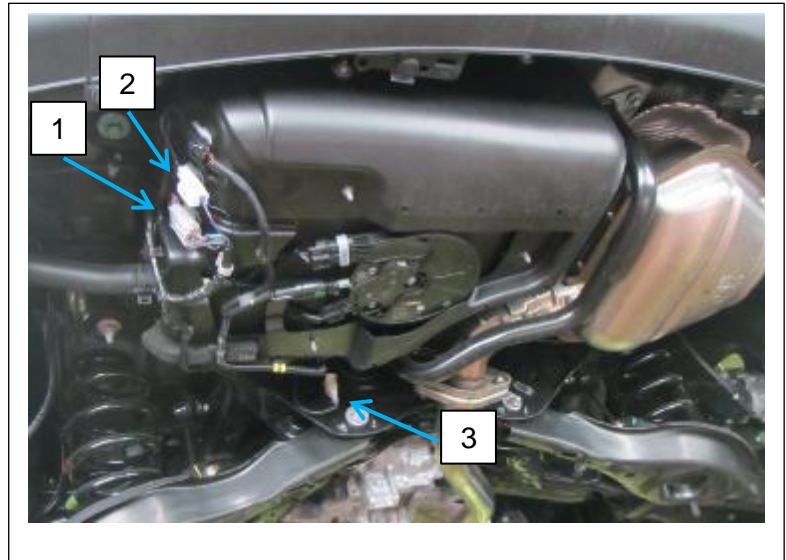
Check the connector with the exposed core wire, and if corrosion is found on the connection, replace both the male and female connector’s harness with new ones.

If it is found that the connectors contain corrosion, please replace using the information below. Please note that this repair will be very low. Contact Dealer Recall help with photos of the damage. They will provide authorization and place the harness order through the DAG and provide a SO# by email.

Connector fixed to the vehicle	Connector Not fixed to the vehicle
1	Connector #1	KB8F 67SH0A (Short cord)	*----6705Y (Rear harness)
2	Connector #2	KB8F 67SH0A (Short cord)	*----6705Y (Rear harness)
3	Connector #3	KB8F 67SH0A (Short cord)	*----6705Y (Rear harness)

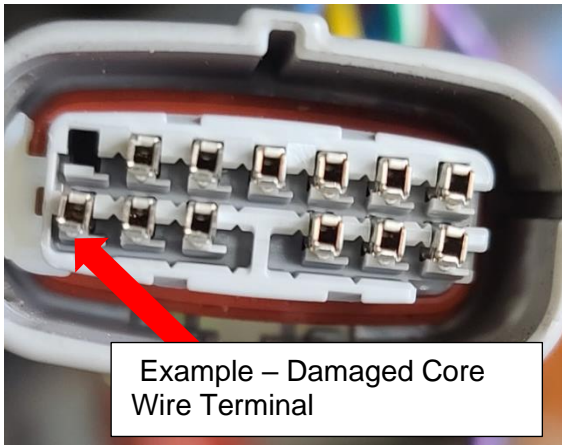
Example – Damaged Core Wire Terminal

7. Replace exposed harness with new one according to **"Installation of Repair wires"**
8. Install PVC tubes according to **" Installation of PVC tubes"**
(Include Re-installation of the Urea tank cover and Re-connect battery ground terminal)

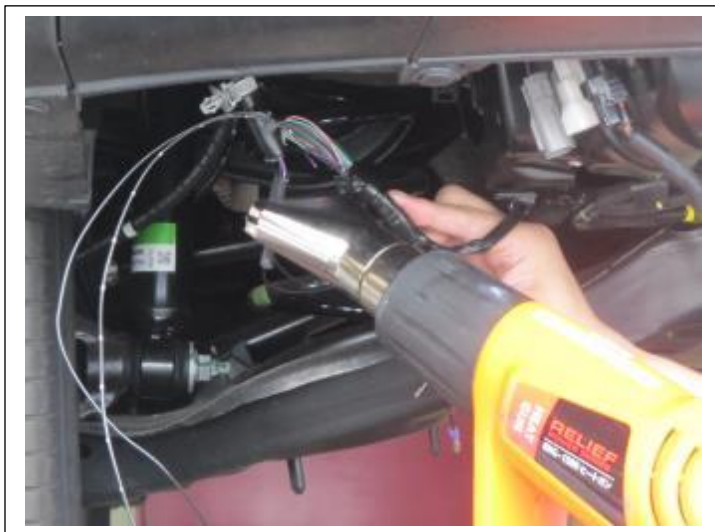
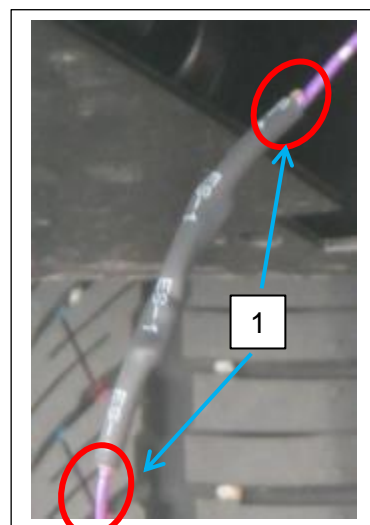
1 Adhesive seeps out

7. Properly place the heat shrink tube over the crimp connection and shrink it using a heater until the adhesive seeps out.

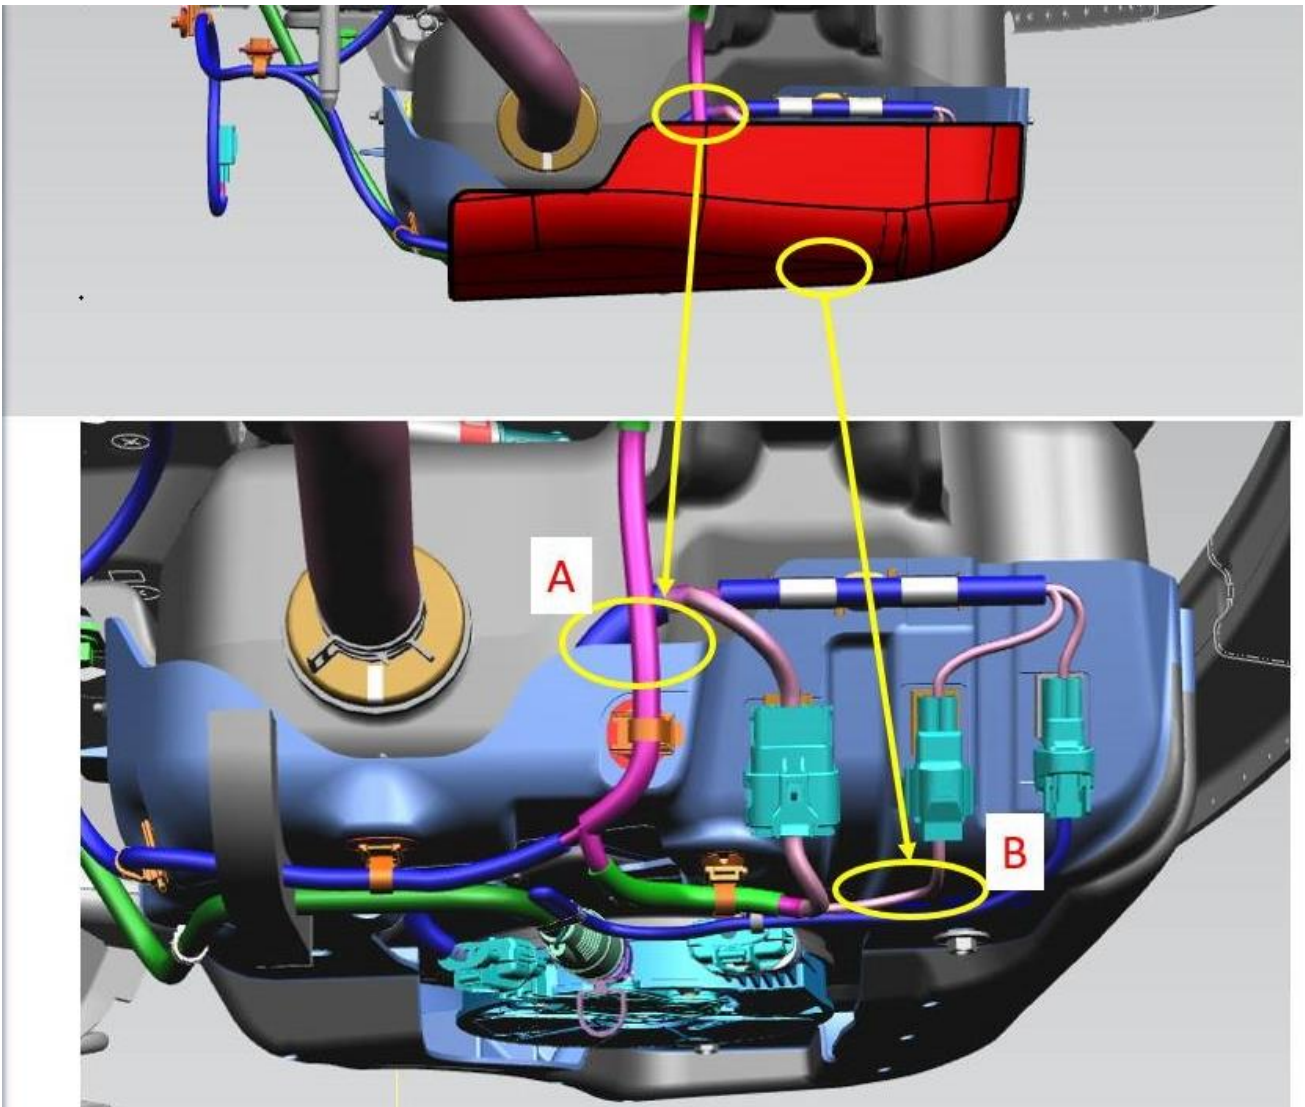
- a) At the area shown below which you inspected and might have repaired according to this procedure already
- b) At the areas shown below in this picture and the next picture, these are the wires that might have been damaged

Note: The areas of damage are different, see below and on the following pages. Photos here are for reference only.

“Installation of PVC tubes”
