# PRODUCT ADVISORY

## PA705

**SUBJECT:** 2017 – 2020 Model Year Ford F550 Frame Reinforcement

**SUBJECT: Customer Satisfaction Program 21B04**

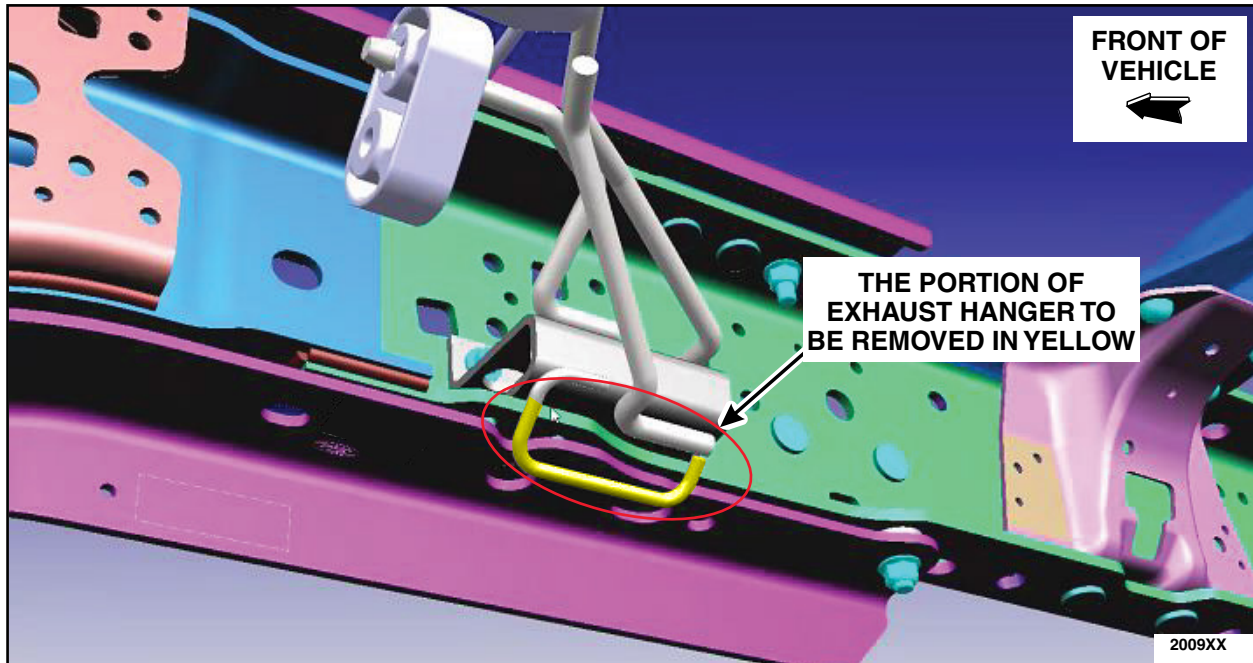
**FIGURE 43**

1. The right hand side exhaust hanger will interfere with right hand side lower reinforcement bracket.

Figure 43 shows the portion of the exhaust hanger that will be removed in order to obtain the clearance needed.

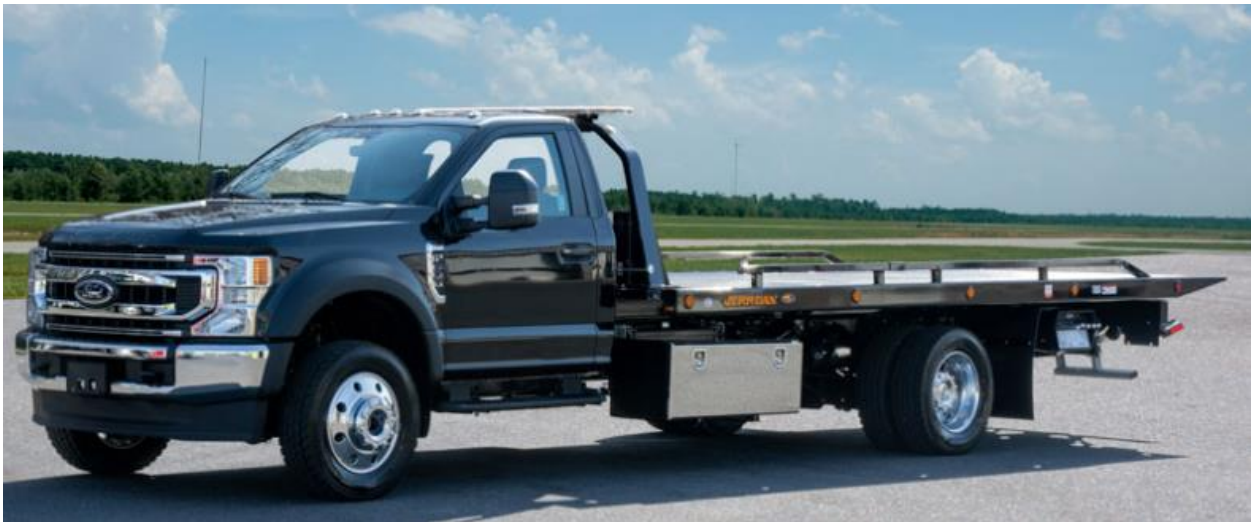
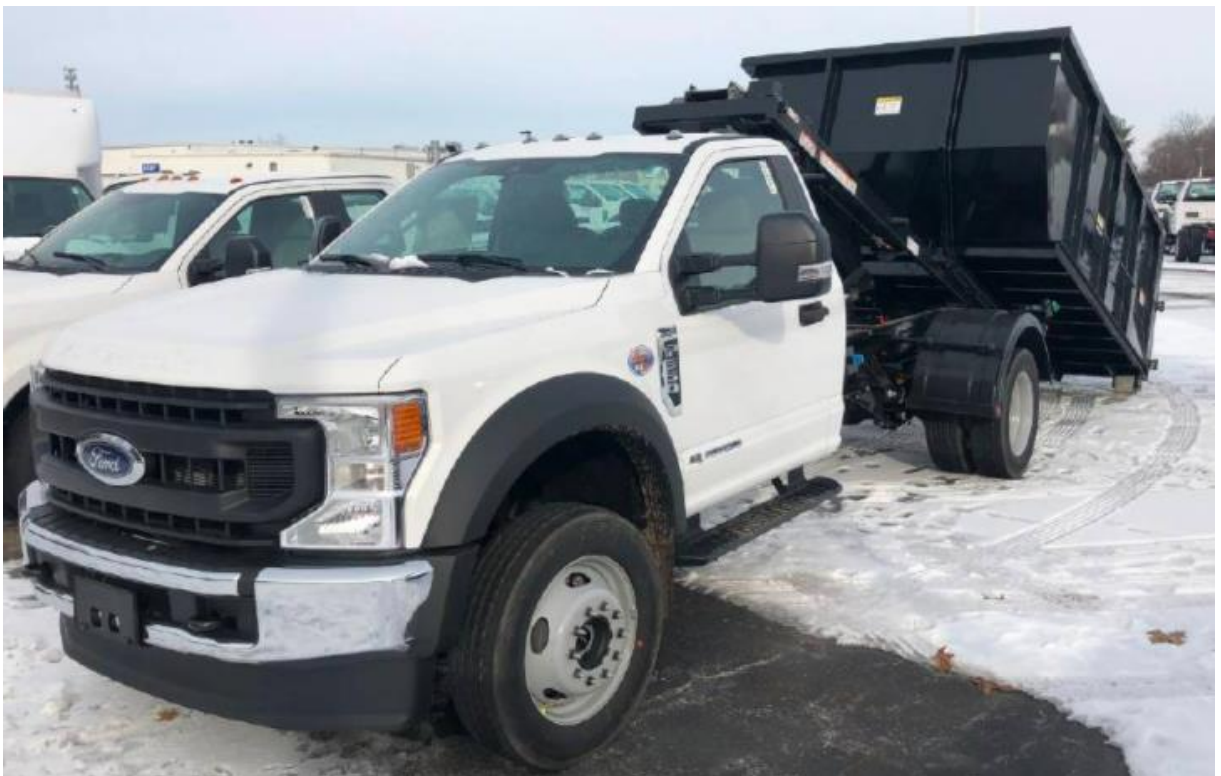
Example

NOTE: To gain access to top of the frame with a service body installed it may have to be removed.
