# Technical Service Bulletin

SUBJECT:		No: <b>TSB-22-23-001REV</b>	
<b>POTENTIAL TRANSMISSION SHUDDER/SURGE WITH POSSIBLE DTC (CVT-8) - REVISED</b>		DATE: <b>February 2022</b>	
		MODEL: <b>See below</b>	
CIRCULATE TO:	<input type="checkbox"/> GENERAL MANAGER	<input checked="" type="checkbox"/> PARTS MANAGER	<input checked="" type="checkbox"/> TECHNICIAN
<input checked="" type="checkbox"/> SERVICE ADVISOR	<input checked="" type="checkbox"/> SERVICE MANAGER	<input checked="" type="checkbox"/> WARRANTY PROCESSOR	<input type="checkbox"/> SALES MANAGER

Certain vehicles with F1CJC/W1CJC (CVT-8) transmissions may exhibit a shudder or surge condition possibly caused by poor reaction of the hydraulic pressure circuit. With continued driving under these conditions, the CVT belt may slip repeatedly when accelerating, and abrasion powder may enter the hydraulic pressure circuit, causing a warning light to turn on with one of the following DTCs: P0776, P0730, P0741, P084A, P0969, P2719. The shudder/surge condition may also be described as engine flare, lack of acceleration, and/or car shake.

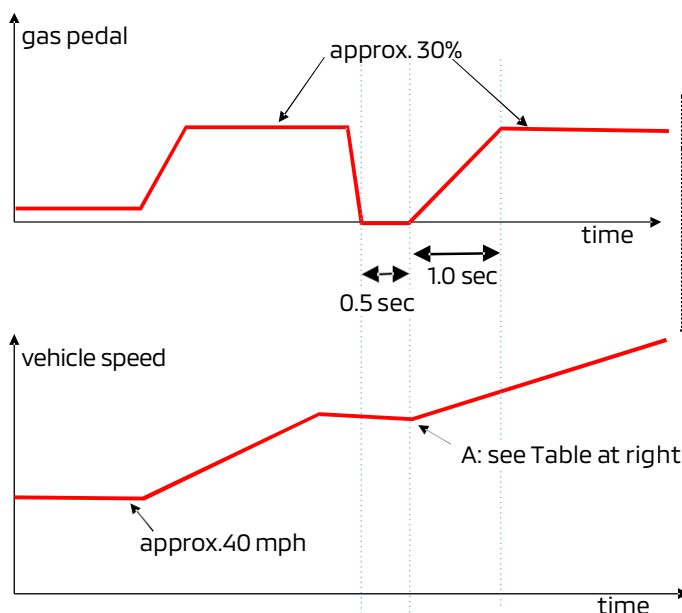
Figure 1: Test Drive Procedure for Duplicating CVT-8 Belt Slip

**Perform Test Drive at least 3 times**

Condition	Driving Criteria	Judgement Criteria
Belt Slip	<ul style="list-style-type: none"> <li>• Acceleration soon after Lifting Foot</li> <li>• ATF Temp &gt; 70° F (20° C)</li> <li>• Vehicle Speed at "A": Over 60 mph (97 km/h)</li> </ul>	<ul style="list-style-type: none"> <li>• Abnormal shock is felt</li> <li>• Caution flashing in MID</li> </ul>

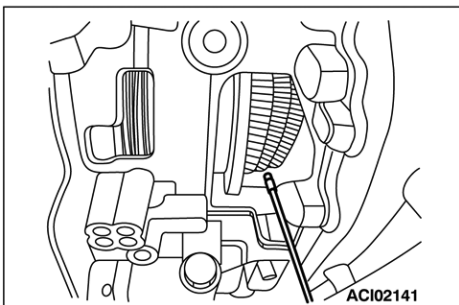
Refer to below damage sample illustrations.

- If damage is found on either side of mating surfaces of the belt, CVT assembly replacement is required.
- If no damage is found on mating surfaces of the belt, a new valve body installation is required. Follow next steps.

**NOTE:** Be sure to replace the filter screen and external filter element. Refer to ASA CAPS for correct part numbers for the vehicle.
