## SERVICE BULLETIN

BT09-052I

NTB09-081I

### WINDSHIELD CRACKING

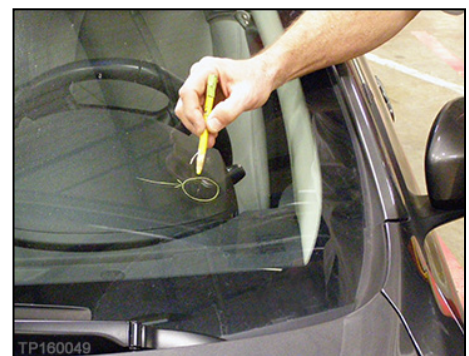
**Prior to removal, dealers must take at least two (2) digital photographs of the damaged area. Dealers are required to mark glass and other components returned that have "visible issues" using masking tape or appropriate means (grease pen, etc.) to identify and highlight the area damaged.**

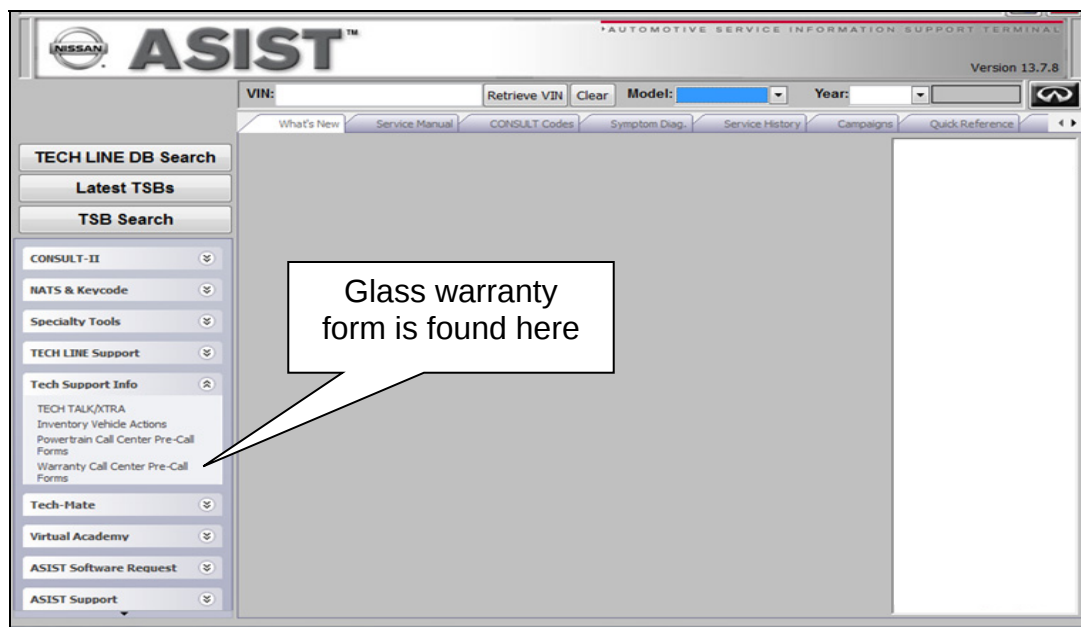
- Dealers are required to take at least two (2) digital photographs that clearly identify the alleged glass defect prior to removing the glass from the vehicle.
- Digital photographs must be kept in dealer records.
- Dealers are required to mark glass and other components returned that have “visible issues” using masking tape or appropriate means (grease pen, etc.) to identify and highlight the area damaged.
- The new glass warranty form must be completed and digital photograph files attached through ASIST for:
  - Over DCAL Warranty Call Center pre-authorization
  - Glass Part Return requests
- The claim will be subject to a claim debit if the part is not marked properly and/or missing the required digital photographs (via ASIST) to support identification of a warrantable defect.**
