Service Bulletin

Bulletin No.: 22-NA-054

Subject: Check Engine Lamp Illuminated on the DIC (Driver Information Center), Temperature Gauge Inaccurate and/or Cooling Fans Continue Running after Vehicle is Turned Off, with DTC P0128 Set

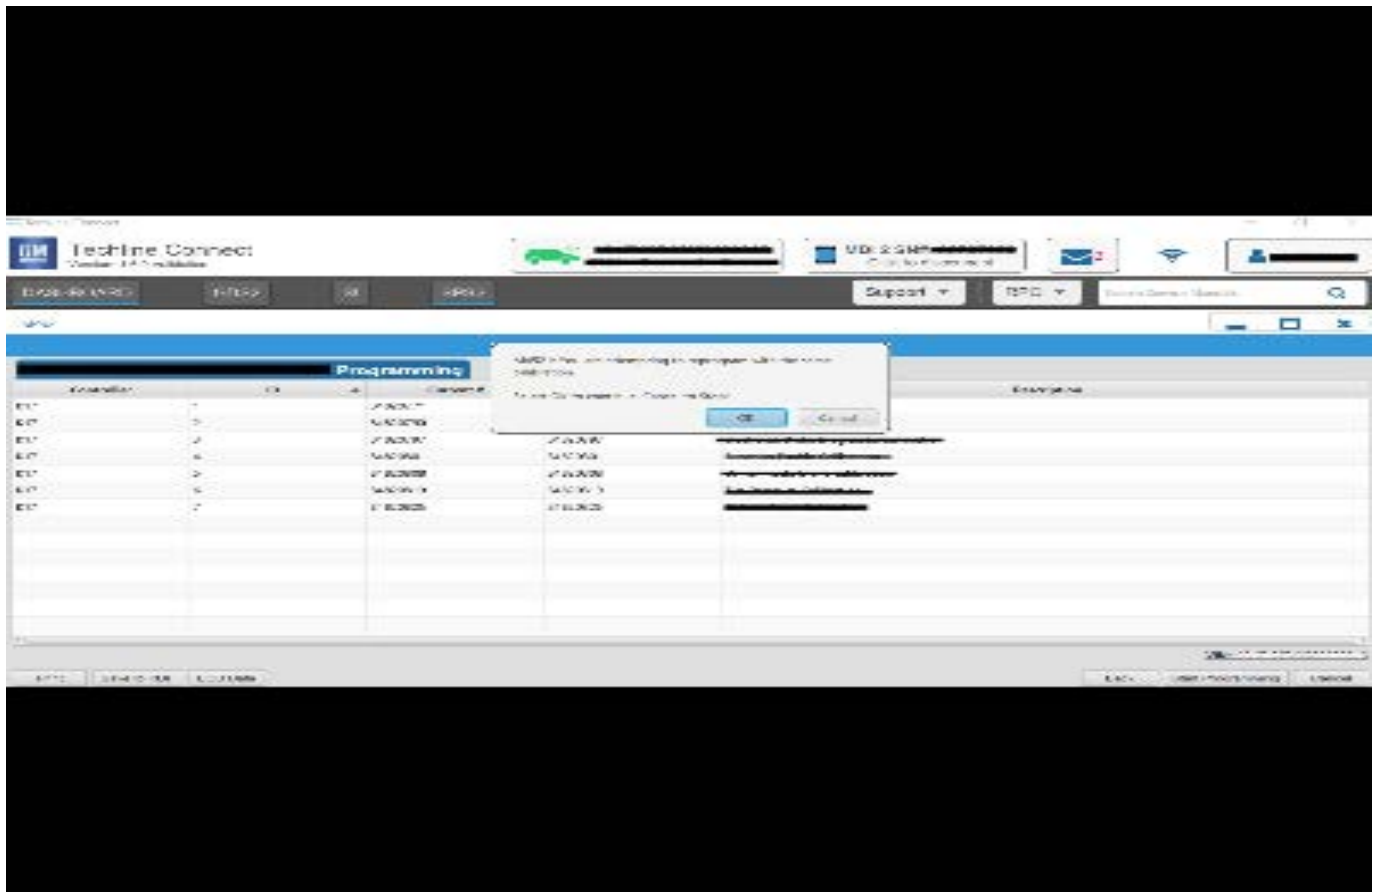
5644477

Important: Techline Connect and TIS2WEB screens shown above.

Important: If the same calibration/software warning is noted on the TLC or SPS Summary screen, select OK and follow screen instructions. After a successful programming event, the WCC is located in the Service
