Service Bulletin

Bulletin No.: 19-NA-076

Subject: Blue or Black Screen and Service Rear Vision System Message on Radio Display Shifting into Reverse

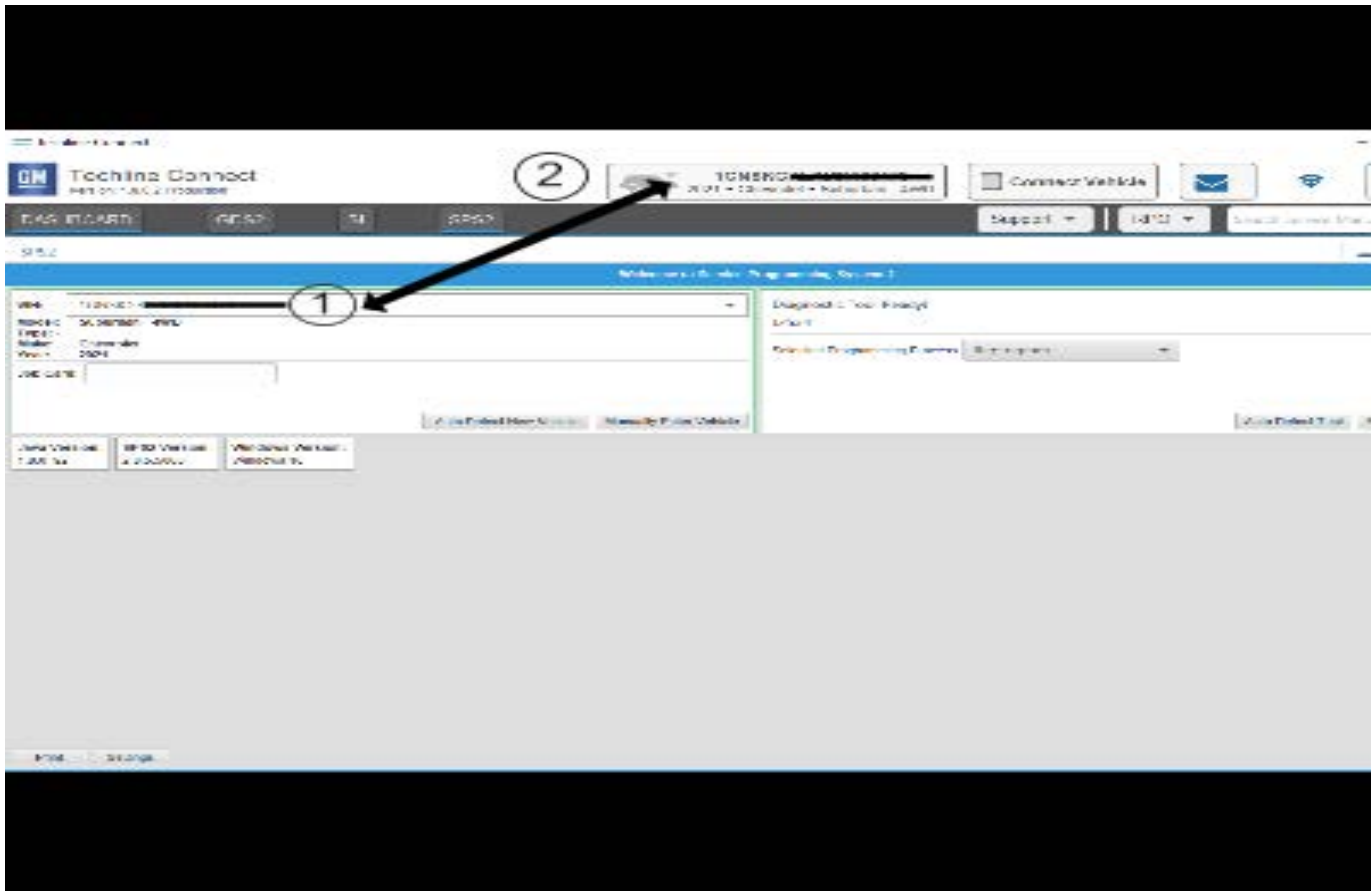
Caution: Be sure the VIN selected in the drop down menu (1) is the same as the vehicle connected (2) before beginning programming.

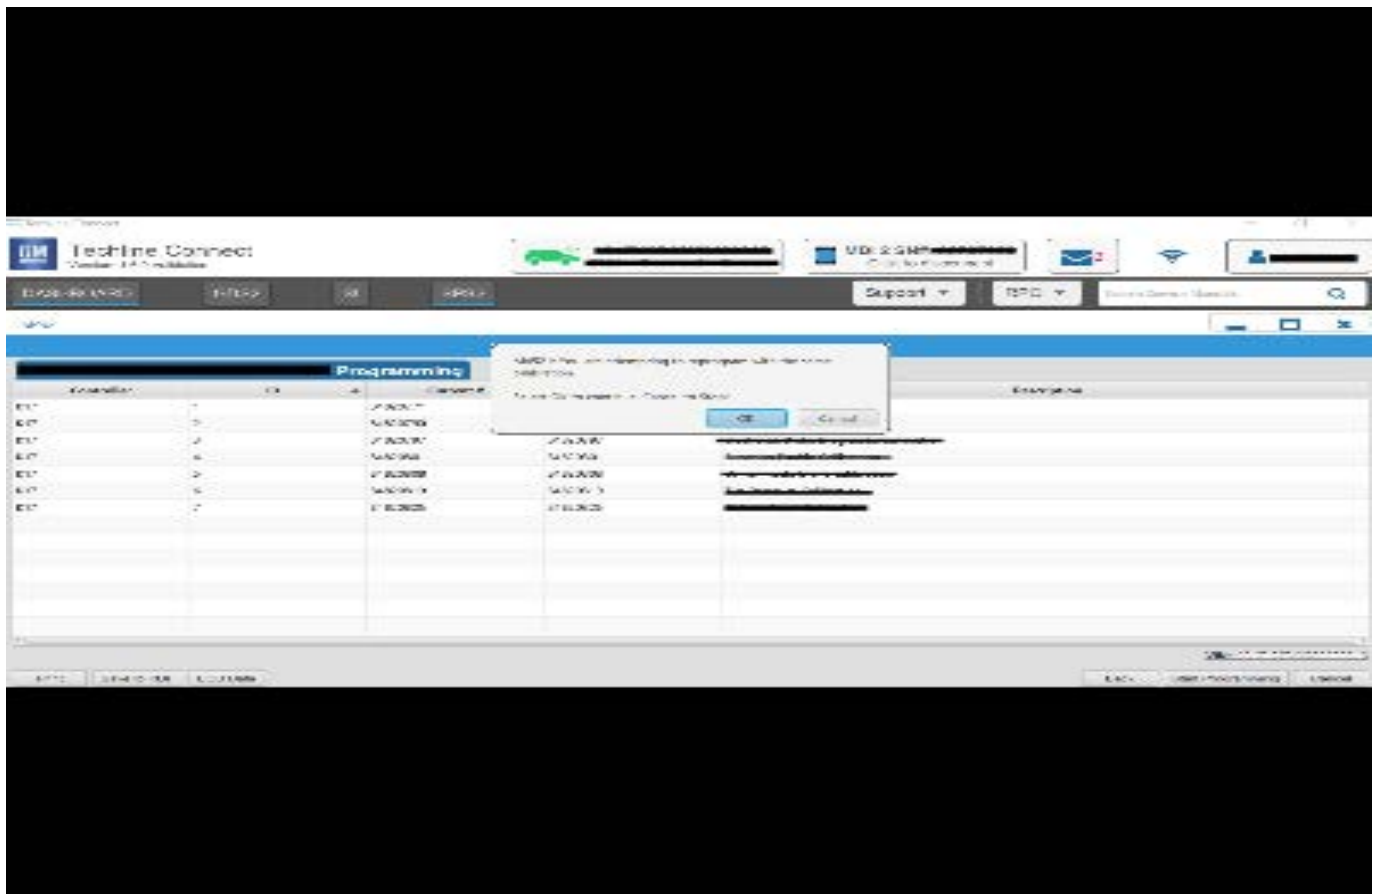
5644477

Important: Techline Connect screen shown above.

Important: If the same calibration/software warning is noted on the TLC or SPS Summary screen, select OK and follow screen instructions. After a successful programming event, the Warranty Claim Code (WCC) is located in the Service Programming System dialogue

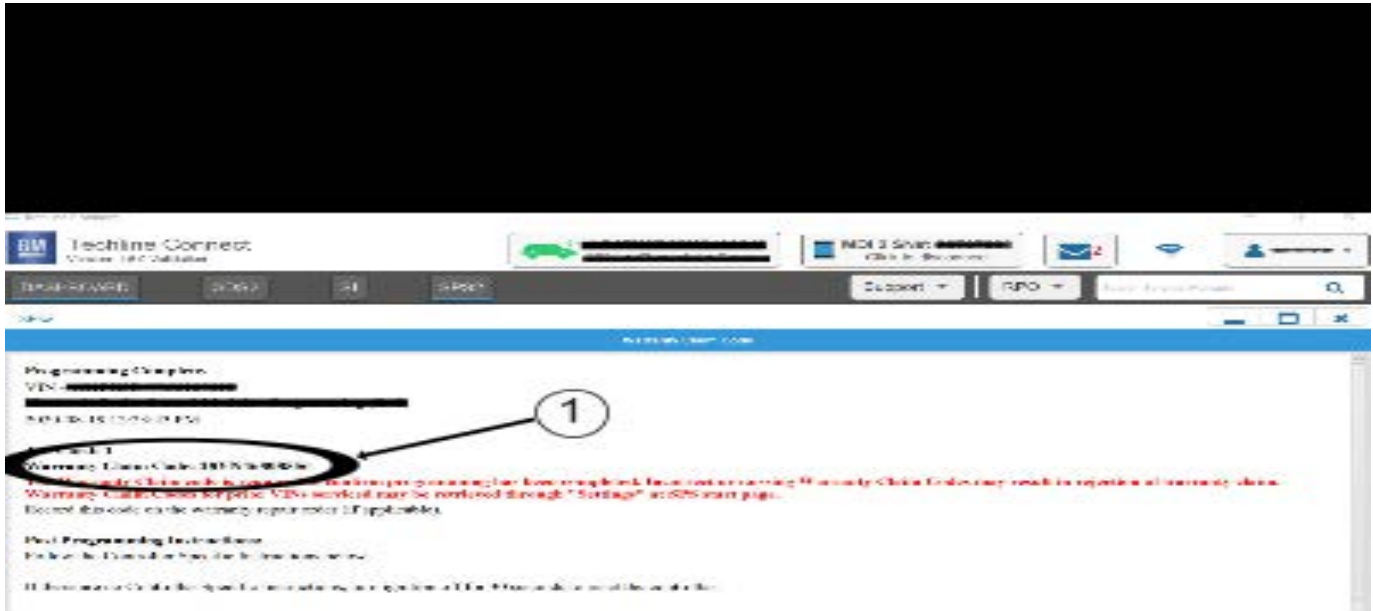
Note: The screenshot above is an example of module programming and may not be indicative of the specific module that is being programmed. Module selection and VIN information have been blacked out.

Important: To avoid warranty transaction rejections, you **MUST** record the warranty claim code provided on the Warranty Claim Code (WCC) screen shown above on the job card. Refer to callout 1 above for the location of the WCC on the screen.

1. Reprogram the Video Processing Control Module. Refer to *K157 Video Processing Control Module: Programming and Setup* in SI.
