SERVICE INFORMATION BULLETIN

APPLICABILITY: 2019-22MY Ascent
2020-22MY Legacy & Outback 2.4L

NUMBER: 02-190-22

SUBJECT: Proper Diagnosis of Oil Level Switch Leaks

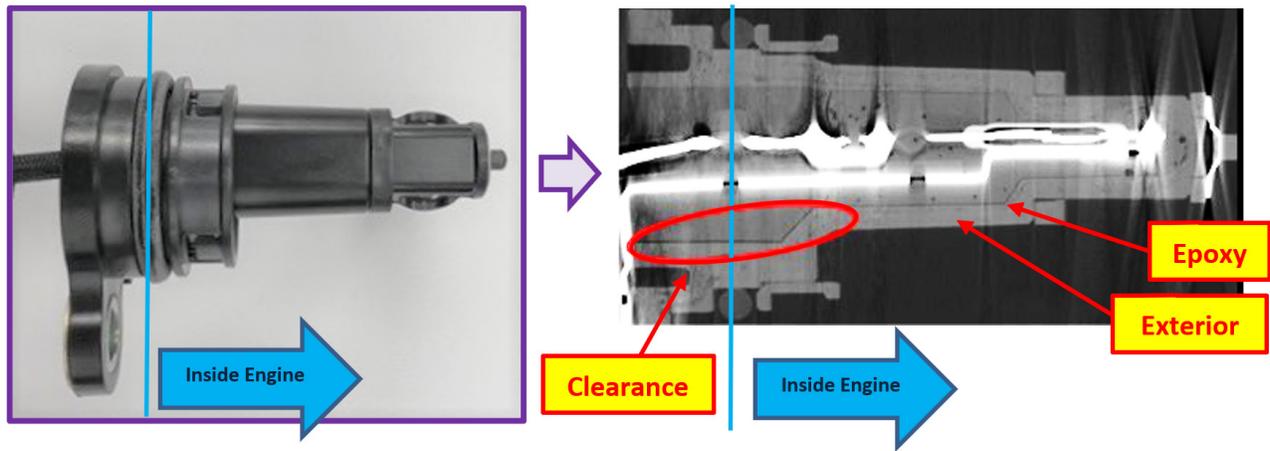
Please follow the procedure below if you find any engine oil on the level switch when an oil leak is being detected. First clean the area and apply a leak seeking powder for easier observation.

1. Observe contact surfaces of the following:
2. Oil Level Switch, Lower Oil Pan, Upper Oil Pan, Engine Block, Cylinder Heads, and Transmission.
3. Confirm if engine oil is leaking from anywhere other than the oil level switch.
4. If any leaks are found, drain the engine oil, and replace and/or reseal the leaking part(s) as necessary.
5. When replacing the leaking component, take special care not to damage the oil level switch by contacting it with other parts while removing and installing, as the float may become damaged. As for the oil level switch, if there's no cracks or damage found during visual inspection, clean and reinstall the switch.
6. Correct the engine oil level. Perform a road test. Re-inspect for any leaks.
