<b>HYUNDAI</b> <b>Technical Service Bulletin</b>	GROUP <b>BODY</b>	NUMBER <b>22-BD-002H</b>
	DATE <b>MARCH, 2022</b>	MODEL(S) <b>TUCSON (NX4a)</b>
<b>SUBJECT:</b> REAR CENTER COMBINATION LAMP MOISTURE INSPECTION AND REPLACEMENT

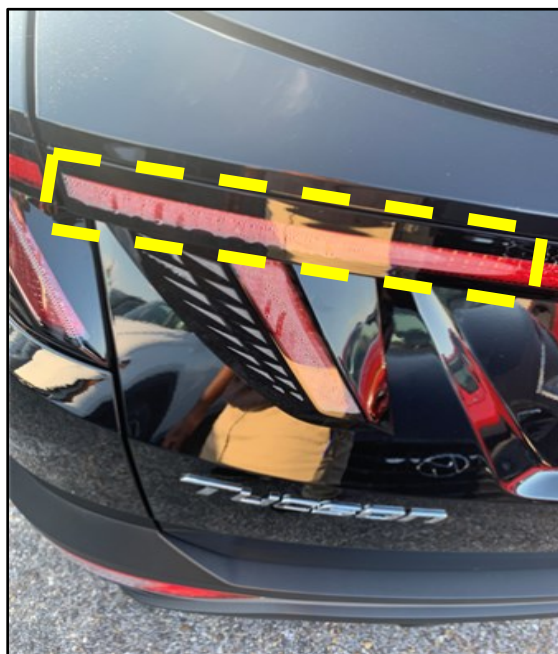
**Description:** Certain 2022MY Tucson (NX4a) vehicles may exhibit excessive moisture in the rear center combination lamp. This bulletin describes the procedure to inspect the rear center combination lamp and repair or replace it if necessary.
