<b>HYUNDAI</b> <b>Technical Service Bulletin</b>	<b>GROUP</b> <b>AUTOMATIC TRANSMISSION</b>	<b>NUMBER</b> <b>22-AT-002H</b>
	<b>DATE</b> <b>MARCH, 2022</b>	<b>MODEL</b> <b>SONATA (DN8A)</b> <b>SANTA FE (TMA)</b> <b>TUCSON (NX4A)</b>
<b>SUBJECT:           AUTOMATIC TRANSAXLE ATF LEAK AT REAR COVER</b>

***This TSB supersedes TSB 21-AT-017H to require a photo of the ATF leak.***

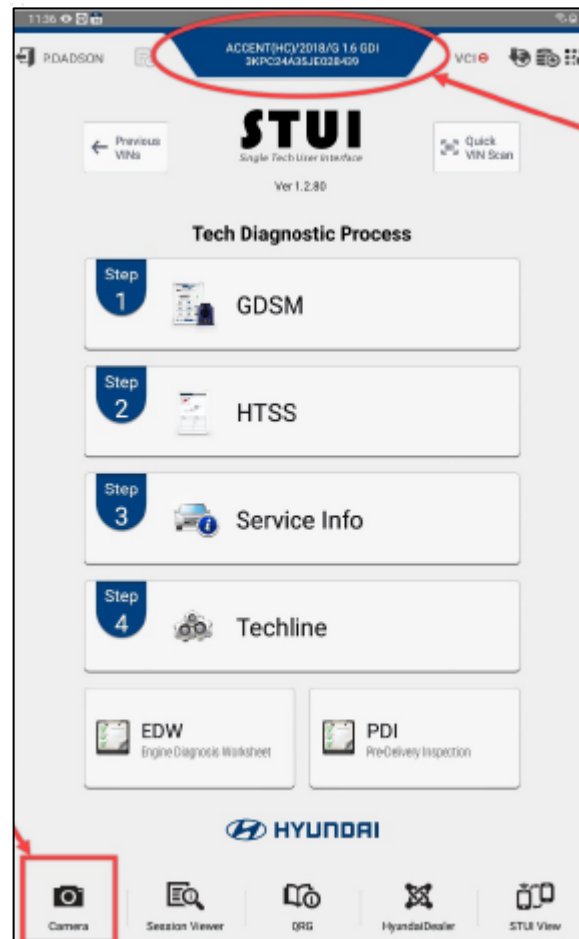
- A. From the GDS home page, select **GDS**. **STUI** will open.  
Confirm the VIN at the top of **STUI** is correct.  
If the VIN is not correct, attach the VCI to the vehicle. Select **Fault Code Searching**. Select **OK** to connect the VCI to STUI. When the correct VIN is displayed, select **OK**.  
Select the **Camera** icon on the lower left.
- B. Select **Add New**.
- C. Select **Take a Photo**. Take a photo of the ATF leak on the rear cover.
- D. Review the photo. Select **Save**.
- E. Select **Submit** to send the photo to Techline.
- F. Wait for the upload to complete. Select **Retrieve** to verify the uploaded image so PA can review the photo once the Prior Approval (PA) for the transmission is submitted.
