Technical Service Bulletin

GROUP CAMPAIGN	NUMBER 22-01-030H
DATE MARCH 2022	MODEL(S) ELANTRA (AD/ADa)

SUBJECT: TCU UPDATE AND IVT REPLACEMENT
(SERVICE CAMPAIGN 963)

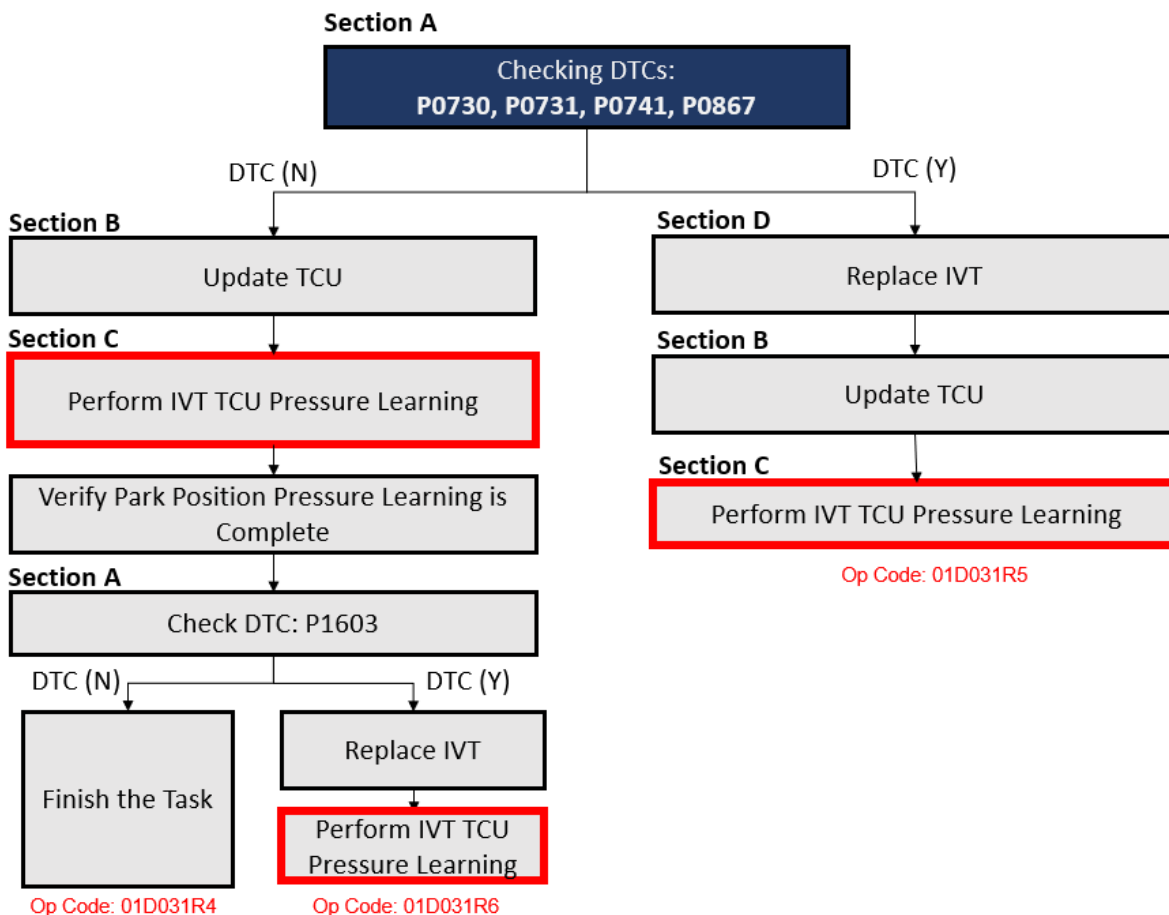
TCU Update Flow (AD/ADa with IVT):

Description: Certain 20MY Elantra (AD/ADa) vehicles may experience an illuminated check engine warning light due to Diagnostic Trouble Codes (DTC) listed below. Perform the Transmission Control Unit (TCU) update, and, if necessary, replace the IVT (Intelligent Variable Transmission) to resolve this condition. This update also includes the software for optimizing CLR_DIST (distance traveled since DTCs cleared) display.

- TCU DTC Codes: **P0730, P0731, P0741, P0867, P1603**

1. Use the GDS-M to check the TCU DTC.
2. If one of the DTC(s) P0730, P0731, P0741, P0867 applies (History, Current, or Pending), replace the IVT.
3. Replace the IVT according to the applicable vehicle shop manual.
4. After IVT replacement, perform TCU update first, then perform the IVT resetting auto T/A values, oil-pressure characteristics input, TCU adaptive values learning procedure.
