<b>HYUNDAI</b> <b>Technical Service Bulletin</b>	GROUP <b>CAMPAIGN</b>	NUMBER <b>22-01-032H</b>
	DATE <b>MARCH 2022</b>	MODEL <b>ELANTRA (CN7) KONA (OS)</b>
<b>SUBJECT:</b>	WATER TEMPERATURE SENSOR LEAK INSPECTION AND REPAIR (SERVICE CAMPAIGN T8F)

**Description:** On certain 2021 Elantra and 2022 Kona vehicles equipped with 2.0L engine, a coolant leak at the Water Temperature Sensor (WTS) may be observed due to machining burrs at the mounting port of the cylinder head, resulting in improper coolant sealing.

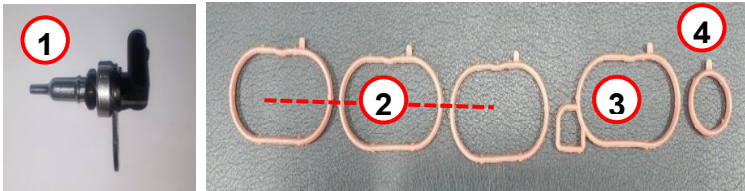
<b>Kit Includes:</b> ① Water Temp Sensor (39220-2J100) ② GASKET-PORT (28313-2J300) -3EA ③ GASKET-PCV (28313-2J301) -1EA ④ GASKET-EGR (28314-2J300) -1EA

**NOTE:** Always install all contents of the WTS and Gasket after mounting hole matching.

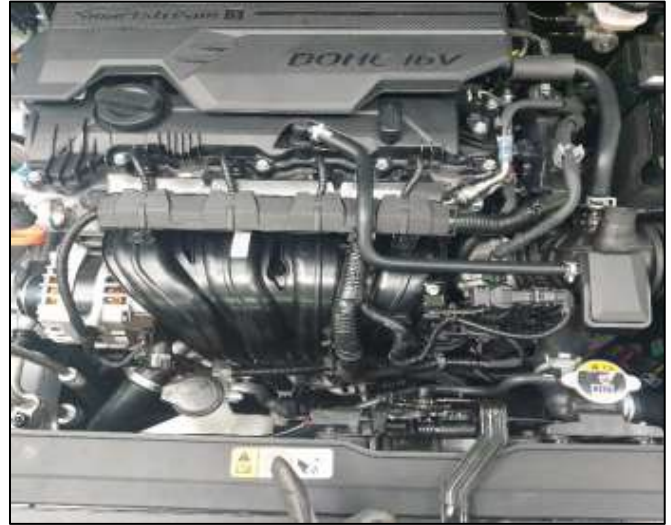
Low coolant level and/or improper air bleeding of the cooling system may result in poor engine cooling, improper HVAC system performance, and abnormal noise from the cooling system.

22. Refill and air bleed the cooling system according to the Shop Manual.
