Subject: REVISION: N212354170-02 – Emission Recall
DPF Regeneration Temperature
Population Expansion to Include US VINs

Models: 2020 Chevrolet Silverado 2500HD/3500HD
2020 GMC Sierra 2500HD/3500HD
Equipped with the 6.6L Diesel Engine (RPO L5P)

Product Emission Recall

N212354170 DPF Regeneration Temperature

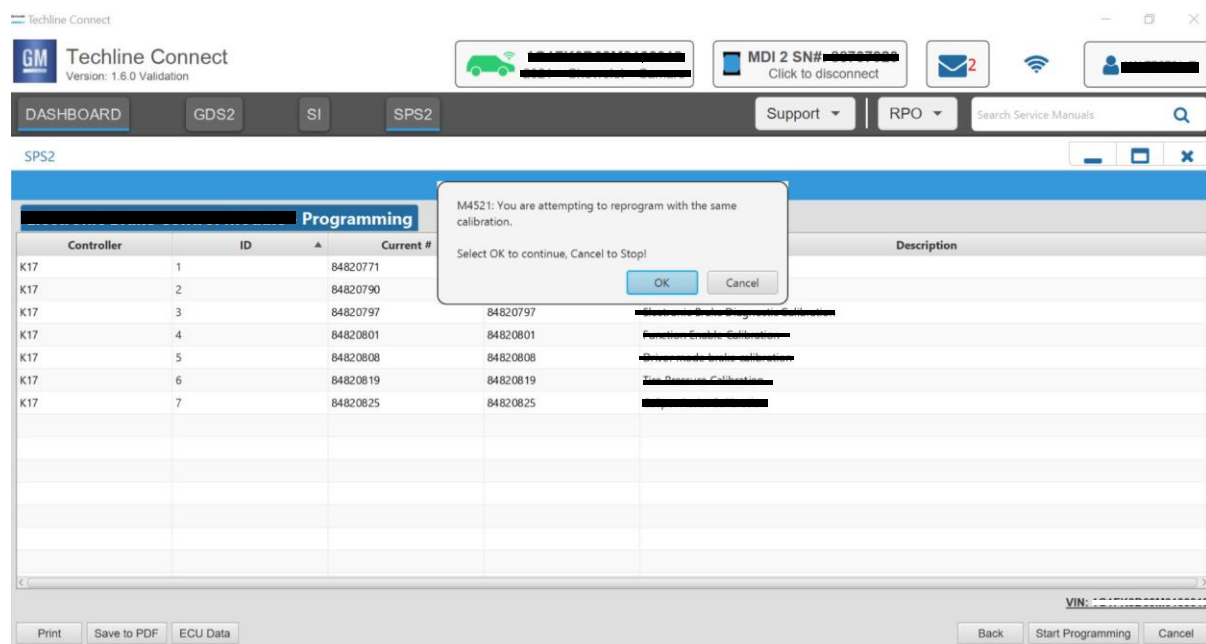
5644477

Important: Techline Connect screens shown above.

Important: If the same calibration/software warning is noted on the TLC Summary screen, select OK and follow screen instructions. After a successful programming event, the WCC is located in the Service Programming System dialogue box of the SPS Summary screen. No further action is required. Refer to the Warranty section of the bulletin.
