HYUNDAI Technical Service Bulletin

GROUP STEERING	NUMBER 22-ST-003H
DATE APRIL 2022	MODEL(S) Sonata (DN8A)

SUBJECT: SONATA (DN8A) C-MDPS WORM SHAFT BEARING NOISE

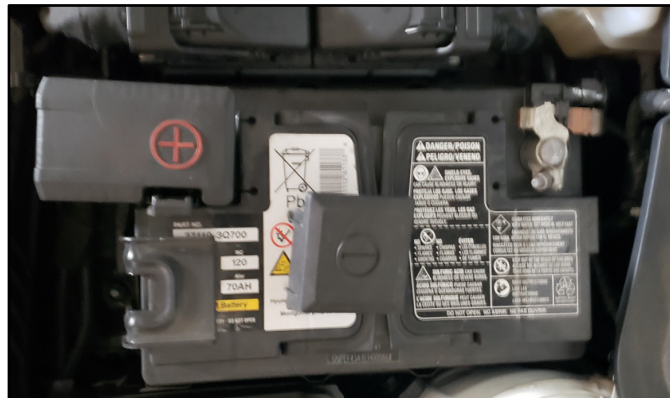
Not removing the negative (-) terminal from the battery may result in accidental airbag deployment and possible physical injury.

Battery Terminal Tightening Torque

lb-in	• 69.6-86.4
lb-ft	• 5.8-7.2
kgf.m	• 0.1-1.0
N.m	• 7.8-9.8

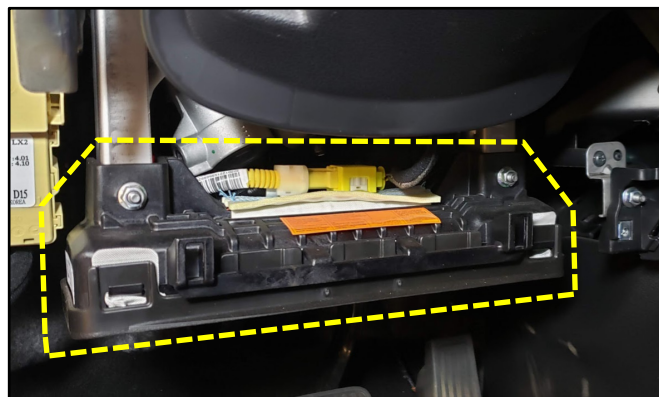
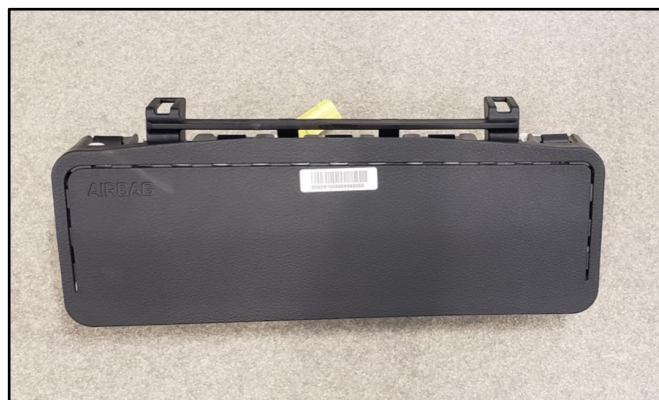
The airbag may accidentally be deployed and possibly cause physical injury. After removing the knee airbag module, position airbag with the cover facing upward.

If equipped, carefully remove the driver's knee airbag following the procedures in the applicable shop manual.

Restraint > Airbag Module > Knee Airbag (KAB) Module
