## Preliminary Information

### PIP5822B MIL Illuminated with DTC P0341 Set

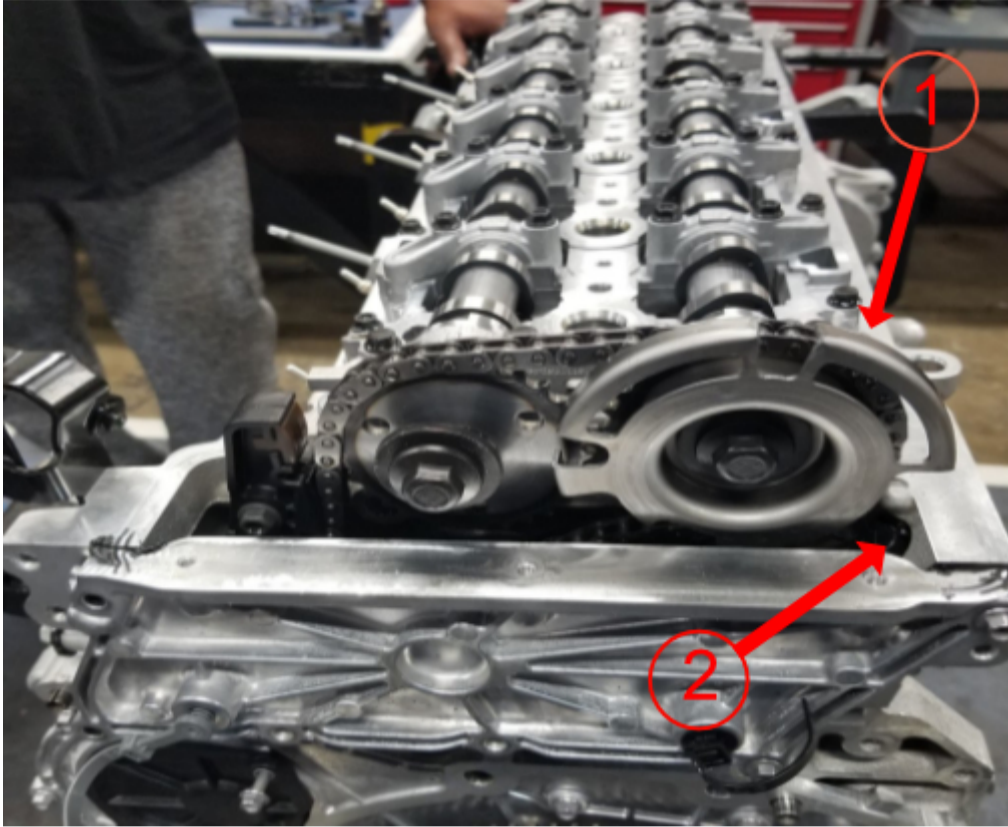
The exciter wheel in the pictures below are for reference only and is NOT bent.

- 1. Camshaft exciter wheel
- 2. Camshaft position sensor

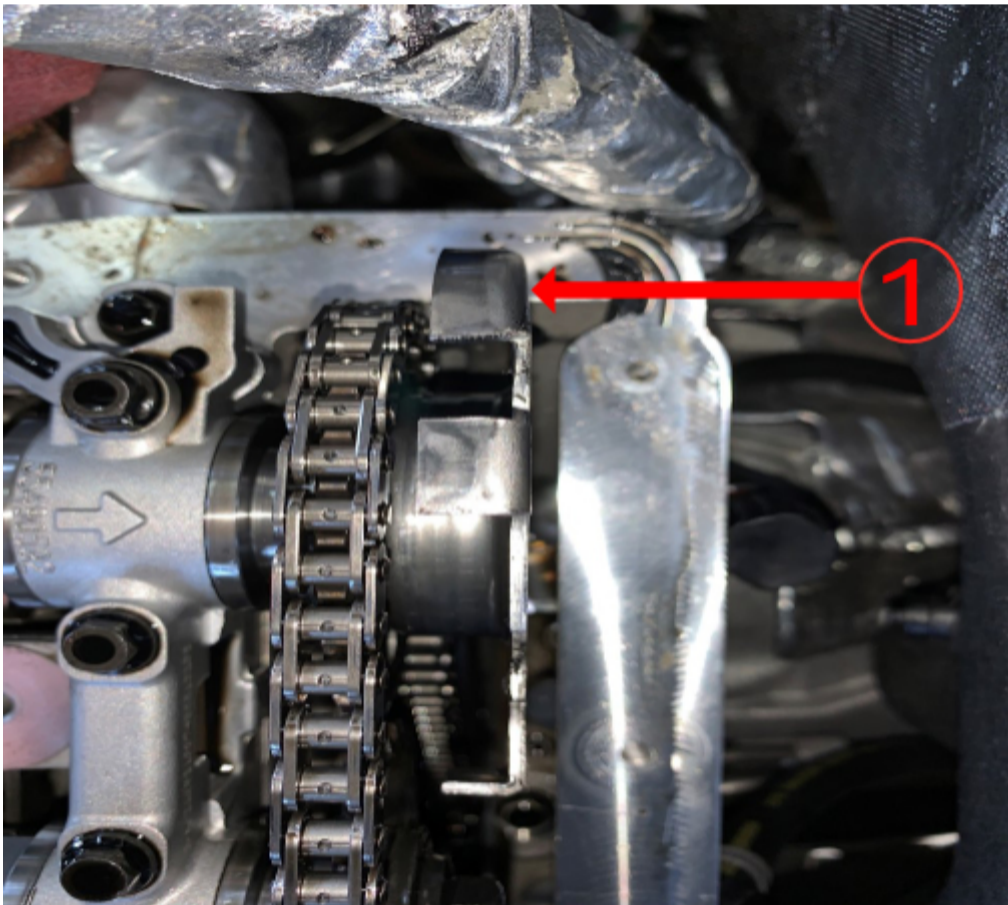
- 1. Camshaft exciter wheel
