SERVICE BULLETIN

Classification:	Reference:	Date:
BT21-022	NTB22-015	March 4, 2022

REAR SLIDING CENTER GLASS SEAL LOOSE OR DETACHED

APPLIED VEHICLES:	2020-2021 Frontier (D40) 2022 Frontier (D41)
APPLIED DATES:	2020-2021 All 2022 Built before September 19, 2021
APPLIED GRADES:	SV with SV Convenience Package Only Pro-X (All) Pro-4X (All)

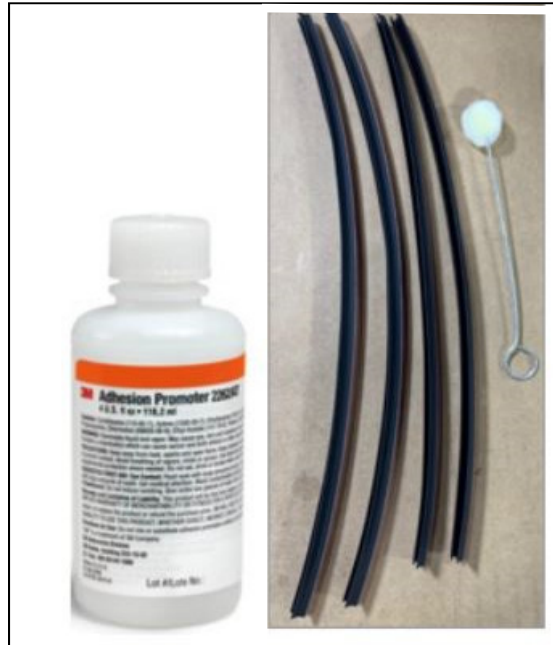
Figure 2

Back Window Glass Sealant Kit 79718-9BV0A includes the following:

- 2 horizontal seals (300 mm)
- 2 vertical seals (280 mm)
- 3M[®] adhesion promoter (2262AT)
- Adhesion promoter applicator

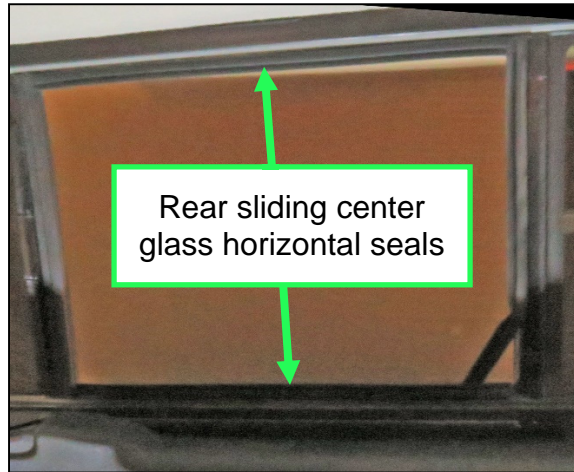
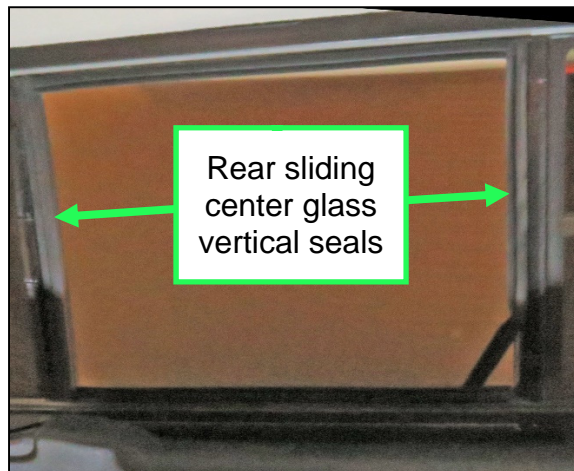
HINT: The rear sliding center glass seals come in two different lengths. Compare the length of the old seal with the new seal before installation.
