MAS002980 (MSC 22-08)

Campaign 487
FROM Maserati TSO
TO Maserati Network

Service Campaign 487 MC20 - Water infiltration through door wiring area

DATE: April 1, 2022

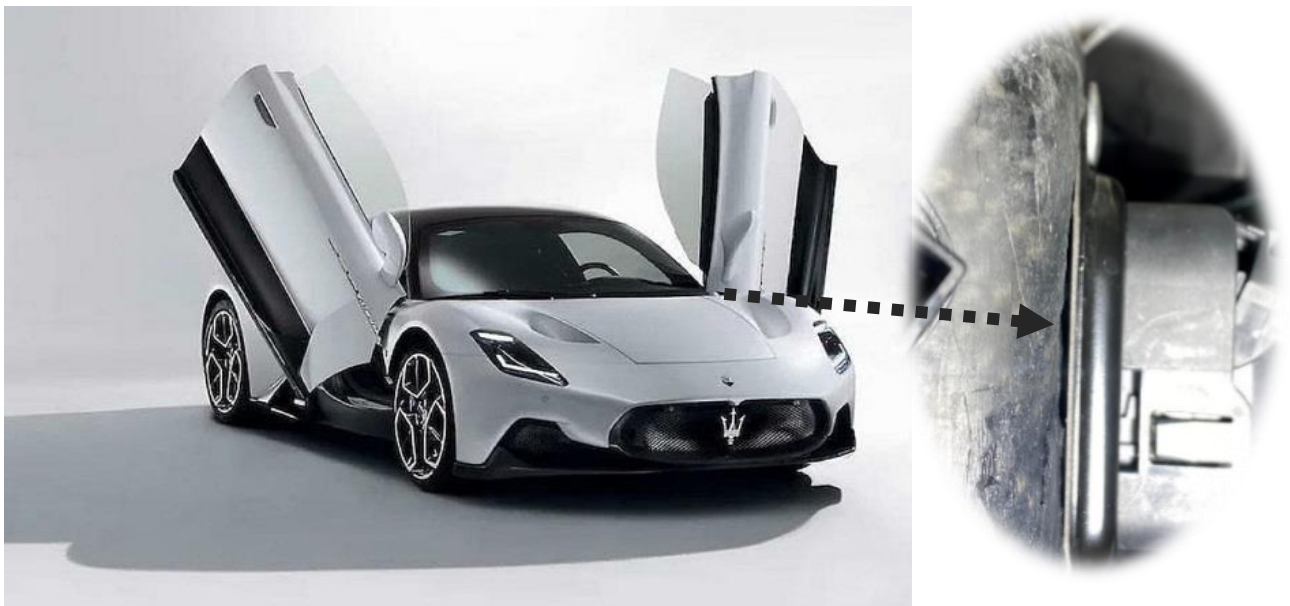
Certain Maserati MC20 (M240) vehicles listed in ModisCs+ are involved in a Service Campaign to help prevent water infiltration through the door wiring area.

This possible infiltration is caused by a poor coupling between the aluminium bracket of the door connector and the carbon fiber of the monocoque body, which could be uneven in the coupling area.

A new coupling has been implemented on later production vehicles to prevent any risk of infiltration.
