## Technical Service Bulletin

Transaction No: 2034898/22

01-18-13 - MIL ON DTC P0401, P2002 or P240F Exhaust Gas Recirculation Flow Insufficient

Release date: 5/16/2022

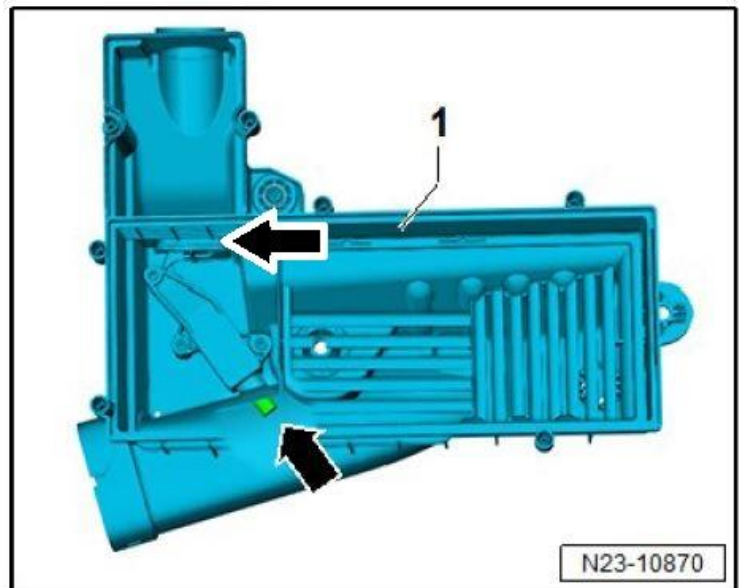
The changeover valve for intake air preheating opens and closes with a slight delay as the expansion element first needs to cool down or warm up.

- Remove snow screen.
- Spray freeze spray (lower arrow) onto the thermal element until the flap opens (upper arrow). If it does not open, replace flap.
- After the flap opens wait for 15 minutes. If the flap is not completely closed after that time replace the flap.
