# Service Bulletin

Bulletin No.: 22-NA-007

**Subject: Poor Engine Performance in Extremely Cold Weather Conditions for LE2 Engines, Charge Air Cooler (CAC) Icing - Malfunction Indicator Lamp (MIL) Illuminated, DTC P0299, P0234, P0236, P2227, P00C7 Set**

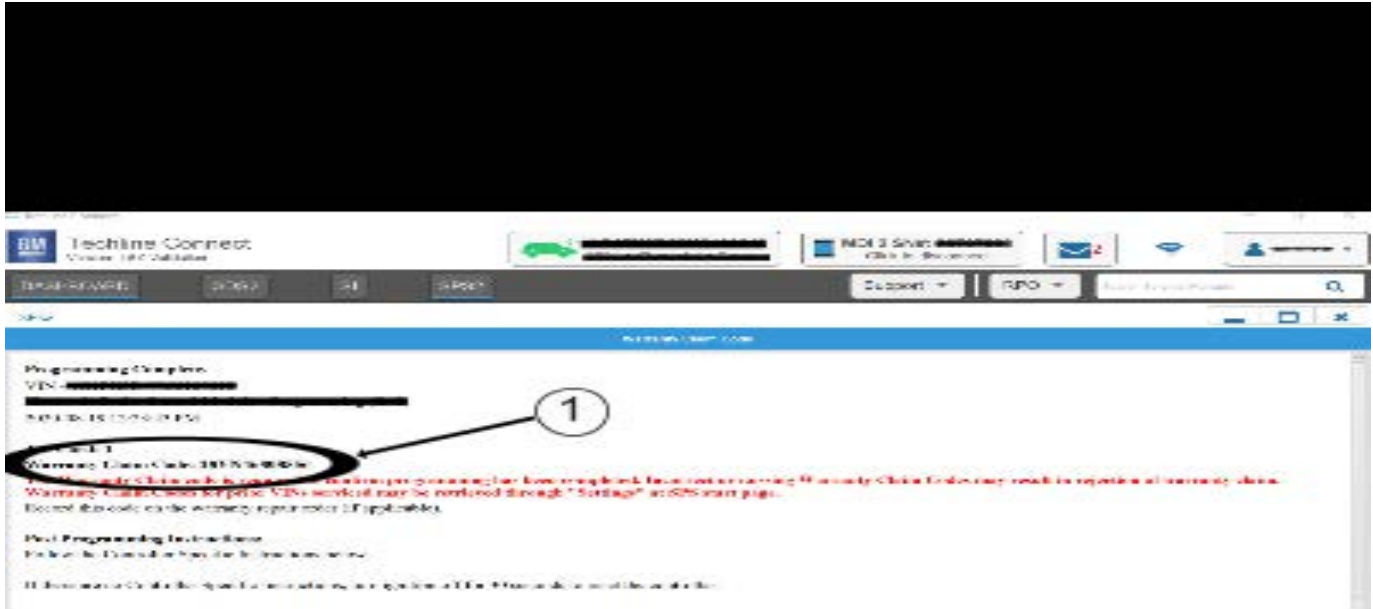
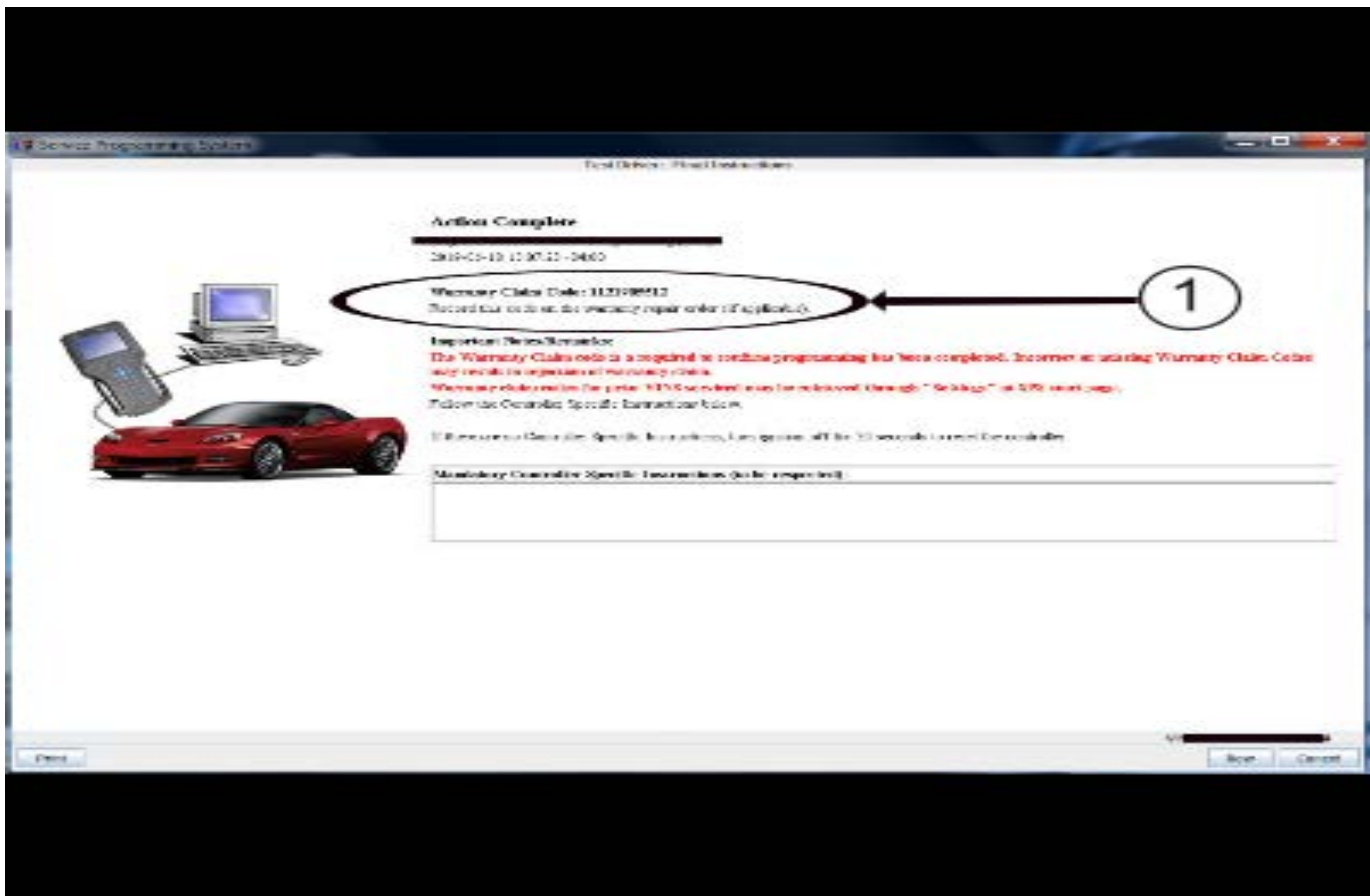
5431209

**Note:** The screenshots above are an example of module programming and may not be indicative of the specific module that is being programmed. Module selection and VIN information have been blacked out.

1. Reprogram the ECM. Refer to *K20 Engine Control Module: Programming and Setup* in SI.
