Service Bulletin

Bulletin No.: 22-NA-016

Subject: Transmission Control Module Offline Event

Brand:	Model:	Model Year:		Breakpoint Date:		Engine:	Transmission:
		from	to	from	to		
Chevrolet	Tahoe Suburban	2021	2021	SOP	August 24, 2020		
GMC	Yukon Yukon XL

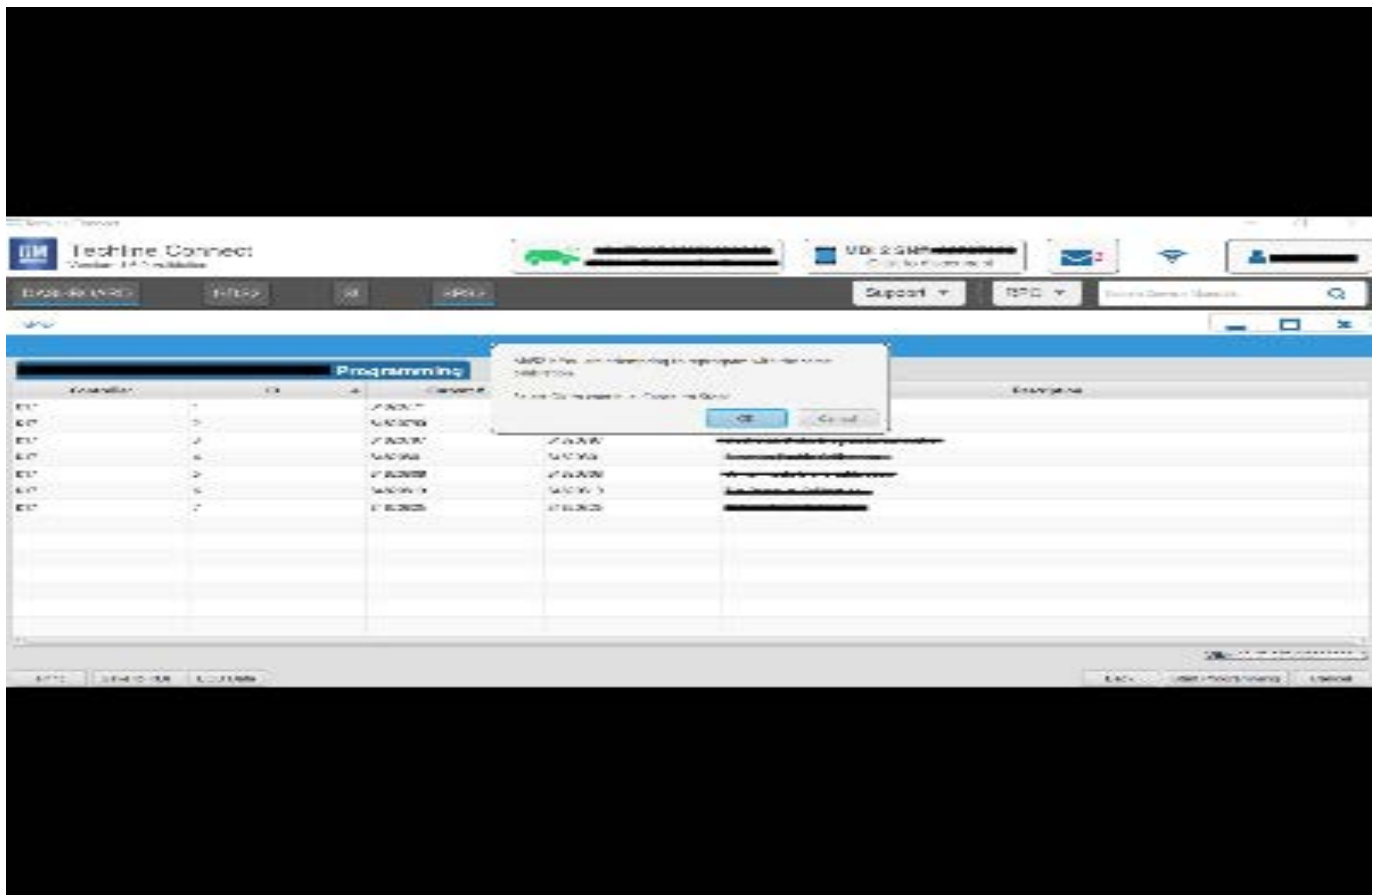
5644477

Important: Techline Connect and TIS2WEB screens shown above.

Important: If the same calibration/software warning is noted on the TLC or SPS Summary screen, select OK and follow screen instructions. After a successful programming event, the WCC is located in the Service
