2022 Ontour

ONTOUR 2.2 SQUEEK NOISE FROM MIDDLE KITCHEN GALLEY

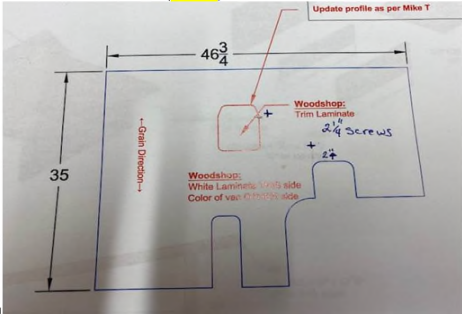
CUSTOMER INDICATED THE SQUEEK NOISE WAS COMING FROM WHERE THE COUNTER TOP MEETS THE FELT WALLS BEHIND THE KITCHEN GALLEY.

TO REPAIR, REMOVE THE MICROWAVE AND ADD A SCREW (2 3/4" size) 2" ABOVE THE LEFT LOWER CUTOUT AS SEEN IN PICTURE 2 BELOW. ADD ANOTHER SCREW (2 3/4" size) 1" ABOVE THE RIGHT UPPER CUTOUT AS SEEN IN PICTURE 3 BELOW.
