## AHM Support

## miniMoto / Sport

Editor: Trevor Blackburn E-mail *The Wrench* at: [EditorTheWrench@ahm.honda.com](mailto:EditorTheWrench@ahm.honda.com)

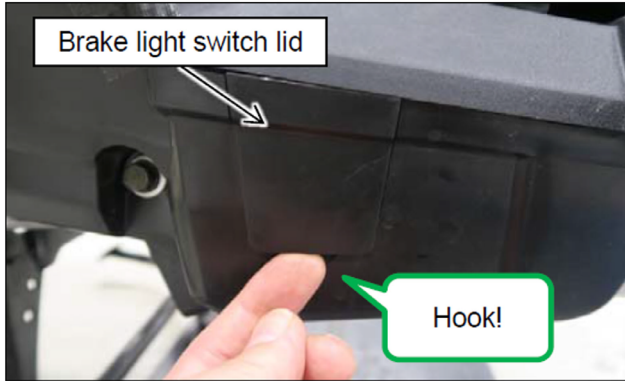
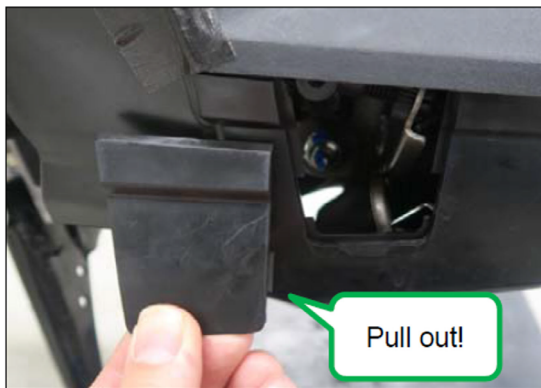
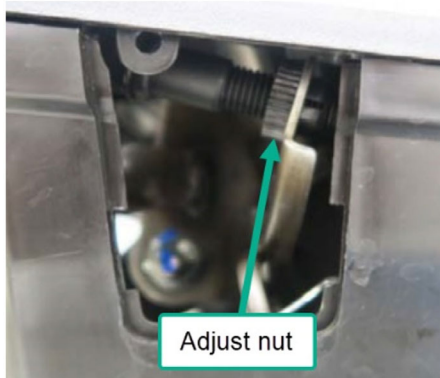
## Rear Brake Light Switch (NVA110 '22)

Access the rear brake light switch via the brake light switch lid on the right side of the floor lower cover. Lift from the bottom edge of the lid, then pull outward. The lid has a "hook" on the bottom edge for easier access.

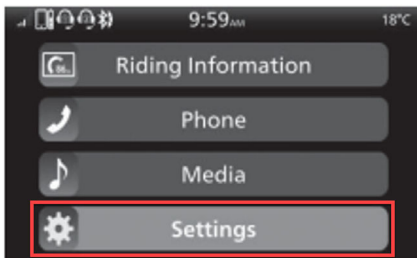
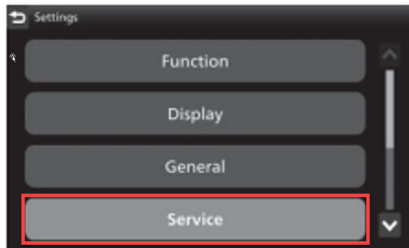
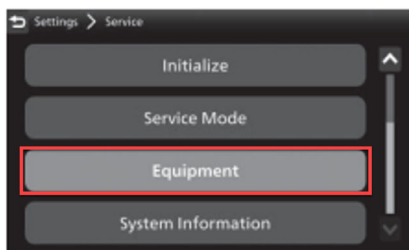
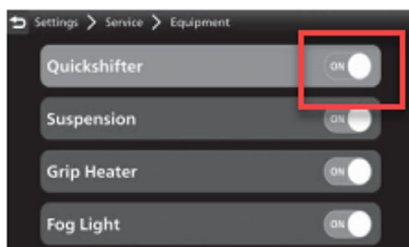
If the indicator warning light is on at all times and the motorcycle functions normally, you could have a DTC code P170D (shift sensor ground fault) due to the unit not having the quick shift option installed. Using the *Accessory Quick Shifter Installation Instructions* (p/n 08U71-MKS-E00), follow the initialization procedure found on pg. 7 and proceed to turn the quick shift option to the "off" position. You should test ride the motorcycle and verify the DTC does not return.

4. Select the "Settings", then press the ENT option.

5. Select the "Service", then press the ENT option.

6. Select the "Equipment", then press the ENT option.

7. Select the "Quickshifter", then press the ENT option to the "OFF" function.
