HYUNDAI Technical Service Bulletin	GROUP AUTOMATIC TRANSMISSION	NUMBER 22-AT-007H
	DATE MAY 2022	MODEL(S) TUCSON (TL) 1.6T SONATA (LFa) 1.6T KONA (OS) 1.6T
SUBJECT: DUAL CLUTCH TRANSMISSION JUDDER DETECTION AND TCU SOFTWARE UPDATE

This TSB supersedes 21-AT-014H to include 2018-21MY Kona (OS) 1.6L Turbo vehicles.

Description: Certain vehicles (listed below) equipped with 7-speed Double Clutch Transmissions (DCT) may exhibit abnormal vibration at low speeds. This bulletin outlines the procedures for diagnosing clutch judder, updating the Transmission Control Unit (TCU) with revised logic, and/or replacing the Double Clutch.

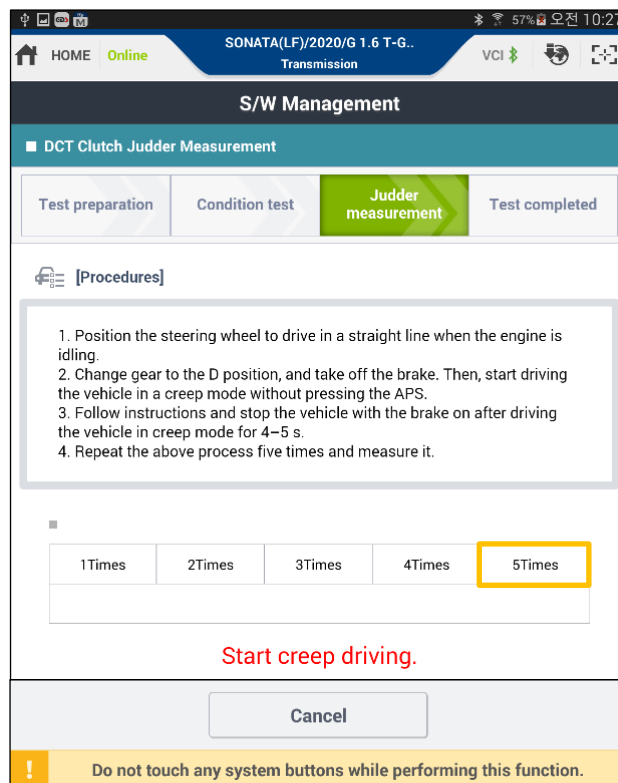
- Follow the instructions from the Judder Measurement screen to perform the judder clutch inspection.

The inspection is complete when the **5Times** reading appears.

Do not brake or operate the accelerator during the inspection.

- After the measurement is complete, apply the brakes for 4-5 seconds.
- If the result is **“PASS, No Judder Detected”**, the service procedure is complete.

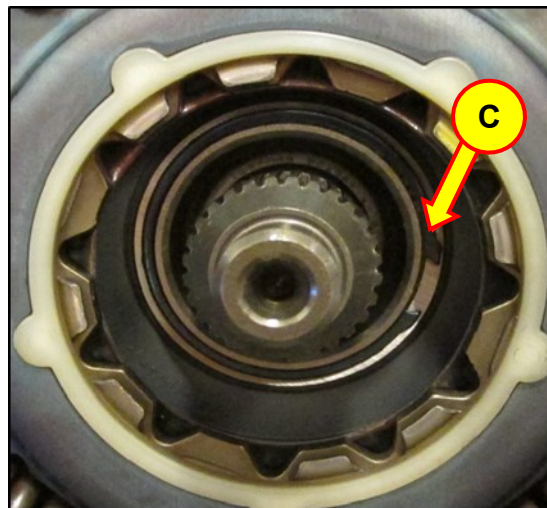
The snap ring can become deformed in the removal process. Do not reuse the existing snap rings when reinstalling the Double Clutch into the transmission.

3. Remove the snap ring (C) (41068-2D000).

When installing the new snap ring, make sure it is fully seated and can be easily rotated left and right.

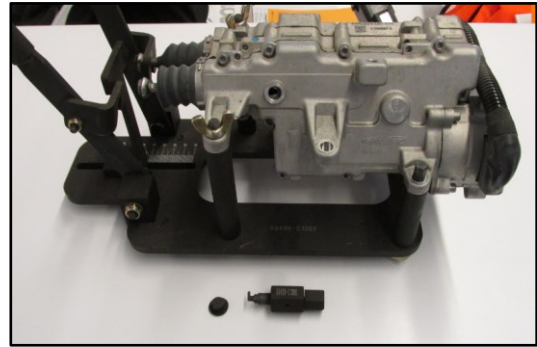
When installing a new Double-Clutch, the clutch actuator rod length must be reset back to the factory zero. If the rod length is not adjusted correctly, the GDS-M DCT relearn procedure will not complete.

8. Reinstall the clutch actuator in the order that it was removed.

Torque: Fork Cover - 2.9-4.3 lb-ft (3.9-5.9 N.m)

Torque: Clutch Actuator - 14.5-19.5 lb-ft (19.6-26.5 N.m)
