MAS003093 (MSC 22-17)

Campaign 486  
FROM Maserati TSO  
TO Maserati Network

# Service Campaign 486 MC20 - Suspension Lifter 3-Way Block Oil Leakage

DATE: MAY 18 2022

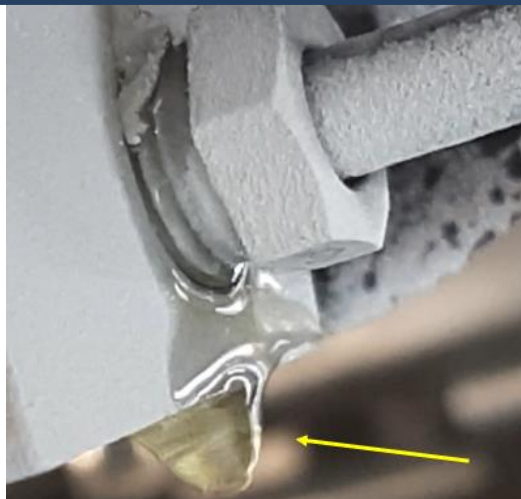
Certain Maserati MC20 (M240) vehicles listed in ModisCS+ are involved in a Service Campaign concerning a potential oil leak from any of the 3 Hydraulic lines connected to the 3-way block housing of the suspension lifter caused by loose pipe screws.

The remedy consists of a dedicated rework cycle to restore the correct tightening torque between the 3 Hydraulic pipe screws and the 3-way block housing.
