Technical Journal

Center wheel caps, removal instructionREF NO:
TJ 28739.3.0ISSUING DEPARTMENT:
Technical ServiceCAR MARKET:
United States and CanadaPARTNER:
3 US 7510 Volvo Car USAISSUE DATE:
2022-04-29STATUS DATE:
2022-05-06FUNC GROUP:
7718FUNC DESC:
Hub cap**Page 1 of 7**

TJ Instruction VCC-471202-1

Title	Wheel cap	Page	1 (4)
Action	Removal	Operation number:	98522-2

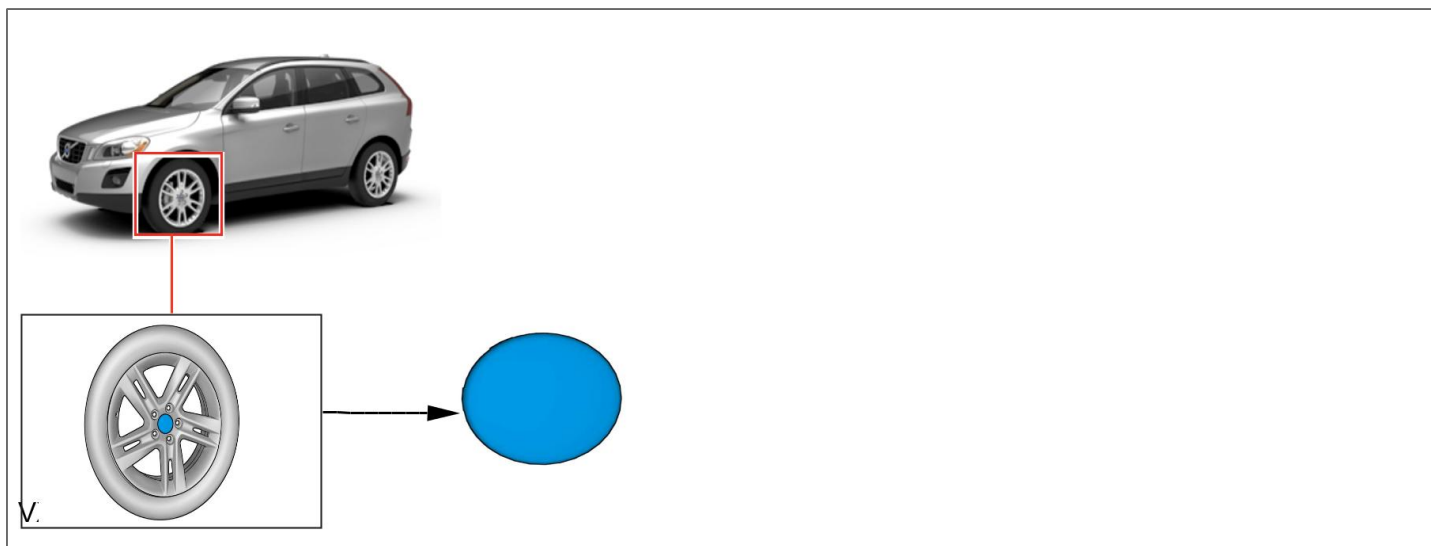
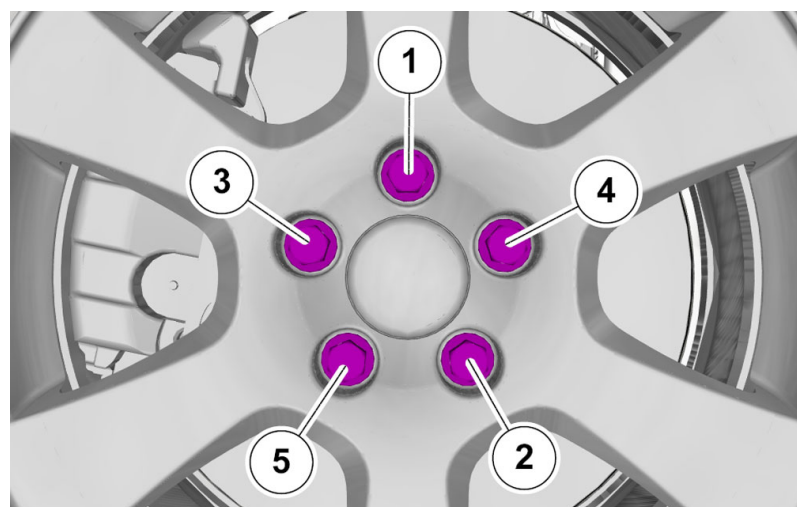
Removal

If the center wheel cap is removed incorrectly, for instance using a smallscrew driver to remove the center wheel cap from the front side, **Note:** Doing this will cause damage to the rim.

The correct way to remove the center wheel cap is to push it out from the inner side, refer to the attached TJ instruction.
