Service Bulletin

Bulletin No.: 21-NA-149

Subject: Engine Wire Harness Chafing / IPC Gauges Sweep / IPC Warning Message / SES/Check Engine/MIL / No Start / No Crank / Runs Rough / Stalls / Reduced Engine Power / Various DTCs

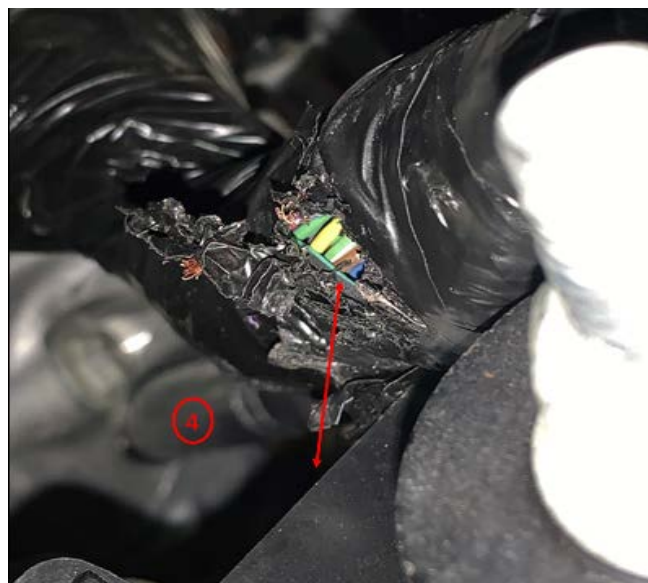
5583331

The cause of the condition may be an engine wire harness clip was removed during production due to ergonomic issues (hand clearance and branch stiffness). This led to an uncontrolled branch that came into contact with a sharp edge (1) & (2) on the ECM/TCM bracket, driver side upper control arm, and/or shock tower and caused chaffing during engine vibration and roll.

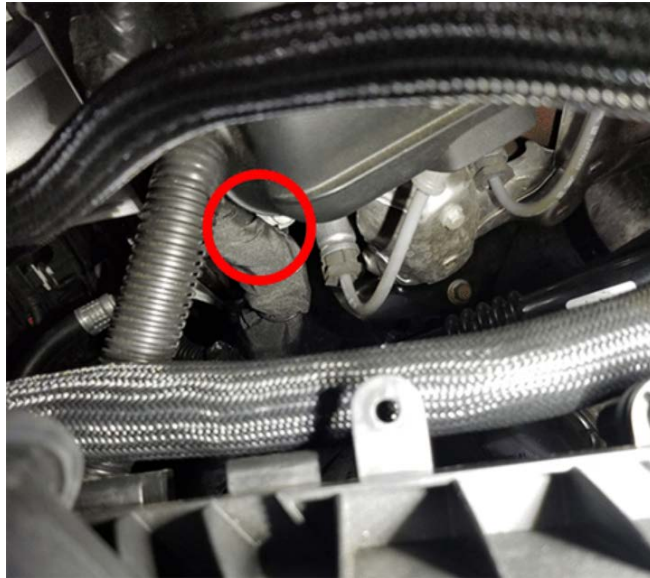
5412204

This Correction pertains to vehicles equipped with engine 4.3L, LV3 only.
Note: The first graphic below is a before, and after (2), repair example of harness chaffing at the Oil Dipstick bracket.

To correct this concern, repair the damaged wiring following the SI wire-to-wire repair procedures. Once repaired, protect and reposition the engine wiring harness to prevent future harness damage.

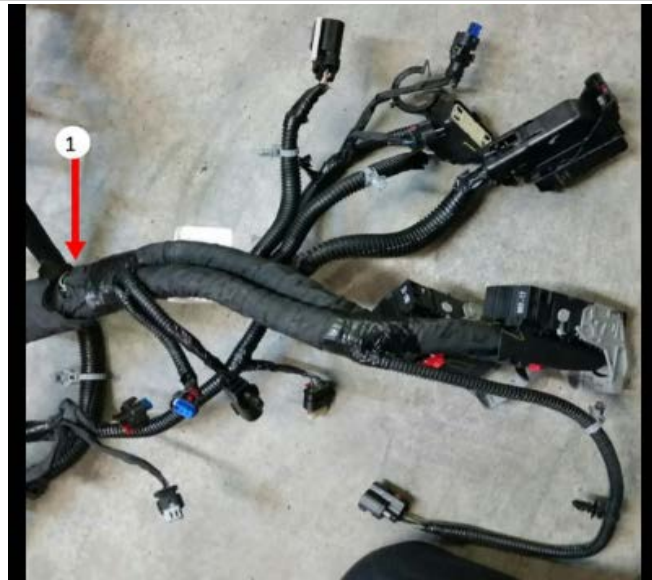
5628370

<p style="text-align: right;">5643651</p> <p>In many cases, the ECM has been unnecessarily replaced for these concerns. Please thoroughly inspect the areas shown above and follow published SI diagnostics before any parts are replaced. If any concerns are found, then follow SI Wiring and Connector repair instructions to correct the concern.</p>
<p>Correction 4</p>	<p>This Correction pertains to vehicles equipped with engines 5.3L L82, 5.3L L84, 6.2L L87, 4.3L LV3, 2.7L L3B, or 3.0L LM2.</p> <p>Utilizing Engine Harness sleeves, anti-abrasion tape, and zip-ties to secure the harness away from one or more of the chaffing points. Follow the Service Procedure steps below.</p> <ol style="list-style-type: none"> 1. Lift and support the vehicle. Refer to <i>Lifting and Jacking the Vehicle</i> in SI. 2. Remove driver side tire and wheel and driver wheelhouse liner. Refer to <i>Tire and Wheel Removal and Installation</i>, and <i>Front Wheelhouse Liner Replacement</i> in SI.
