**SIB 65 01 22**

Knee Air Bag Check Control Message G01 Variants

This Service Information Bulletin (Revision 2) replaces SI B65 01 22 **dated April 2022**.

Audio, Navigation, Information, Safety Systems

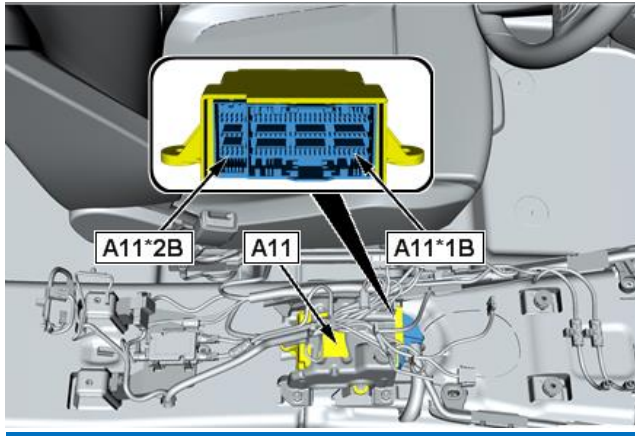
1-Perform a vehicle test with ISTA.

2-Remove the **center console** as per **Repair Instructions 51 16 165** to access the Air Bag Control Module **A11 (ACSM)** wiring connector (**A11*2B**).

Check the ACSM module for signs of corrosion within the electrical connectors.
