Technical Service Bulletin

01-18-13 - MIL ON DTC P0401, P2002 or P240F Exhaust Gas Recirculation Flow Insufficient

Release date: 6/14/2022

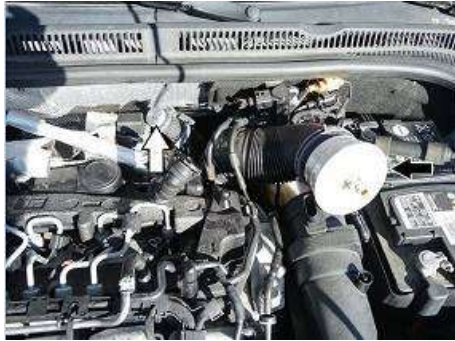
Special tool VAG 1687/10 pressure adapter, installing

2.0L TDI shown

- Separate intake hose from the Mass Airflow Sensor assembly (MAF).
- Insert VAG 1687/10 pressure adapter in intake hose -black arrow- using existing clamp (as shown).
- Remove crankcase ventilation valve or tube from intake hose at -white arrow-.
- Plug hose with appropriate metal plug and hose clamps supplied with VAG 1687 special tool kit at -white arrow-.

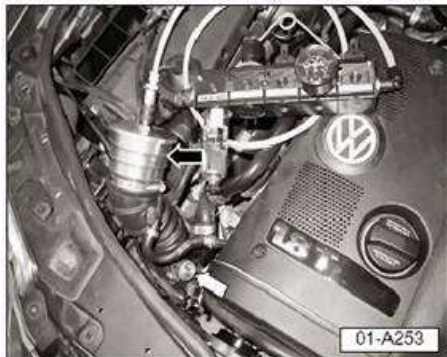
Special tool KLI9210 (EVAP system leak detector)

1.8T shown

- Install optional fitting KLI 9210/50 on hose of special tool KLI9210.
- Connect KLI9210 to VAG 1687/1 adapter (KLI 9210 is shown attached to VAG1687/1 at arrow on 1.8L Turbo).
