STAR ONLINE PUBLICATION

Case Number: S2108000209 REV. A

Symptom/Vehicle Issue: Multiple Electrical Concerns, Reduced Cooling Fan Speed, Start Stop Does Not Work Intermittently, EPS Steering Warning Message, Check Engine Lamp On, Discharged Battery, No Start, Drained AUX Battery

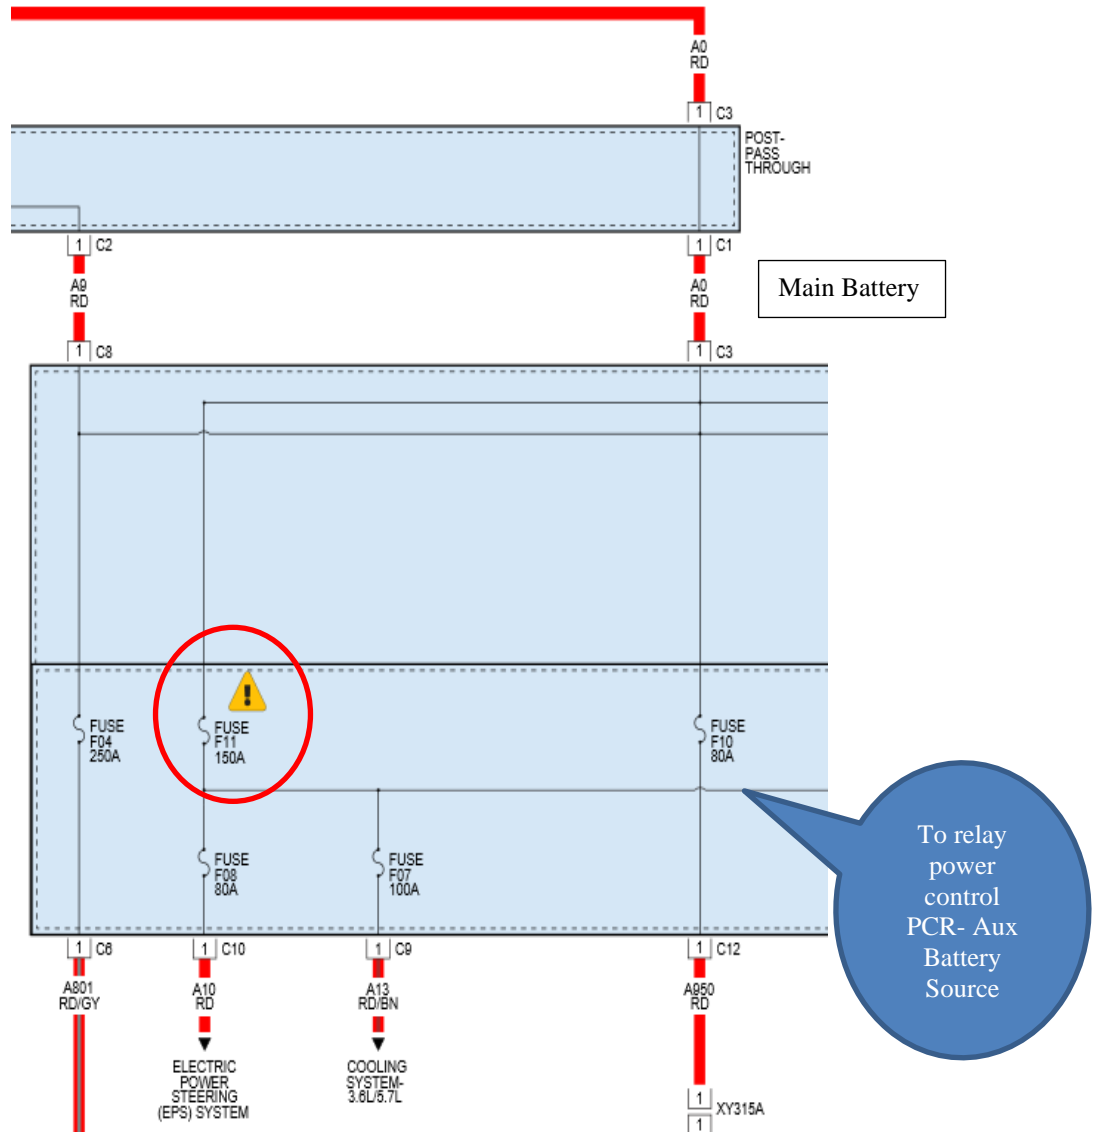
Fig 1

Jump starting the vehicle improperly can cause the 150amp fuse to open.
Part #68496448AA

This fuse open concern may not set any DTC's but can cause intermittent Start/Stop, EPS and cooling concerns as the aux battery is not getting fully charged.

Repair Procedure: Inspect the 150amp fuse (F11) at the at the front PDC. This circuit has a redundant power source with the PCR to supply AUX battery power during a fuse open concern. Inspect the rear PDC fuse array, #5 – C7 150amp fuse from the main battery, location #3 - C6 shunt from the aux battery Fig 4.
