# Technical Service Bulletin

## 51 Water ingress into the front footwells

51 22 25 2067103/2 June 6, 2022. Supersedes Technical Service Bulletin Group 51 number 22-24 dated May 23, 2022, for reasons listed below.

Model(s)	Year	VIN Range	Vehicle-Specific Equipment
A8 e quattro	2020 – 2021	All	PHEV

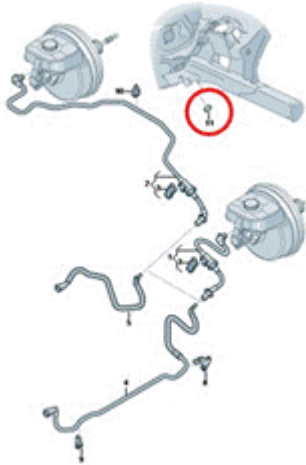
4N0611817A

<p>Body plug</p>	1
------------	--	---

Remove the speed nut for the heat shield on the plenum chamber bulkhead and loosen the heat shield to provide access to this opening. Install body plug 4N0 611 817 A in this opening (Figure 3).
