TECHNICAL INSTRUCTIONS

LIMITED SERVICE CAMPAIGN 22LD01

OPTIONAL BODY-COLORED REAR SPOILER DESIGNED FOR:

CERTAIN 2021 MODEL YEAR IS 300 VEHICLES

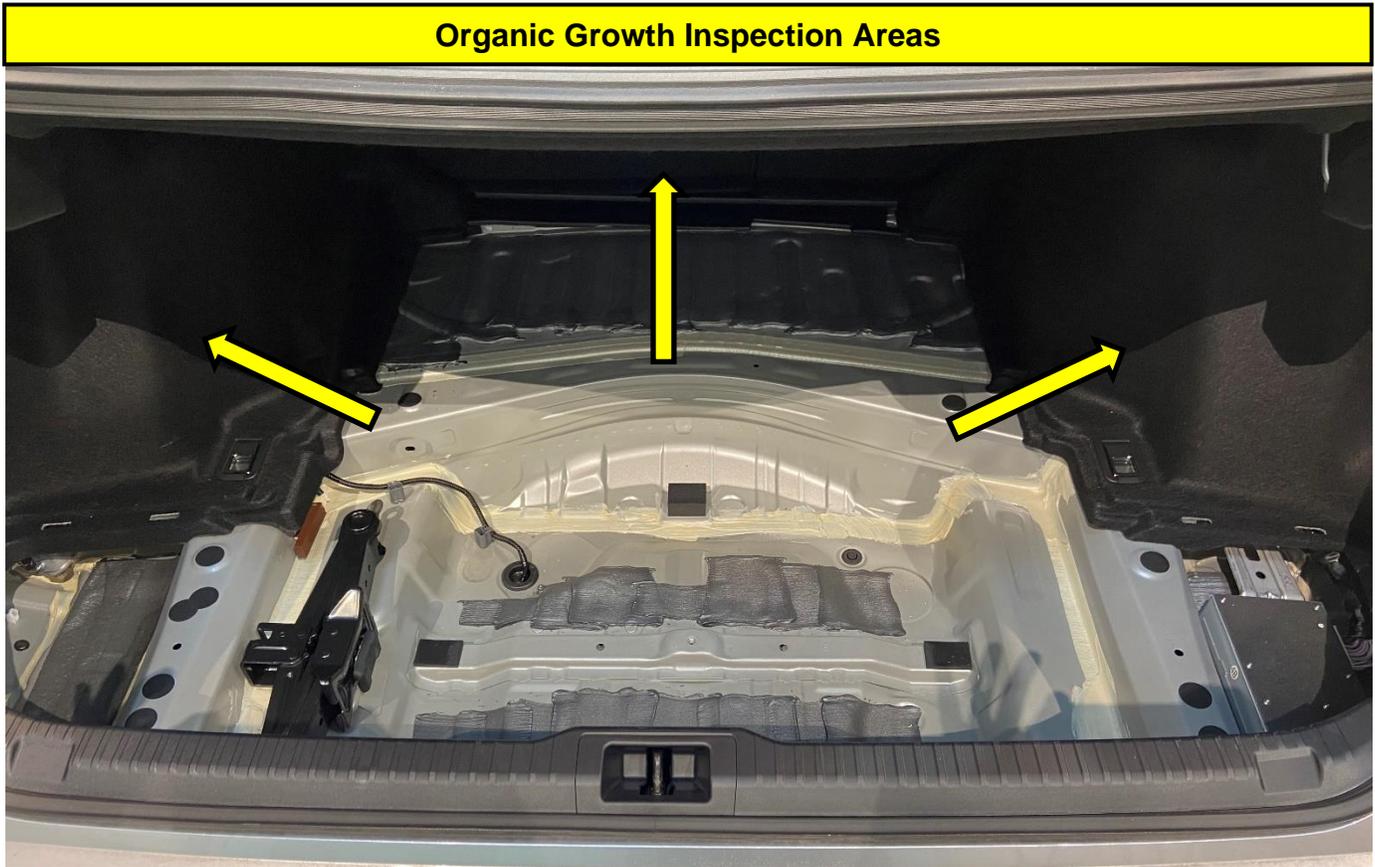
11. **VISUALLY INSPECT TRUNK FABRIC LINER COMPONENTS FOR ORGANIC GROWTH**
a) Visually inspect the fabric liners, shown below, for signs of organic growth caused by water intrusion.

Examples of Organic growth

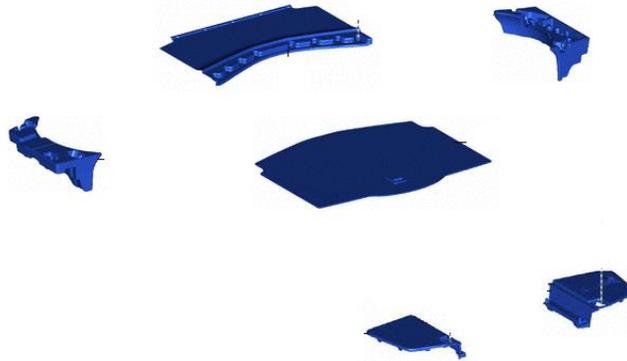
- a) Visually inspect the trim components, removed in earlier steps, for signs of organic growth caused by water intrusion.

- b) Organic growth is most commonly found on the jute padding. But you should inspect both sides of the panel
