**Title: Cab Water Leak Troubleshooting Tips**

**Applies To:** LT, RH, ProStar, HX Steel Cab, and Lonestar sleeper cabs. However some aspects may also apply to all cabs in the High Performance Vehicle family - MV, HV, LT, RH, ProStar, LoneStar, TransStar, WorkStar(HV), DuraStar(MV), HX- (Steel cab) and TerraStar. Does not apply to: 9000i, PayStar(HX) Aluminum Cab, CityStar, CV, or LoadStar.

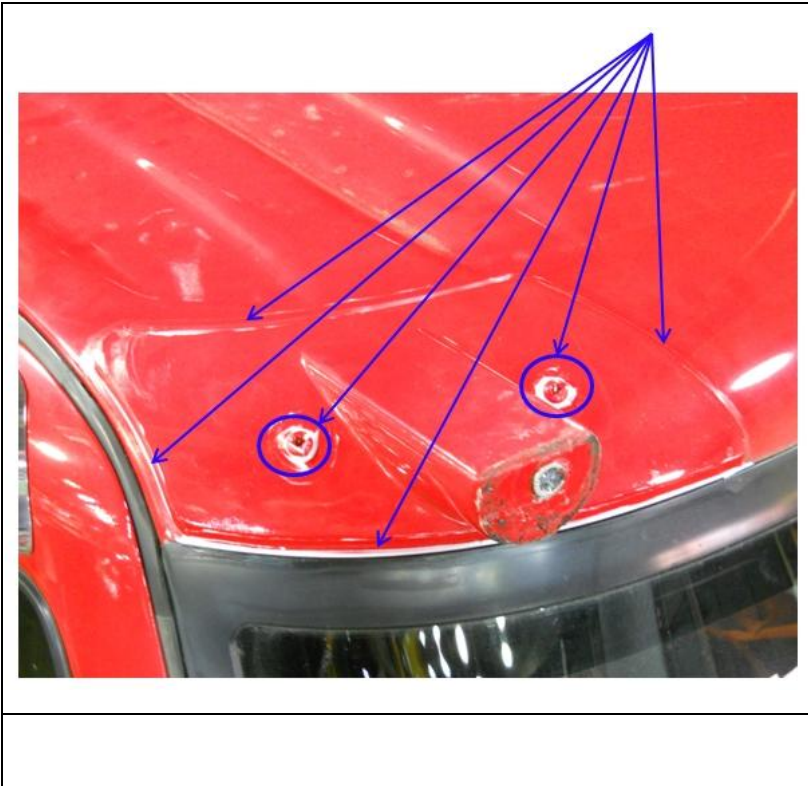
### **Sunshade Mounting Leaks**

- Water leaks from the sunshade mounting can originate where the bracket mounts to the cab or where the sunshade mounts to the mounting bracket. One or both areas may not be properly sealed.

1. Remove the marker lights to access the sunshade attachment bolts.
2. Disconnect the wire harness.
3. Remove the sunshade from the vehicle at the three mounting attachments and dispose of the fasteners (if the replacement fasteners, 3820148C1, are not available then keep the original fasteners for reassembly).
4. Remove and dispose of the foam gaskets on the mounts.
5. Thoroughly clean the fasteners that attach through the sunshade mounting brackets as well as the perimeter surface of each mounting bracket with IPA (isopropyl alcohol).

6. Allow the surfaces to dry.
7. Apply Dow® BETASEAL™ (2611723C1) to the same areas cleaned in Step 5.
8. Immediately wipe off the surfaces (prolonged exposure to the Dow® primer could damage the paint). These surfaces are now prepped for good adhesion to the sealer.
