Technical Service Bulletin

| SUBJECT: | | No: TSB-21-42A-011REV2 | |
| MODIFIED HOOD FOR HOOD FLUTTER - 2022 OUTLANDER - REVISED | | DATE: June 2022 | |
| | | MODEL: 2022 Outlander | |

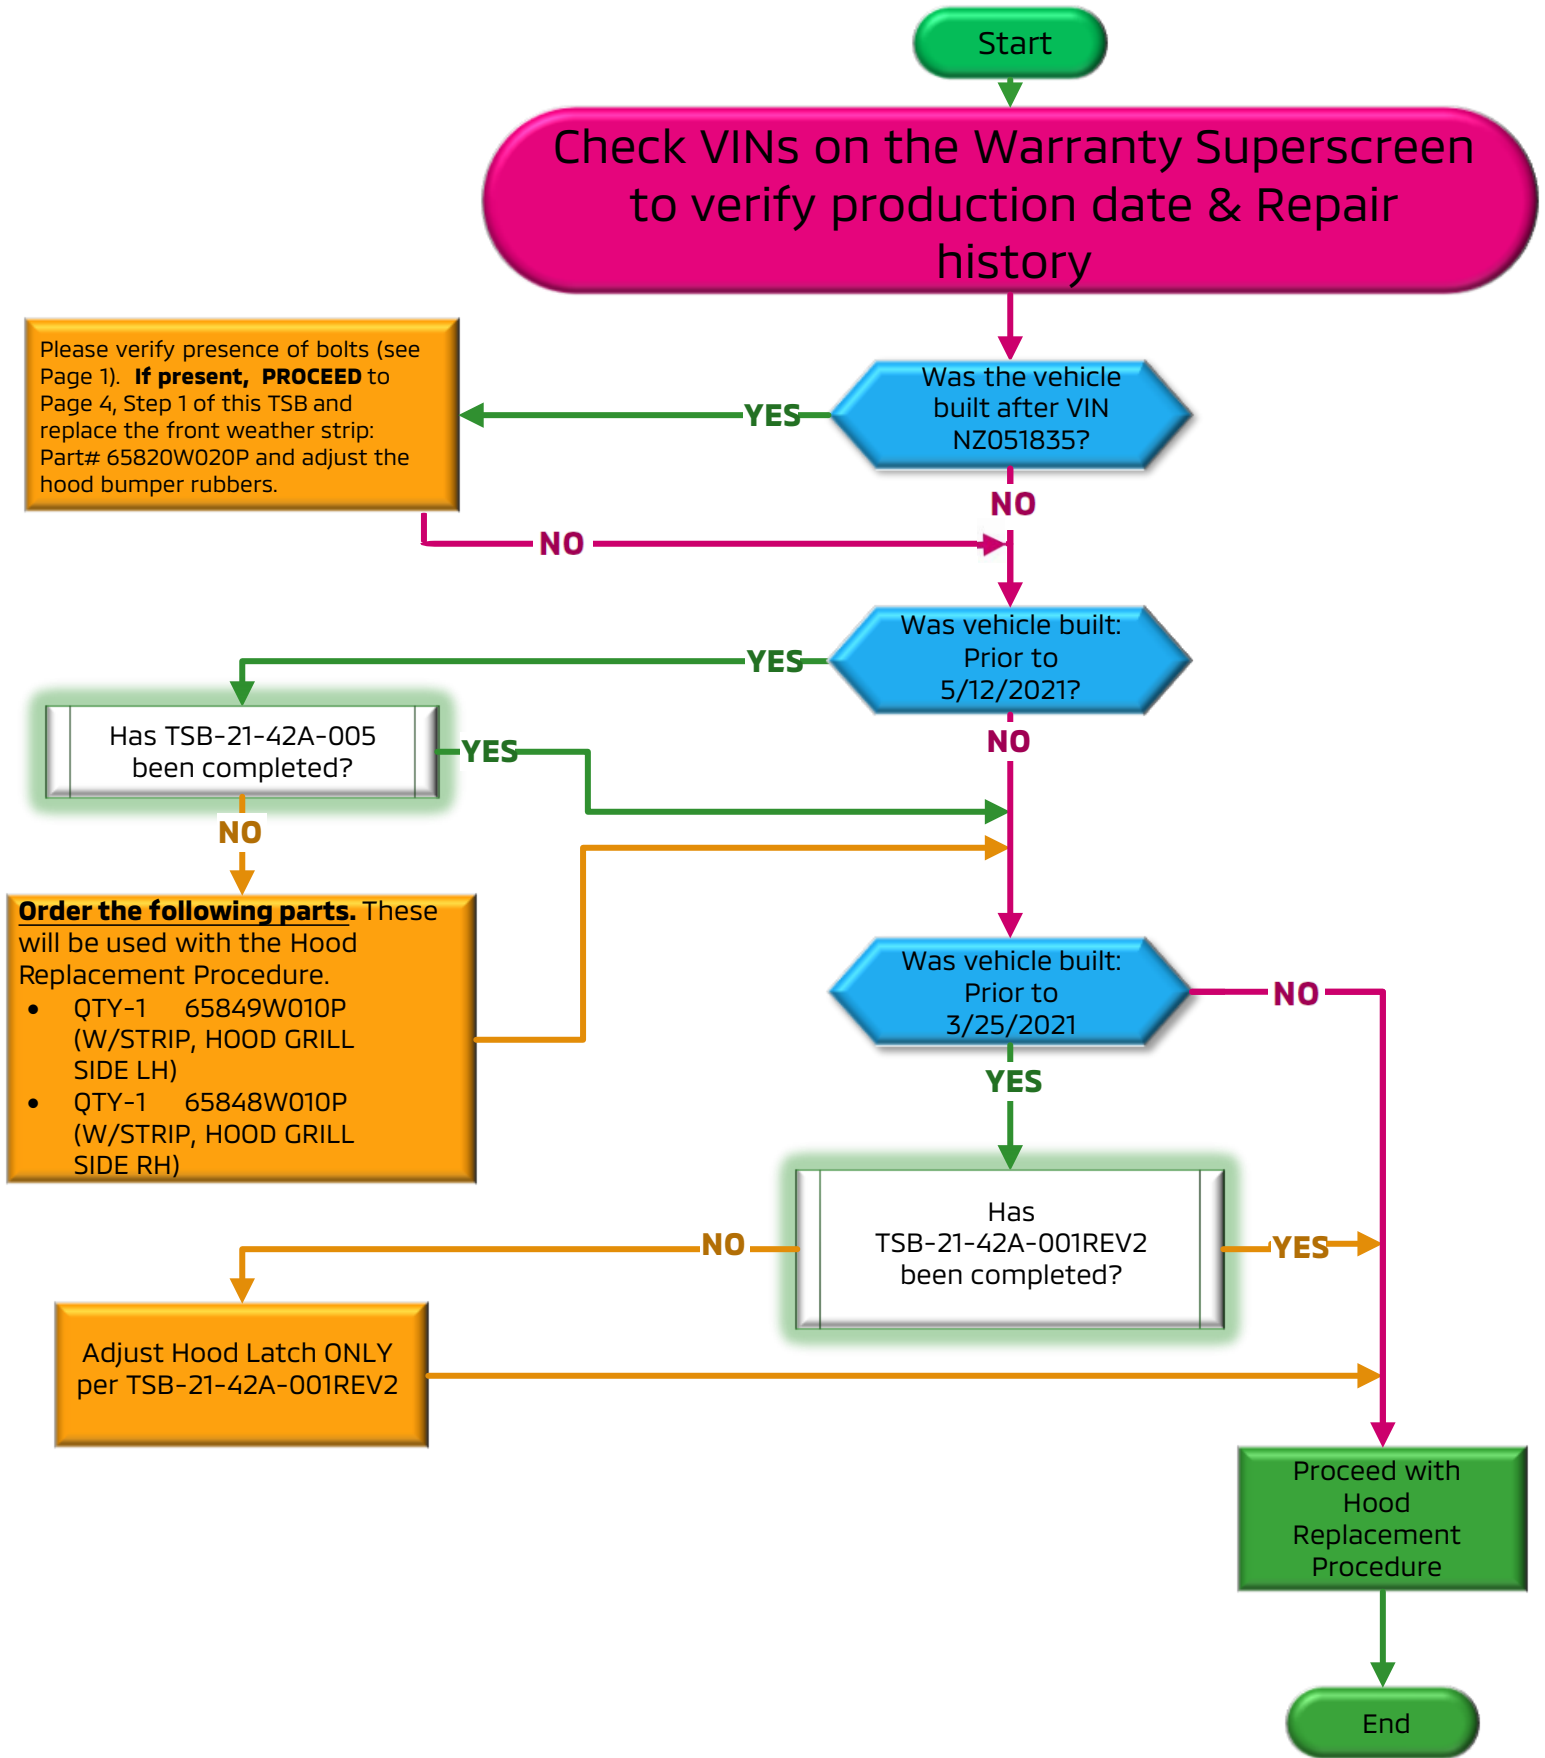
Please refer to the flow chart (page 2 of this bulletin) prior to proceeding with the procedure to determine/confirm the next appropriate steps.
