Technical Service Bulletin

22-ST-005H-1

JUNE 2022

SUBJECT: C-MDPS WORM SHAFT BEARING NOISE

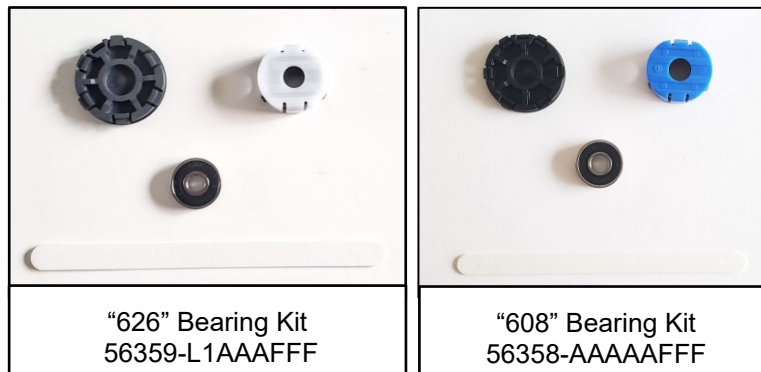
Description: Certain vehicles may develop a bearing noise within the Motor Driven Power Steering (MDPS) column worm shaft assembly. If bearing noise is heard, follow the procedure in this bulletin to replace the worm shaft bearing.
