Service Bulletin

Bulletin No.: 19-NA-076

Subject: Blue or Black Screen and Service Rear Vision System Message on Radio Display Shifting into Reverse

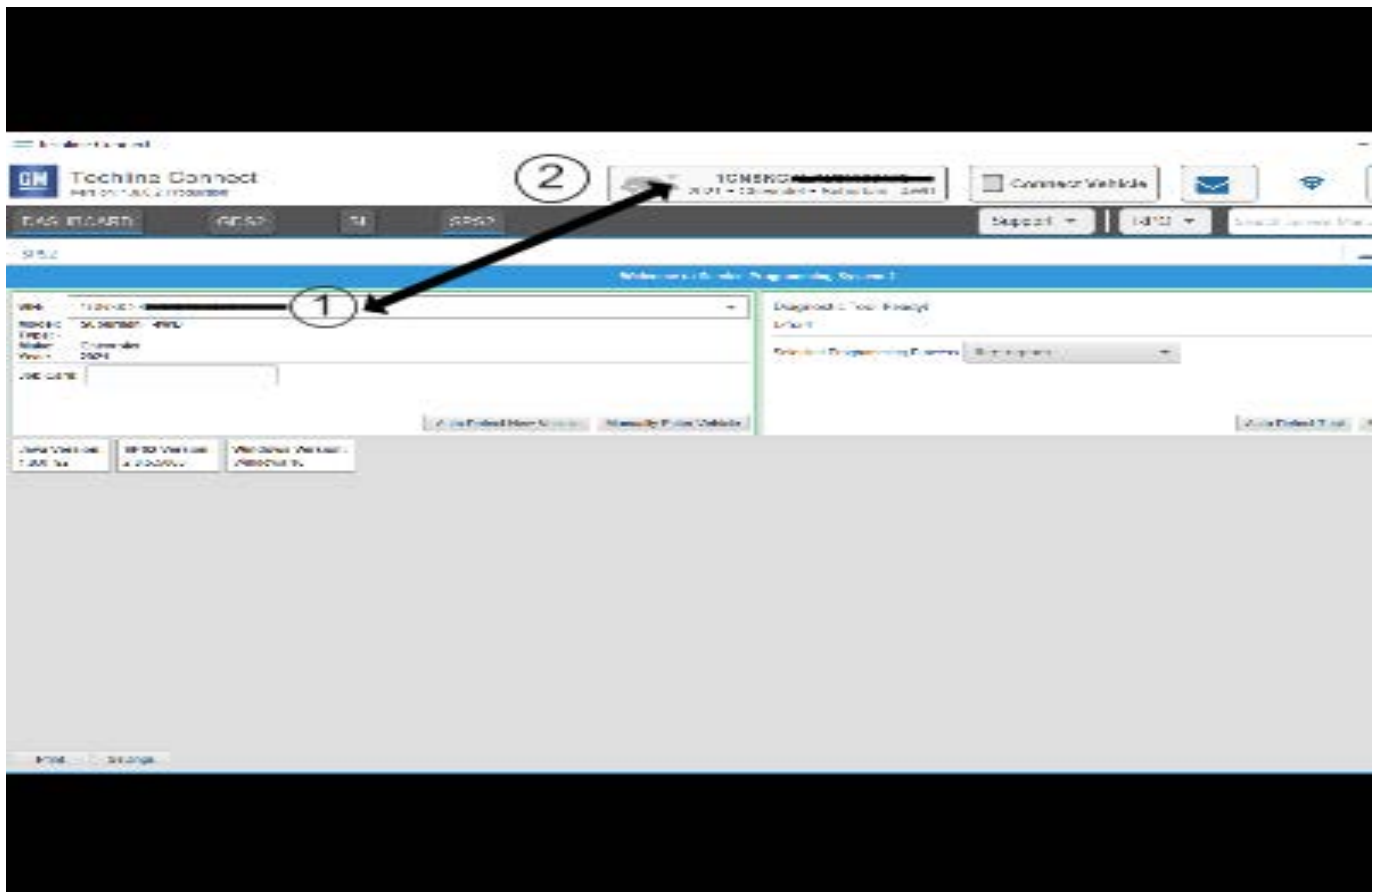
Caution: Be sure the VIN selected in the drop down menu (1) is the same as the vehicle connected (2) before beginning programming.

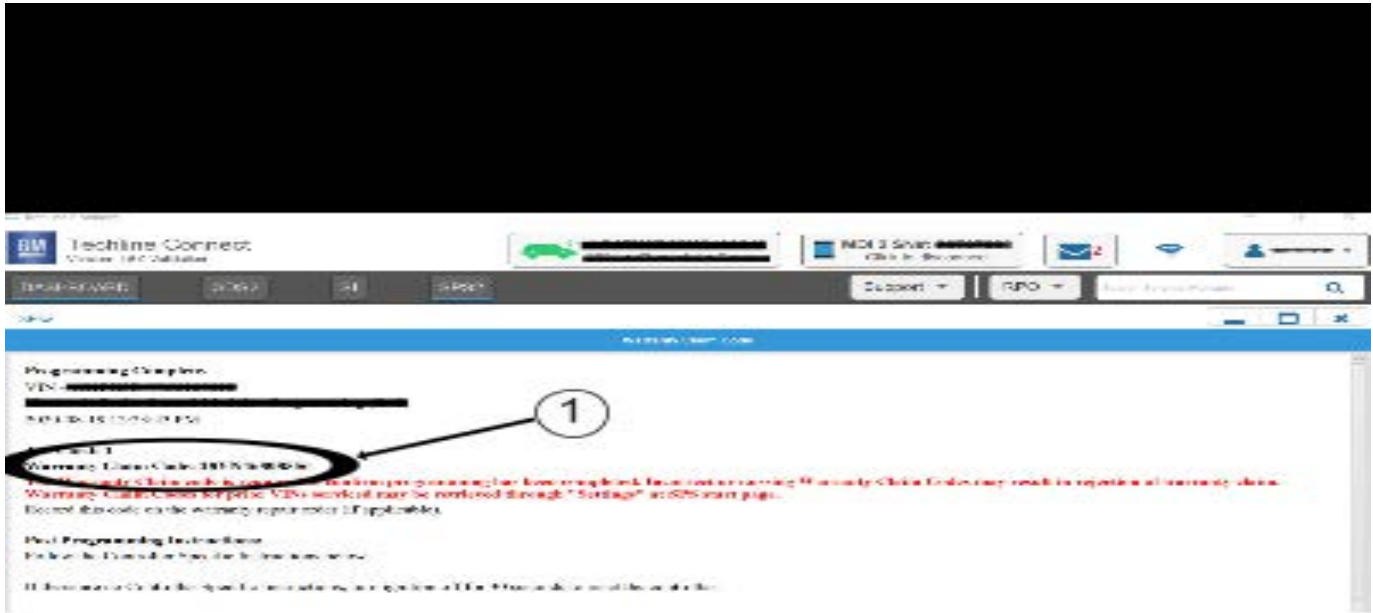
5644477

Note: The screenshot above is an example of module programming and may not be indicative of the specific module that is being programmed. Module selection and VIN information have been blacked out.

Important: To avoid warranty transaction rejections, you **MUST** record the warranty claim code provided on the Warranty Claim Code (WCC) screen shown above on the job card. Refer to callout 1 above for the location of the WCC on the screen.
